The Development of Asphalt Surfacing for Steel Bridge Decking

J. J. TROTT

D. S. WILSON

Road Research Laboratory, Department of Scientific and Industrial Research,
United Kingdom

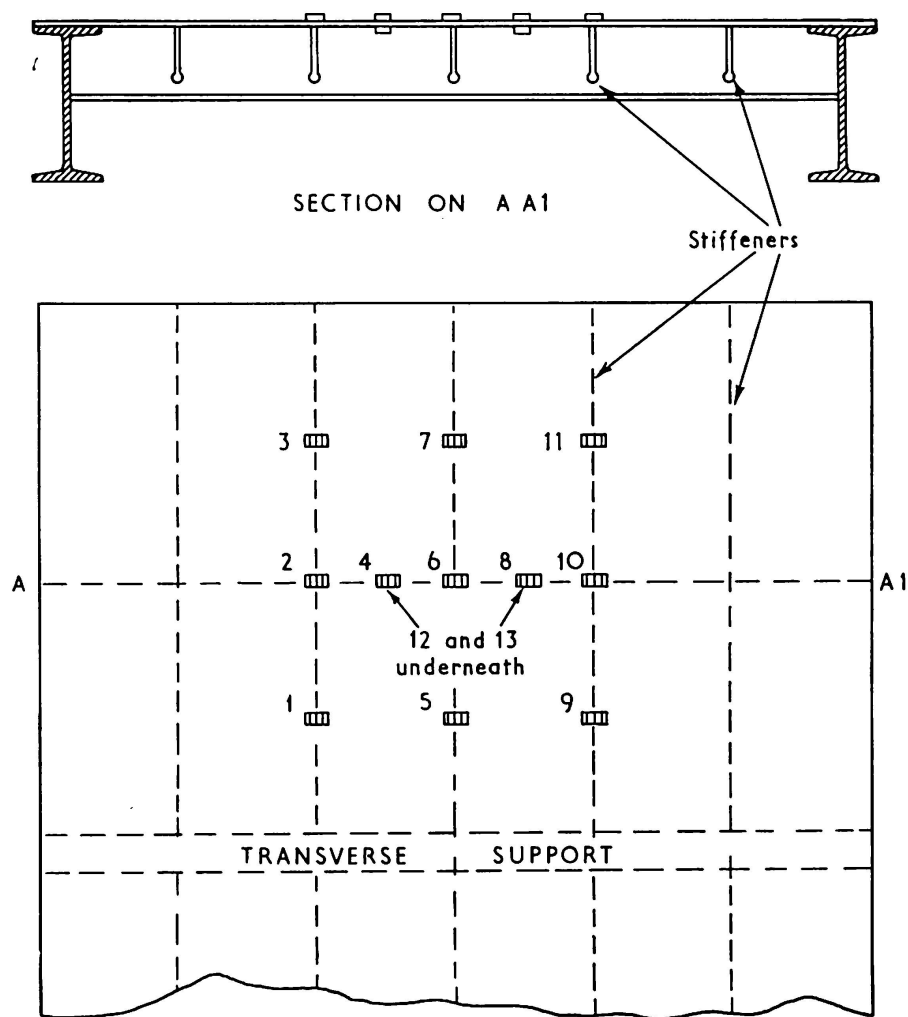
Fig. 11. Portion of Deck Plate Showing the Positions of Strain Gauges.

Gauges 1 to 11 were used on the upper surface of the steel and gauges 12 and 13 were attached to its under side. The strain gauges were of the foil type and were cemented to the steel by an epoxide resin. A thermocouple was also attached to each steel plate to measure the temperature of the asphalt surfacing.

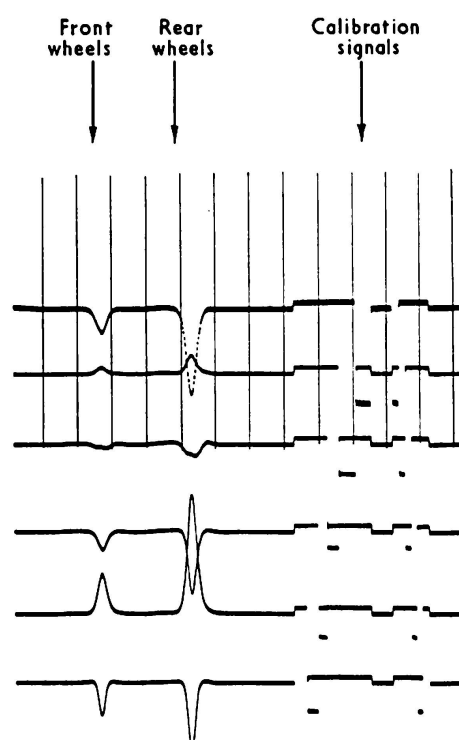
Fig. 14. Dynamic Strain Record. Vehicle Travelling at Creep Speed (About 3 mile/h).

The waveform of the recorded strain did not vary with vehicle speed, but the duration of the strain was, of course, inversely proportional to the speed. A typical set of records is shown in fig. 14.
