Artikel: The development of asphalt surfacings for steel bridge decking

The Development of Asphalt Surfacings for Steel Bridge Decking

Road Research Laboratory, Department of Scientific and Industrial Research,
United Kingdom

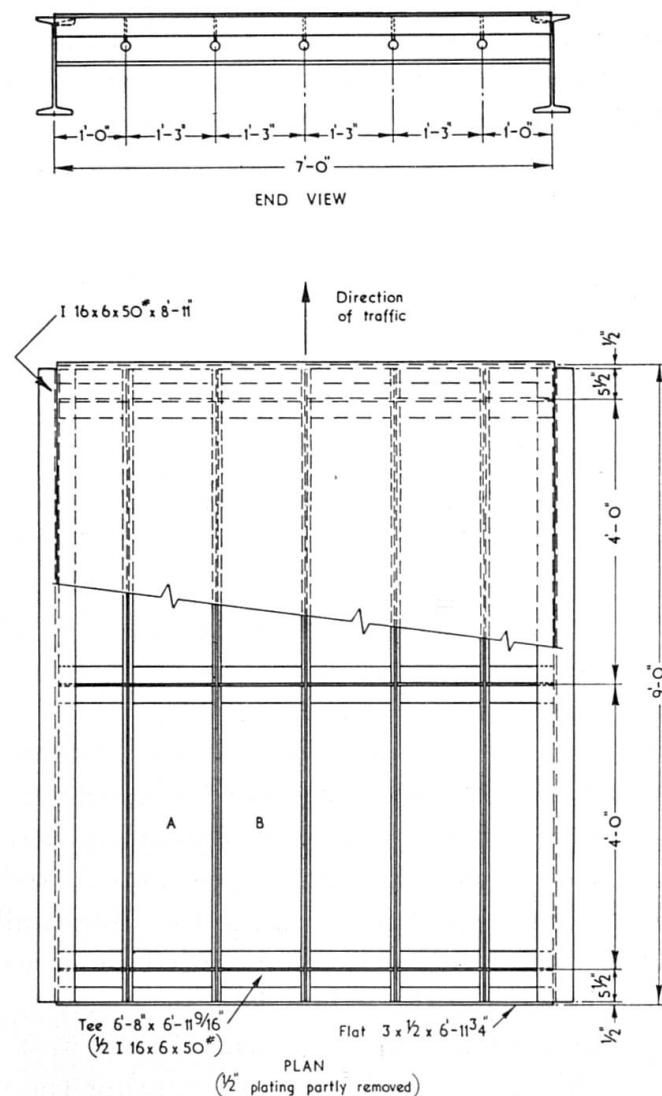
Fig. 1. Deck Panels for First Surfacing Test.

Loading tests were made on these panels on two occasions — 2nd February and 1st March, 1950 — to determine whether the surfacings would crack due to the deflection of the decking under the maximum design wheel load of $12\frac{1}{2}$ tons. The load was applied in turn at positions A and B (see fig. 1) on each panel. The load was applied to the plate by a hydraulic jack through a section of 14-in. wide solid rubber tyre mounted on a wooden block, and released rapidly by unscrewing the valve. The tests were repeated twice each day and the temperature of the mastic at the time of test varied between 1 and $4\frac{1}{2}^{\circ}\text{C}$. The mastic surface did not crack during these tests. Since the stiffness of the decking on the proposed bridge is greater than that of the

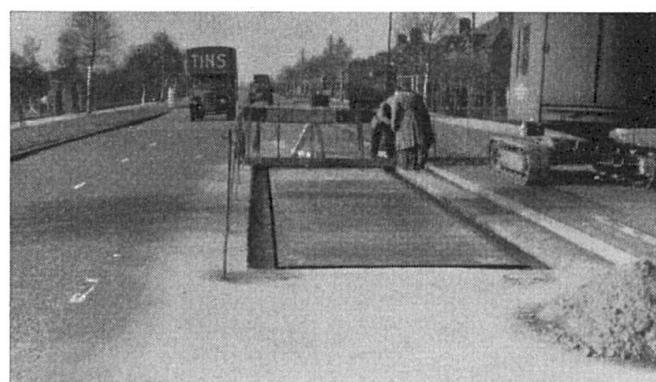
Fig. 2. Panels in Position Prior to Surfacing.

For the full-scale tests, four panels, each 9 ft. long by 7 ft. wide, were laid in the road (see fig. 2). Three of the panels had smooth deck plates while the fourth had a chequered plate which was included because it was feared that the surfacing might "push" on a smooth plate. The four plates were sand-blasted and painted as described, and then placed in the carriageway with their ends supported on concrete beams. The levels of the panels were stepped to permit thicknesses of surfacing of 1 in., $1\frac{1}{2}$ in. and 2 in. to be laid on the three smooth plates and a $1\frac{1}{2}$ -in. surfacing on the chequered plate. Fig. 2 shows the panels in position before surfacing. Steel plates 12 in. wide covered the gaps between the sides of the panels and the road. The panels were sited on the braking side of a bus-stop and thus received maximum traffic forces. A proprietary brand of mastic asphalt was selected as suitable; this was supplied and laid by the Limmer and Trinidad Lake Asphalt Company Limited. The material complied in general with B.S. 1447, Table 1, Col. 3, but the penetration of the 50/50 mixture of Trinidad Lake asphalt and asphaltic bitumen was in the neighbourhood of 10. The penetration of the soluble portion of this binder was about 20. 40 per cent of granite chippings were added, as indicated in B.S. 1447. $\frac{1}{2}$ inch coated granite chippings were rolled into the surface of the mastic to provide a non-skid surface.

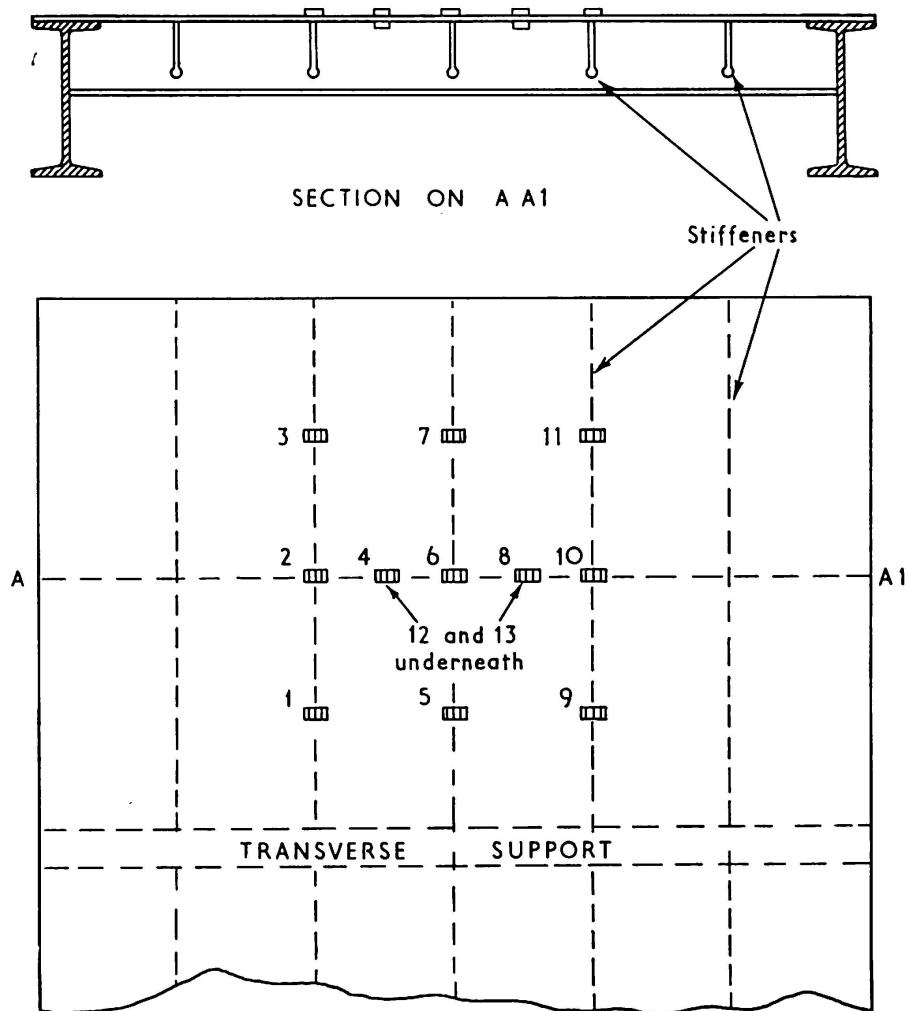
Fig. 11. Portion of Deck Plate Showing the Positions of Strain Gauges.

Gauges 1 to 11 were used on the upper surface of the steel and gauges 12 and 13 were attached to its under side. The strain gauges were of the foil type and were cemented to the steel by an epoxide resin. A thermocouple was also attached to each steel plate to measure the temperature of the asphalt surfacing.

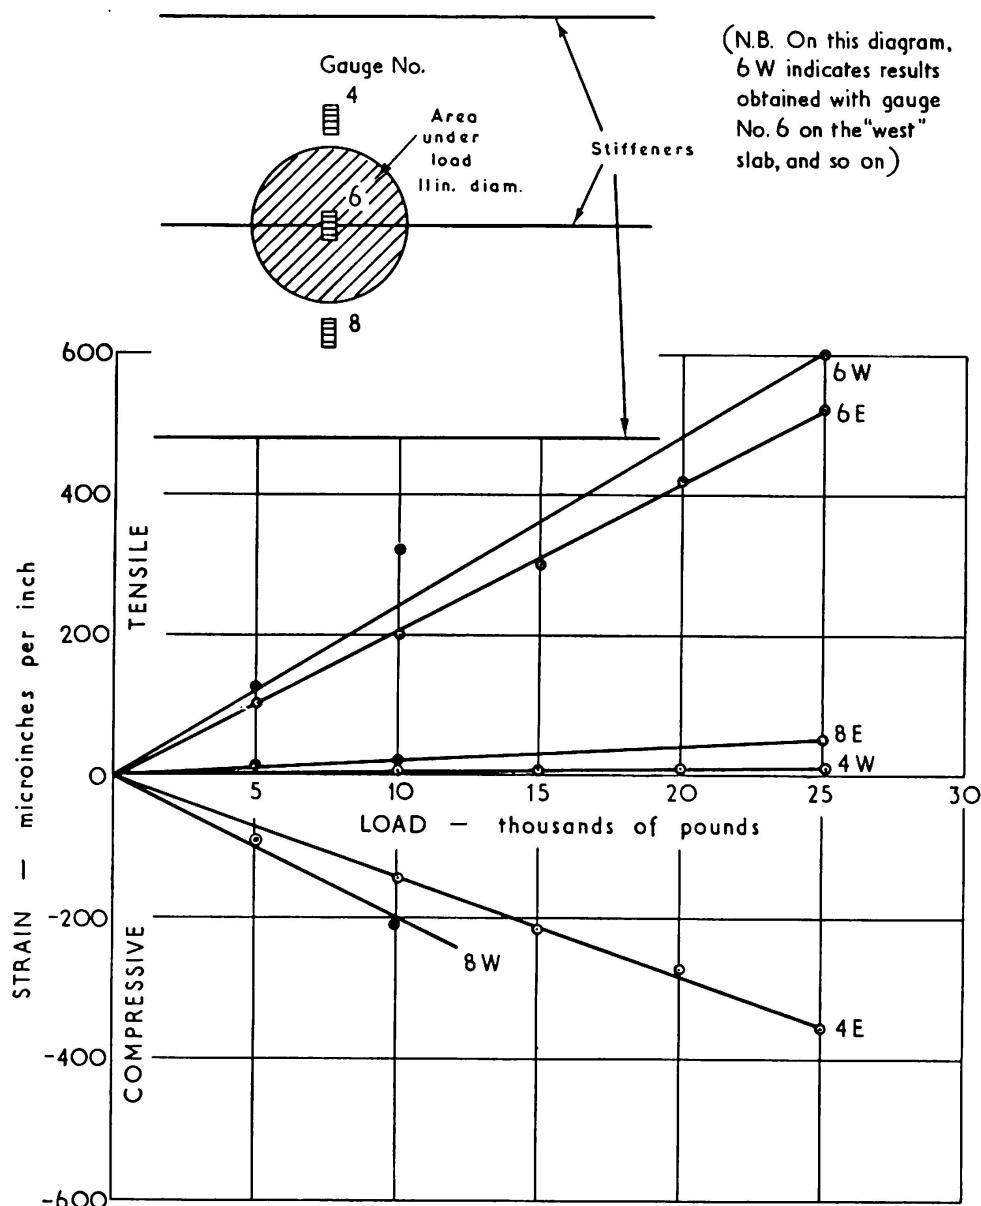
Fig. 12. Results of Static Tests on the Bare Steel Plate With Centre of Load Over Gauge No. 6.

were made are shown in figs. 12 and 13, one test being made directly over the central stiffener and the other midway between two stiffeners. Figs. 12 and 13 show the measured strains plotted against applied load. Linear relationships occurred between strain and load in all cases, hence these diagrams could be used to determine the strain in the steel at a load equal to that applied by each wheel when tests were made later with a moving vehicle. The largest tensile strains in the transverse direction occurred at gauge No. 6 on both panels, this gauge being that placed across the stiffener. As figs. 12 and 13 show, the rigidity of the panels (marked "East" and "West") was approximately equal, particularly having regard to the variations that might occur in producing the complicated welded structures.

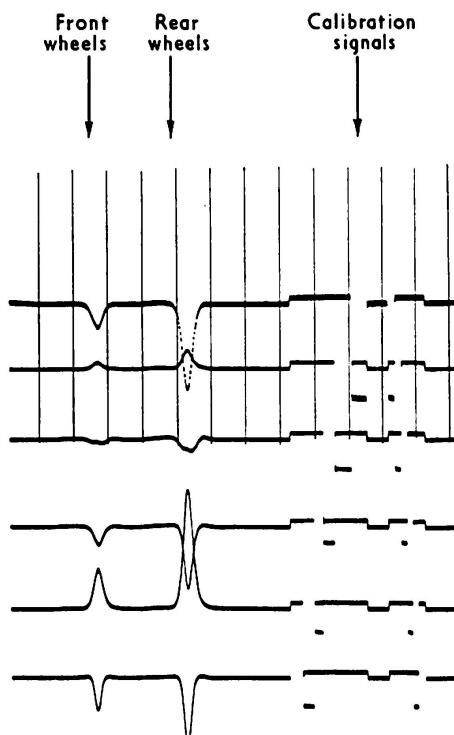
Fig. 14. Dynamic Strain Record. Vehicle Travelling at Creep Speed (About 3 mile/h.).

The waveform of the recorded strain did not vary with vehicle speed, but the duration of the strain was, of course, inversely proportional to the speed. A typical set of records is shown in fig. 14.

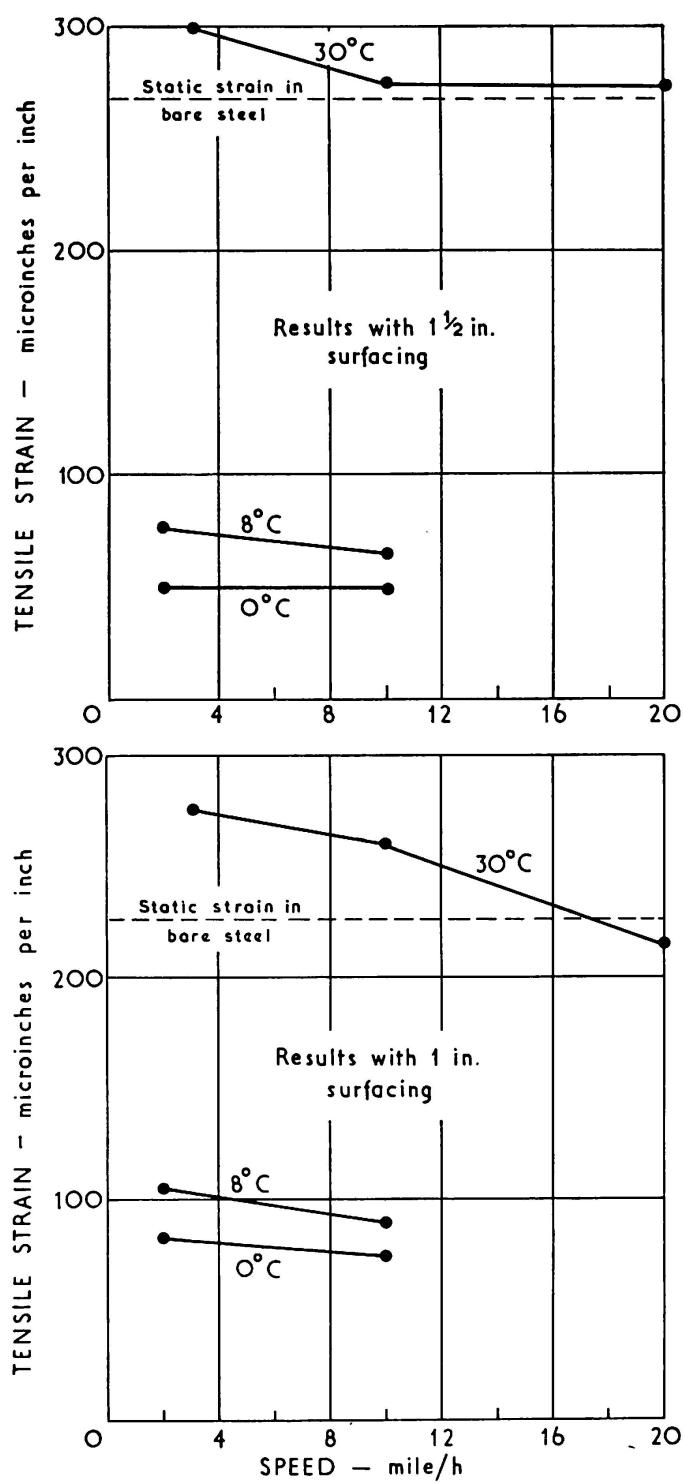
Fig. 15. Effect of Vehicle Speed and Temperature on the Dynamic Strains in Bridge Panels Caused By a Wheel Load of 11000 LB.

Values of the peak tensile strain recorded by gauge No. 6 in each test run are shown in fig. 15 plotted against the vehicle speed, separate curves being shown for the three surfacing temperatures studied. Separate sets of curves are shown for each panel, and each diagram shows the tensile strain deduced from the static tests at a load equal to that applied by the rear wheel of the moving lorry, i. e. 11,000 lb. The distribution of strain occurring under the load applied by the jack to a rubber disc 11 in. in diameter and that applied by the vehicle tyre having an elliptical contact area about 12 in. by 8 in. will not be identical. The static strains have been included in fig. 15 merely as a yardstick by which to judge the strains recorded under the moving vehicle. The fact that, at 30° C, the dynamic strain recorded with, say, a surfacing $1\frac{1}{2}$ in. thick, was actually greater than that recorded statically, with the load applied to the bare steel, therefore, has no significance.

Both sets of diagrams on fig. 15 show much larger strains in the steel when the surfacings were at a temperature of 30° C than at 0 and 8° C. The diagrams indicate that at 30° C, the surfacings made only minor contributions to the rigidity of the steel plate, whereas at the lower temperatures, their contributions were appreciable. If it is assumed that the strains measured in the static test were directly comparable with the dynamic values, it would appear that, at 0° C, the $1\frac{1}{2}$ -in. surfacing contributed about 80 per cent as much as the steel plate to the overall rigidity, while the contribution of the 1-in. surfacing was 60 per cent. If the mastic asphalt behaved elastically under the stresses and rates of loading applied by the moving vehicle, it would be expected that the elastic modulus would be higher at the low temperature than at 30° C. Tests on bituminous materials have indicated that the change of modulus corresponding with this temperature change may be of the order of three to four times greater and this would largely explain the recorded differences in strain at summer and winter temperatures.

The trafficking tests which lasted $4\frac{1}{2}$ years showed a difference in the performance of the 1-in. and $1\frac{1}{2}$ -in. surfacings. It is possible that summer temperatures only applied for a small proportion of the period of test and, at lower temperatures, as fig. 15 shows, there was a difference in the strains generated in the steel plates by vehicles travelling over the two thicknesses of surfacing.
