Artikel: Laboratory testing of full-size aluminium bridge

Autor: Michalos, James / Kubo, Gerald G. / Birnstiel, Charles

Laboratory Testing of Full-size Aluminum Bridge

Department of Civil Engineering, New York University, New York, N. Y., U.S.A.

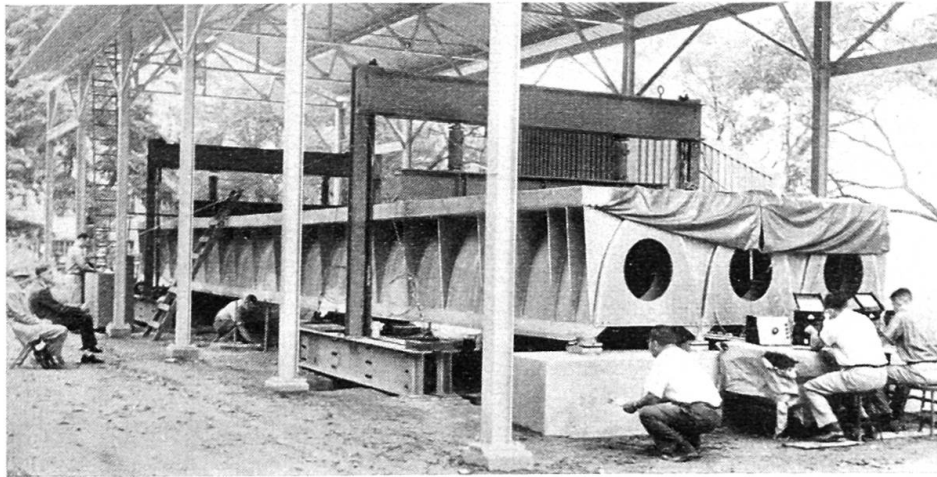
Fig. 1. Static Load Test.

Loads were applied to the test bridge by hydraulic rams reacting against structural steel yokes which transferred the ram reactions to anchor rods embedded in rock. Fig. 1 shows the loading yokes in place for a static load test.

The live loads were applied, as shown in Fig. 1, by means of hydraulic rams symmetrically positioned on transverse distribution beams. Thus the force was distributed essentially as a line load across the width of the deck. The loads were placed 12 ft. 2 in. from each end bearing so as to produce vertical shear and bending moment values which would be proportional to the design shear and design moment respectively. As used herein, design shear and design moment are the maximum values produced in a one-lane, simply-supported bridge by a 20-ton truck, together with impact effect, as defined by the current AASHO specifications.

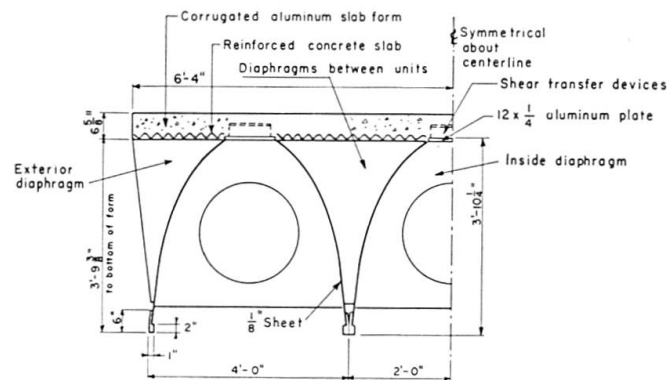
The test bridge (see Fig. 1 and Fig. 2) had three prefabricated, aluminum modular units supported on commercial type (Lubrite) bearings which rested on concrete piers founded on rock. The reinforced concrete slab was, on the

Fig. 2. Half-Section Through Bridge.

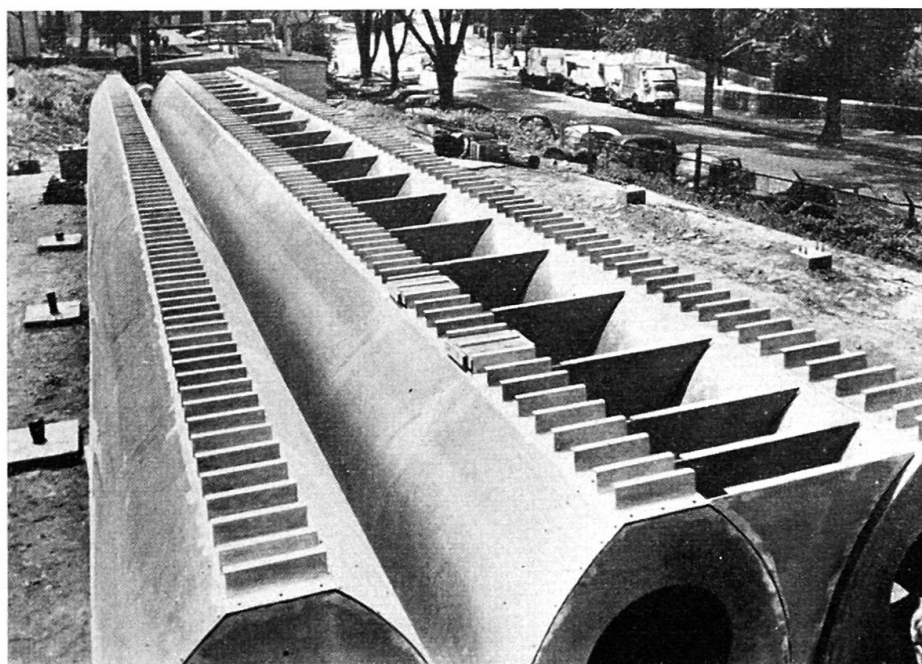
average, slightly over $6\frac{1}{2}$ -in. thick. It was joined to the aluminum modules by means of extruded aluminum shear transfer devices in order to insure composite action. The Z-shape shear devices are shown in place during erection in Fig. 3. All aluminum components were fabricated from a non heat-treatable

Fig. 3. View During Erection.
