# **RECORDED FAILURES OF ELECTRICALLY WELDED WROUGHT-IRON AND MILD STEEL BRIDGES.**

H. J. L. BRUFF, Bridge Engineer, North Eastern Area, London and North Eastern Railway,  
York.

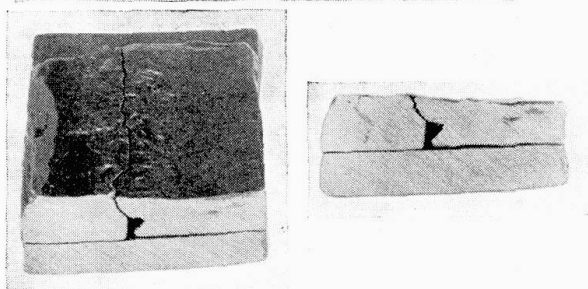
Fig. 5.

As will be seen from the section it was intended that the welds should not only unite the strengthening plates and the toes of the "T" or angle stiffeners, but also the old web itself. On cutting out the fractured welds, as shown in Fig. 5, it was found, that good penetration had been obtained between the strengthening plate and the "T" but that there was no penetration in the case of the web, as will be seen from the photograph of a part of the "T", strengthening plate and web which were cut out in order that the cause of the fracturing might be ascertained.

been in full contact with the web plate. Out of 48 welds 17 were found to be fractured, these were all cut out and in not a single instance had penetration with the web been secured. The practice is now to make the gap  $1/16$ " min. the face of the chamfer the same, using a No. 10 electrode with a slightly higher

Schnitt durch die gerissene Schweißung.  
Coupe à travers la soudure rompue.  
Section of fractured weld.

amperage than normal, which in the case of so light a run is not likely to over-heat the mild steel. Fig. 6 shows the repaired girder with removed section (Fig. 5) which was not replaced, the hole was merely fillet welded round the edges as there was ample section left for strength. The bottom flange, which the photo shows covered with gunite, was badly wasted by blast from engines,
