## 8. Elevated Bridge in Hanshin Expressway in Osaka (Japan)

**Owner:** Hanshin Expressway Public Corporation  
**Consultant:** Prof. Dr. K. Horikawa  
**Contractor:** Takara Giken Co. Ltd.  
**Work's duration (Field work):** 6 months (2 weeks)  
**Repair date:** 1986

### Replacement of Flange without Traffic Interruption

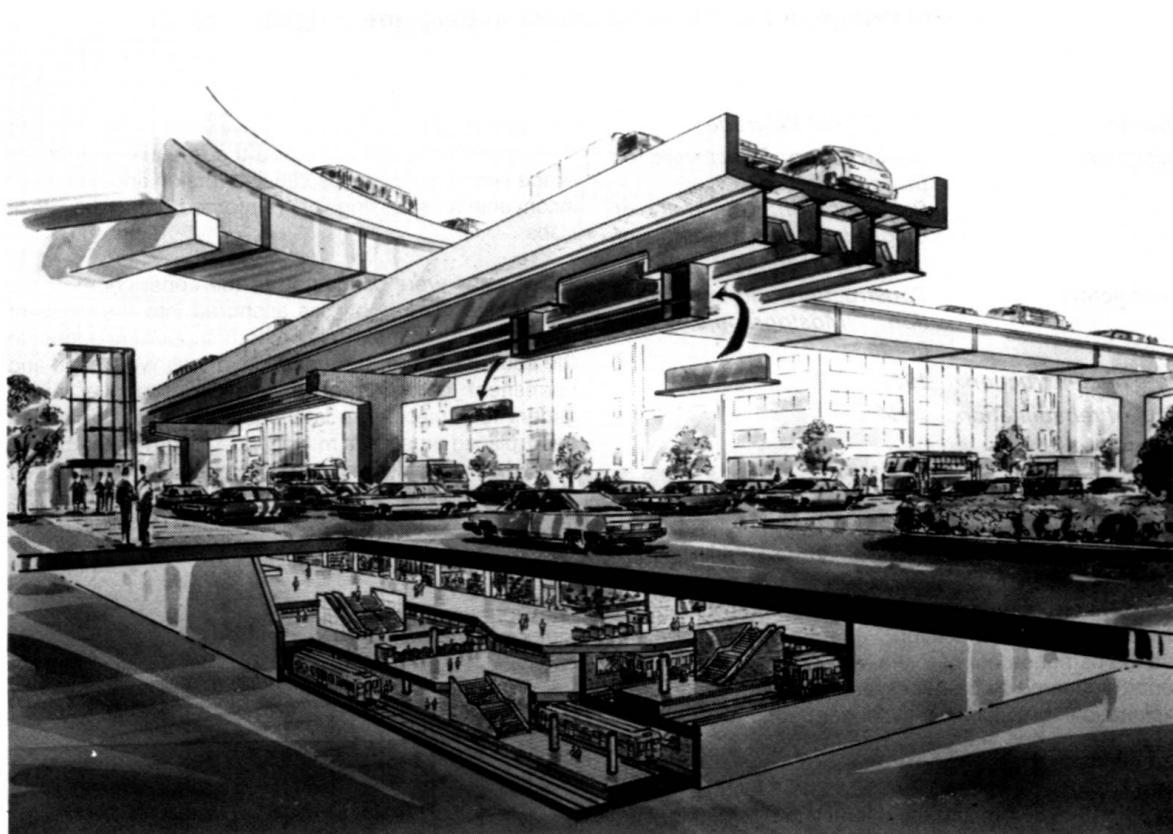
Heavy corrosion appeared at the lower flange plate, the lower end of web plate and one of the vertical stiffeners of a plate girder bridge (Fig. 1). It was caused by leakage of water through the timber plate used for a mold, which had been left in the concrete slab after completion. The location of the corroded area was the main girder near the span center of a 2-span continuous girder bridge for highway. The bridge was an elevated bridge in such a heavy traffic urban area (Fig. 2), that it was impossible to use any intermediate supports for the girder during repair and also impossible to suspend the traffic on the highway. Thus, the corroded area had to be repaired under loading and vibration.

Fig. 1 Corrosion in a bridge

- 1) To remove rust from the surface of the corroded area and paint it.
- 2) To remove rust from the surface of the corroded area and weld a reinforcing cover plate.
- 3) To remove the corroded area and install new members.

Thinking of the heavy corrosion, method 3) was adopted in the repair using a by-pass member, which was to

carry the force that was carried by the part to be removed, during the repair. This repairing method is named «By-pass Method». Connections of the new part were of both welding and fastening with H.T. bolts; the lower flange was welded and the web was fastened with H.T. bolts.
