## 9. The Bridge in the Radnička Street in Belgrade (Yugoslavia)

**Owner:** *The City of Belgrade*  
**Designer:** *Construction: Directorate for Bridges, Belgrade*  
*Rehabilitation: University of Belgrade, Department of Civil Engineering*  
**Contractor:** *Construction and rehabilitation: Mostogradnja, Belgrade*  
**Date of construction:** 1968  
**Date of rehabilitation:** 1984

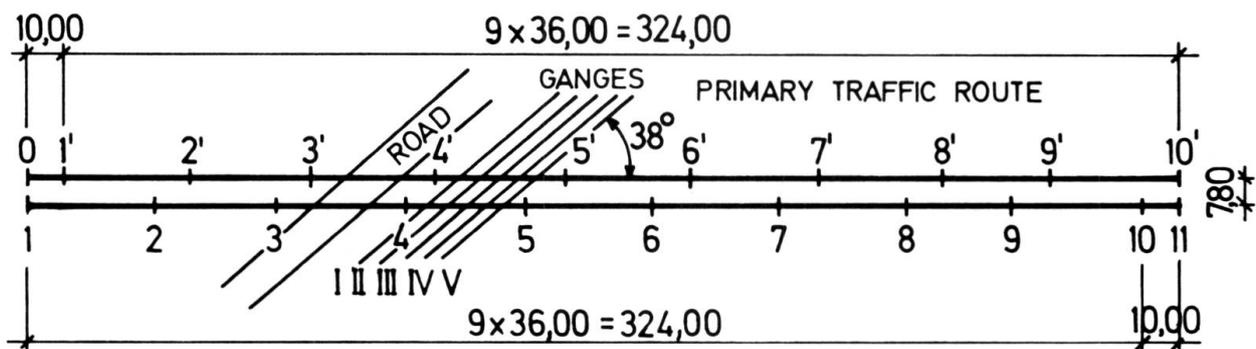
Fig. 1 Location plan of the bridge

The bridge is skewed, in vertical curvature with the biggest slope of 6%, the length being  $9 \times 36 + 10 = 334$  m and the useful width 6 m, (Fig. 1).
