Artikel: The bridge in the Radnika Street in Belgrade (Yugoslavia)
Autor: Nenadi, G. / Pakvor, A. / Darijevi, Ž.
DOI: <https://doi.org/10.5169/seals-20928>

9. The Bridge in the Radnička Street in Belgrade (Yugoslavia)

Owner: The City of Belgrade
Designer: Construction: Directorate for Bridges, Belgrade
 Rehabilitation: University of Belgrade, Department of Civil Engineering
Contractor: Construction and rehabilitation: Mostogradnja, Belgrade
Date of construction: 1968
Date of rehabilitation: 1984

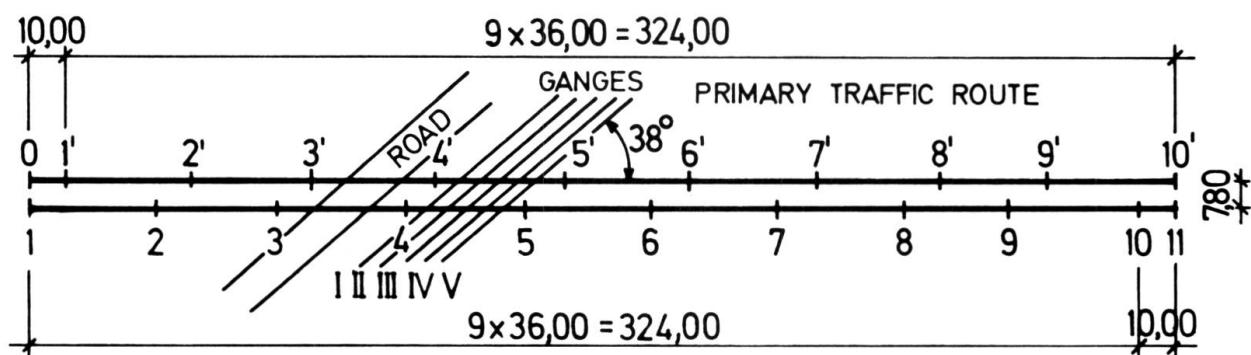
Fig. 1 Location plan of the bridge

The bridge is skewed, in vertical curvature with the biggest slope of 6%, the length being $9 \times 36 + 10 = 334$ m and the useful width 6 m, (Fig. 1).
