9. The Bridge in the Radnička Street in Belgrade (Yugoslavia)

Owner: The City of Belgrade
Designer: Construction: Directorate for Bridges, Belgrade
 Rehabilitation: University of Belgrade, Department of Civil Engineering
Contractor: Construction and rehabilitation: Mostogradnja, Belgrade
Date of construction: 1968
Date of rehabilitation: 1984

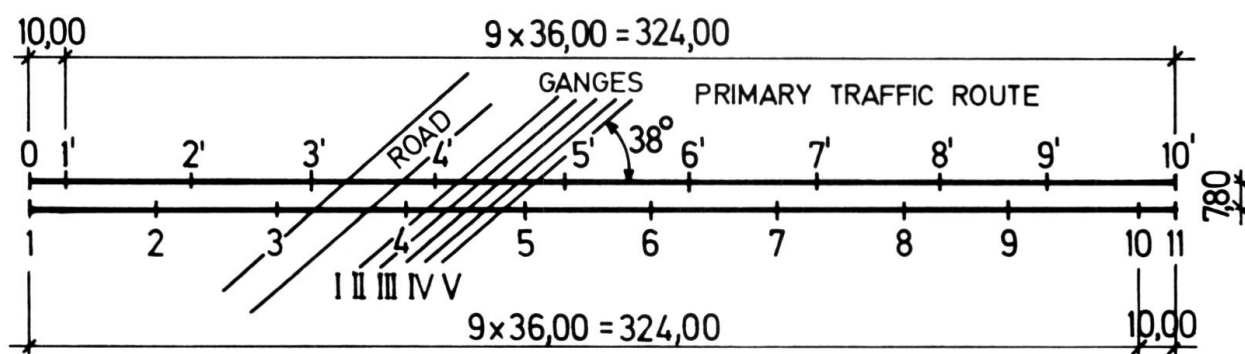
Fig. 1 Location plan of the bridge

The bridge is skewed, in vertical curvature with the biggest slope of 6%, the length being $9 \times 36 + 10 = 334$ m and the useful width 6 m, (Fig. 1).
