**Zeitschrift:** IABSE structures = Constructions AIPC = IVBH Bauwerke  
**Band:** 12 (1988)  
**Heft:** C-47: Repair and rehabilitation of bridges: case studies II

**Artikel:** Ohara Bridge fatigue crack repair (Japan)  
**Autor:** Miyazaki, Shoji  
**DOI:** <https://doi.org/10.5169/seals-20936>

## 6. Ohara Bridge Fatigue Crack Repair (Japan)

**Owner:** Toyama Prefecture  
**Engineer & Contractor:** Kawada Industries  
**Work's duration:** 6 months  
**Date of repair:** 1984 – 1985

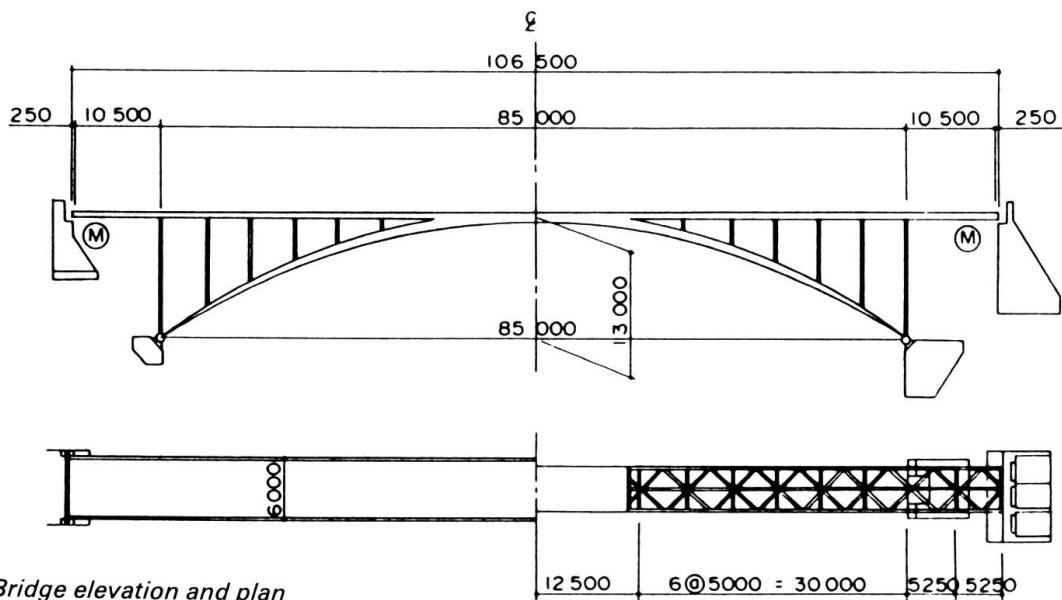
Fig. 3 Crack at gusset

The fatigue cracks occurred at the connecting gusset plates to each panel of intermediate post, which connects the stiffening girder to arch rib (Fig. 2, 3), and also at the web of stiffening girder above end post, which is the joint between center span and side span (Fig. 4, 5). These cracks were found by visual inspection during patrol in 1982.

According to the results of liquid penetrant tests conducted immediately after finding them, the maximum length of the cracks was 65 mm at the gusset plate of intermediate post, respectively 185 mm at the web of stiffening girder.

The fatigue cracks in the gusset plates of intermediate posts were mainly caused by excessive stress concentration at the corner section. This stress concentration was caused by a relatively large longitudinal displacement between stiffening girder and arch rib, which was created by the movability of both end supports. This was confirmed from displacement obtained in a loading test on the actual bridge, results from stress measurements, and the results of 3-dimensional finite element method analysis (Fig. 6). Therefore, as repairing method, new damper bearings were installed on the top of both abutments for reducing the relative longitudinal displacement (Fig. 7). This damper bearing comprised a rubber bearing, return spring and special hydraulic damping system. The supporting condition provides movability at both support bearings for static movement such as temperature effect and resists only to vertical movement caused by live load, giving elastic restraint toward longitudinal movements. Moreover, improvement schemes by making rigid joints or by providing hinges at the gusset plates of intermediate posts were reviewed, but the former indicated an adverse influence upon arch rib and the latter was found to be uneasy to work with. In addition, the compression stress was found to be primary, and the relief of residual stress by the outbreak of cracks was found to be expectable, so both improvement schemes were not adopted this time.
