Artikel: The collapse and reconstruction of a prestressed concrete box-section girder

The Collapse and Reconstruction of a Prestressed Concrete Box-Section Girder

Hugo Bachmann

Werner Horisberger,

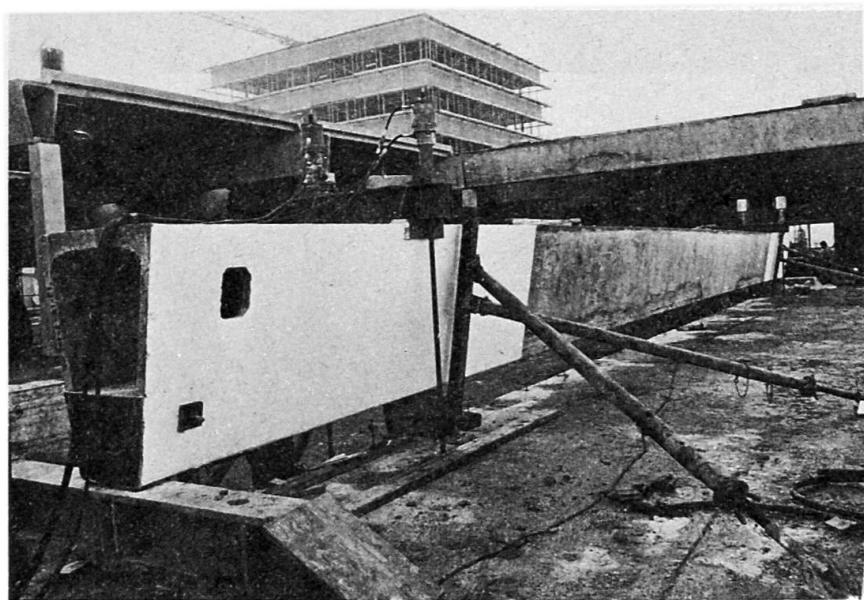
Fig. 19 Test at the building site

A view of the test arrangement is given in Fig. 19. The girder with 25 m span was placed over a wall of the very stiff lower storey. The centre point of the neoprene lay only 7 cm from the girder end which corresponded to the most possible extreme position in the system.

Since the girder was to be tested only for shear force action (relative to the support condition) and not for bending the required loading was applied by means of prestressing jacks only 2.5 m from the support. In order to see the cracks clearly the girder ends were painted white. The loading was applied at each load point initially in steps of 100 kN and later of 50 kN.

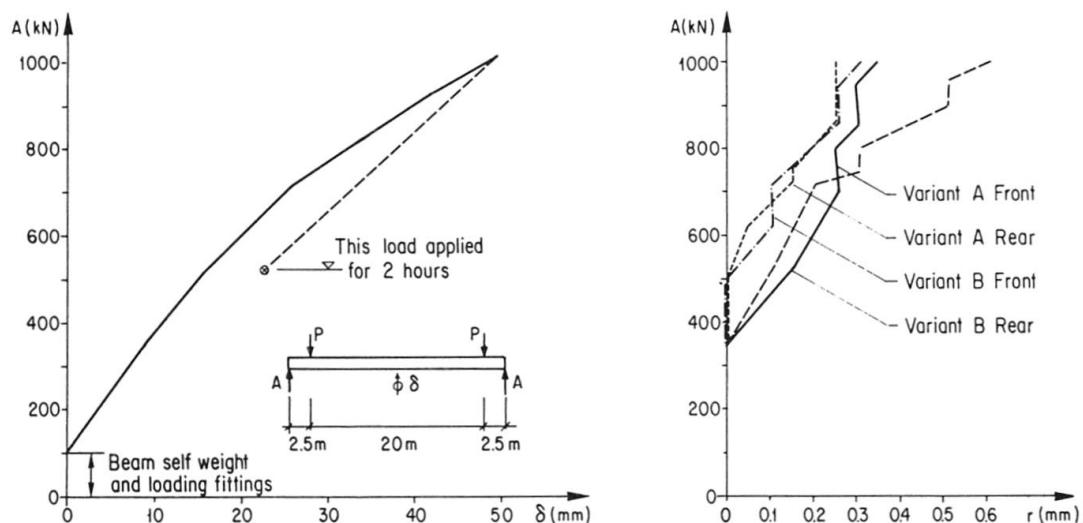
Fig. 20 Midspan deflection of the girder and also the largest crack width r in the webs as a function of the support reaction

Both remedial solutions showed themselves to be workable. The self weight of the beam and the test fittings led to a support reaction of 115 kN. With a support reaction corresponding to that of a full working load i.e. with $Q(g+p) \approx 500$ kN there first appeared a few cracks in the web of maximum width 0.15 mm. The mid-span deflection (without self weight) was 16 mm. Following on from here a load giving a support reaction corresponding to twice the working load reaction, i.e. $2Q(g+p) \approx 1000$ kN, could be obtained without fracture. Under this maximum loading the largest crack width in the webs was 0.60 mm and the deflection midspan = 50 mm. Fig. 20 shows the midspan deflection and also the crack widths as functions of the support reaction. Fig. 21 shows the crack pattern at the girder end A.
