The Collapse and Reconstruction of a Prestressed Concrete Box-Section Girder

Hugo Bachmann

Werner Horisberger,

On the 25th September 1974 a 20 x 25 m section of a prefabricated hall roof collapsed during erection. Within this collapse a box-section girder spanning 25 m and a series of immediately placed 10 m long slab units fell from a height of around 5 m onto the hall floor and were extensively damaged.

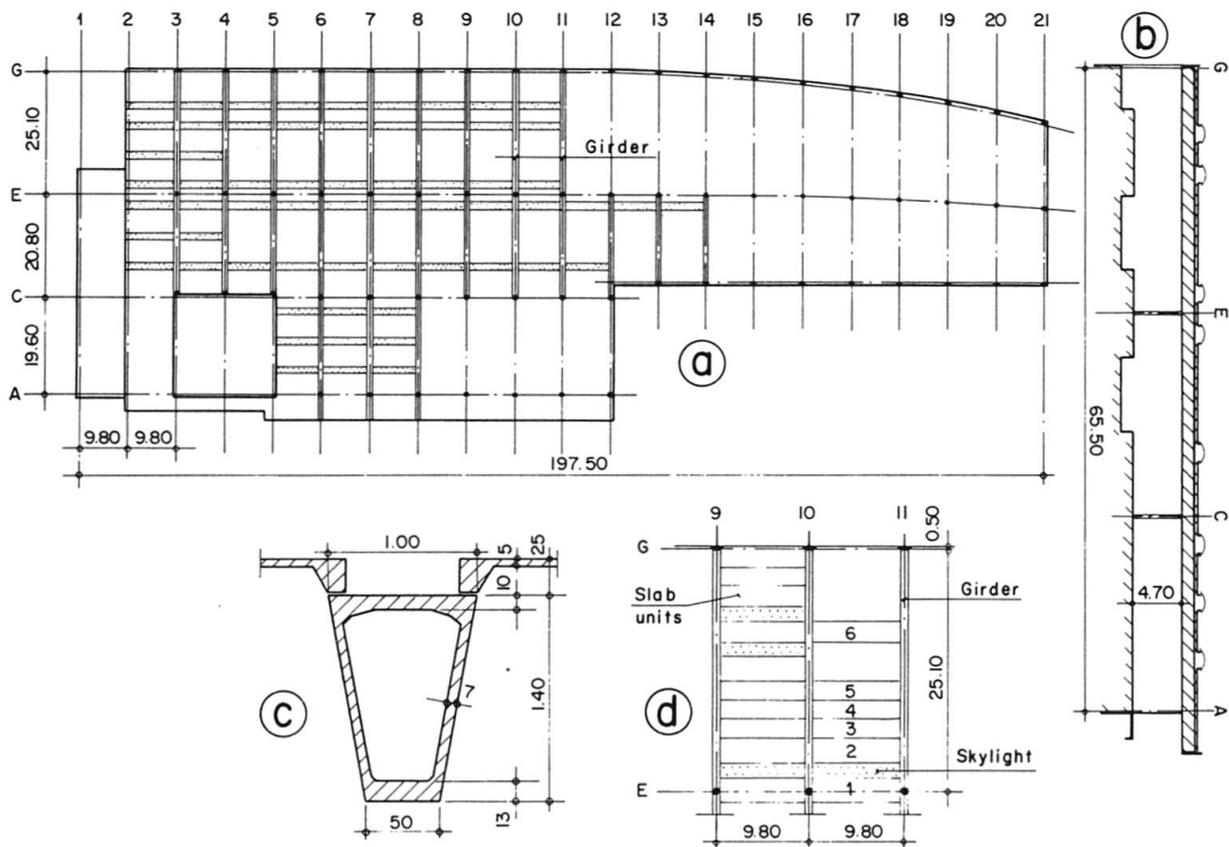
Fig. 1 Rapid goods station Berne

- a) Hall floor plan (position of construction at the time of collapse)
- b) Hall section on grid line 8
- c) Girder cross-section
- d) Plan of the collapse section

The collapse occurred after about half the hall roof was erected. The day before the collapse, the girder 10/E-G and the slabs in section 9-10/E-G had been placed. The next day the erection of the girder 11/E-G and a large part of the slabs in section 10-11/E-G was carried out. Several minutes after the placing of slab unit No. 6 the girder 10/E-G failed. This was without additional external loading (see Fig. 1).

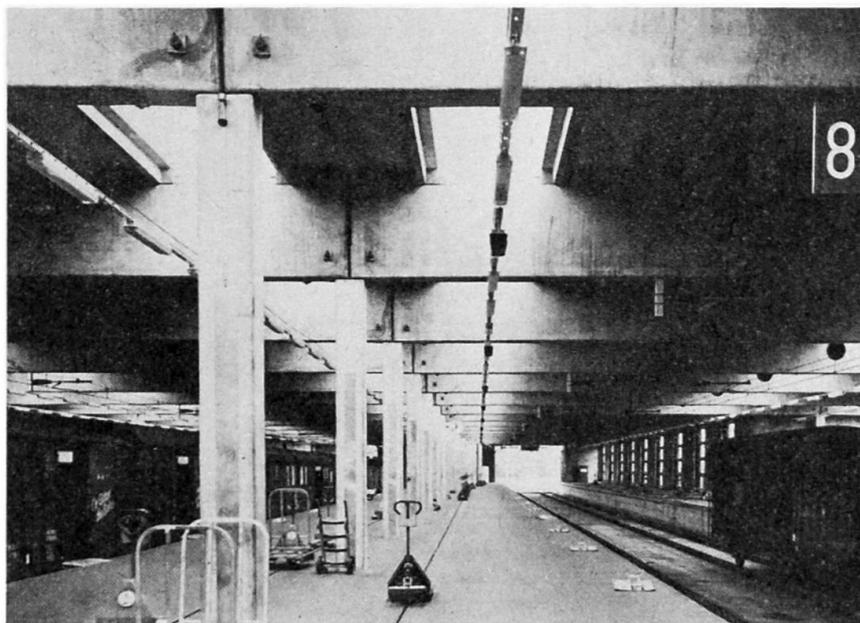
Fig. 24 View of the completed hall

Code safety requirements, service requirements (placement of conduits, accessibility) and aesthetics were all adequately met with this remedial solution. Fig. 24 shows an interior view of the hall after the successful reconstruction.
