## **The Collapse and Reconstruction of a Prestressed Concrete Box-Section Girder**

**Hugo Bachmann**

**Werner Horisberger,**

This surprising event occurred at the building site of the Swiss National Railway's new rapid goods station, Berne. The new rapid goods concept of the Swiss National Railway provides for the turn over of goods traffic on select trains to be concentrated in three centres (Berne, Zürich, Dänikon).

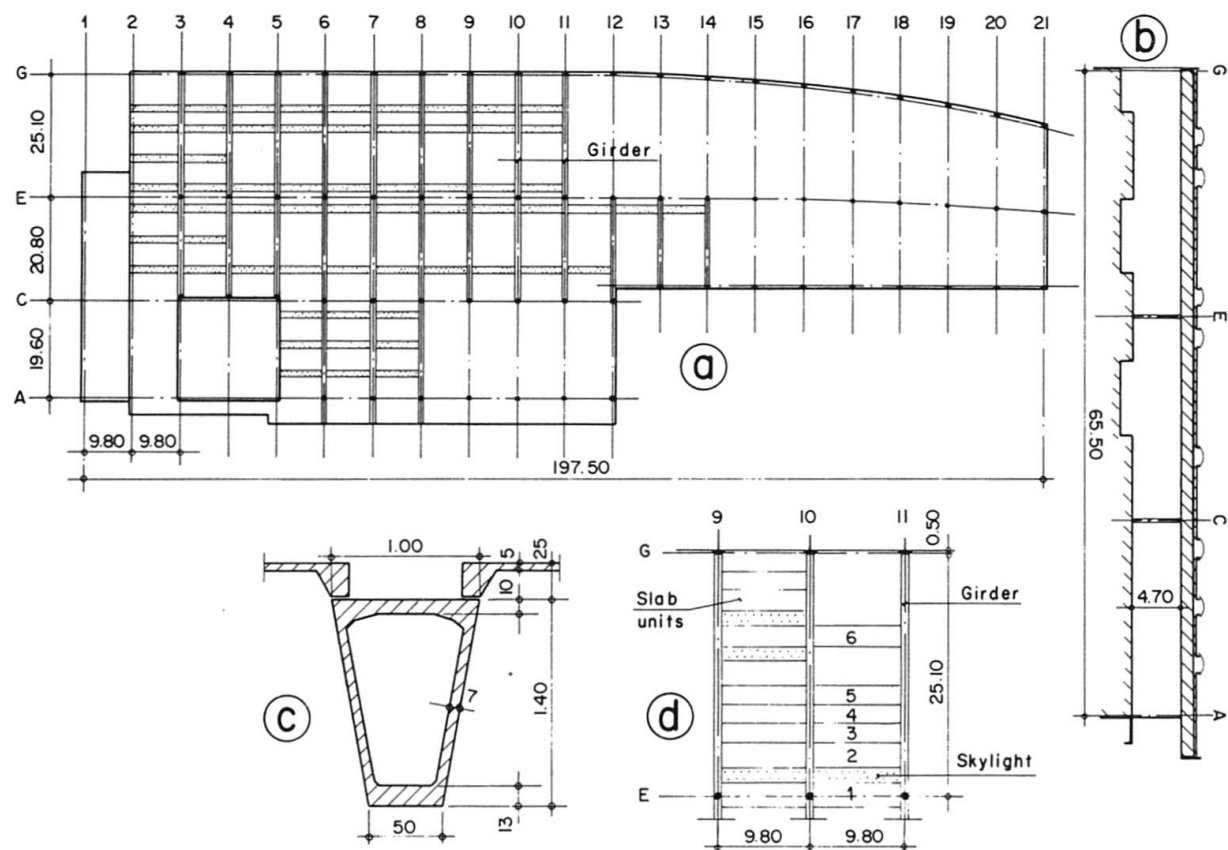
Fig. 1 Rapid goods station Berne

- a) Hall floor plan (position of construction at the time of collapse)
- b) Hall section on grid line 8
- c) Girder cross-section
- d) Plan of the collapse section

The collapse occurred after about half the hall roof was erected. The day before the collapse, the girder 10/E-G and the slabs in section 9-10/E-G had been placed. The next day the erection of the girder 11/E-G and a large part of the slabs in section 10-11/E-G was carried out. Several minutes after the placing of slab unit No. 6 the girder 10/E-G failed. This was without additional external loading (see Fig. 1).

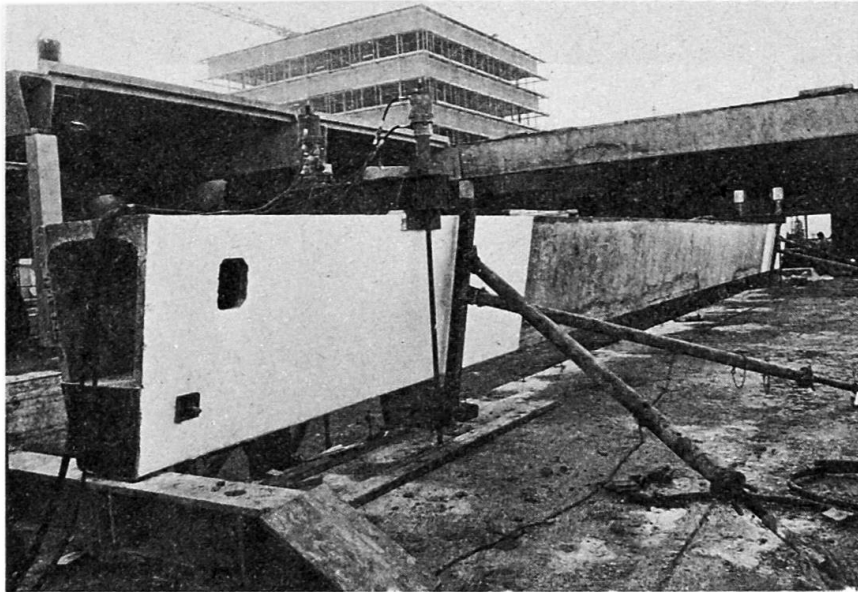
Fig. 19 Test at the building site

A view of the test arrangement is given in Fig. 19. The girder with 25 m span was placed over a wall of the very stiff lower storey. The centre point of the neoprene lay only 7 cm from the girder end which corresponded to the most possible extreme position in the system.

Since the girder was to be tested only for shear force action (relative to the support condition) and not for bending the required loading was applied by means of prestressing jacks only 2.5 m from the support. In order to see the cracks clearly the girder ends were painted white. The loading was applied at each load point initially in steps of 100 kN and later of 50 kN.

The jack forces, the deflections at three points, the support settlement and the crack widths in the webs and bottom flange were all measured at each load step. The test was carried out on 20th December 1974.

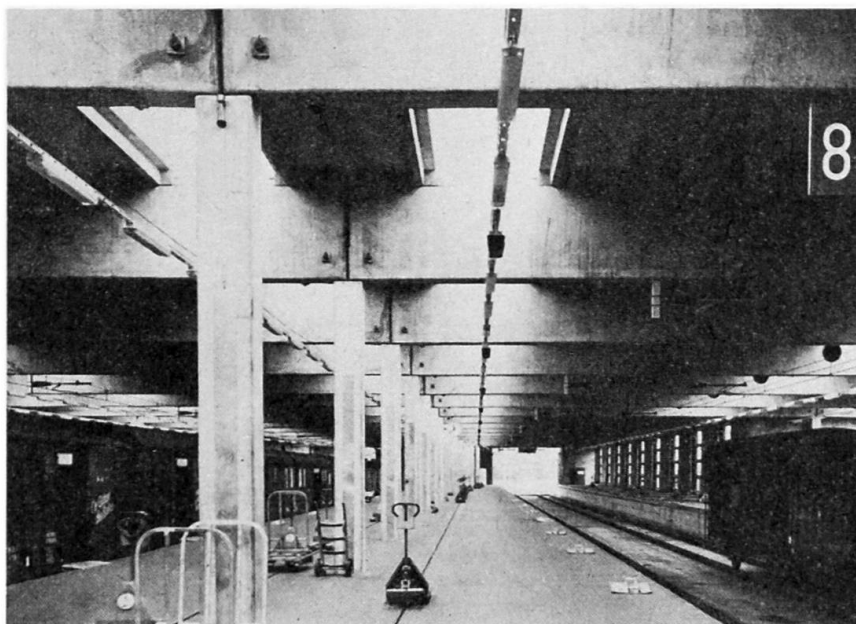
Fig. 24 View of the completed hall

Despite the delays through the accident, the building could be handed over to the management at the timetable change of autumn 1975.

Code safety requirements, service requirements (placement of conduits, accessibility) and aesthetics were all adequately met with this remedial solution. Fig. 24 shows an interior view of the hall after the successful reconstruction.
