**Zeitschrift:** IABSE proceedings = Mémoires AIPC = IVBH Abhandlungen  
**Band:** 10 (1986)  
**Heft:** P-100: The Clifton Suspension Bridge: preservation for utilisation

## **The Clifton Suspension Bridge – Preservation for Utilisation**

### **M. Stuart CULLIMORE**

Deputy Chairman  
Clifton Suspension Bridge Trust  
Bristol, UK

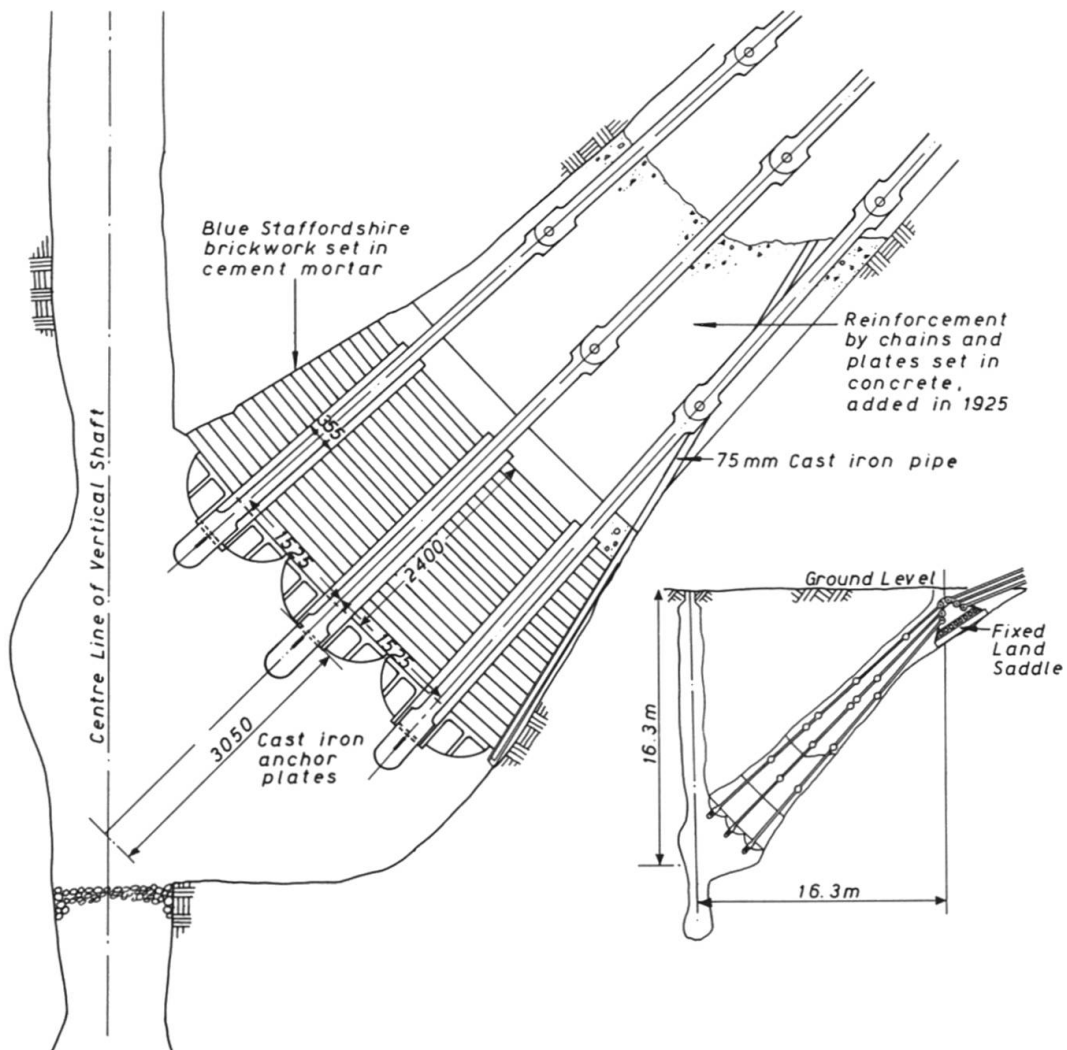
**Fig 4** Anchorage

The mass masonry abutments are faced with red sandstone ashlar. The towers, faced in local Pennant stone, have a freestone capping with a cast iron parapet. They carry the saddles and roller beds which also came from the Hungerford bridge and were increased in height to accommodate the third chain. The land chains are attached to the tower saddles and span freely to fixed land saddles just below ground level. From there they dip down at about  $45^\circ$  for 18m separating to pass through separate cast iron anchor plates which are supported by brick arches abutting on the solid rock (Fig. 4).

The ironwork was originally coated with tar and later with bituminous compounds and paints, although no records are available to indicate how frequently painting was necessary in the increasingly aggressive atmosphere caused by developing local industry. However, by 1924, serious corrosion had occurred in the chains at the bottom of the anchorages, particularly in the Leigh side, caused by drainage from the roadway and inadequate ventilation. The chains were strengthened by adding a new link to each chain where it entered the anchorage arch and reinforcing the sections in the anchorage tunnels by open-link chains from below the land saddles outwards to new anchorages in the tunnel walls. The whole was then embedded in concrete. The Clifton anchorages were similarly treated in 1939.
