The Clifton Suspension Bridge – Preservation for Utilisation

M. Stuart CULLIMORE

Deputy Chairman
Clifton Suspension Bridge Trust
Bristol, UK

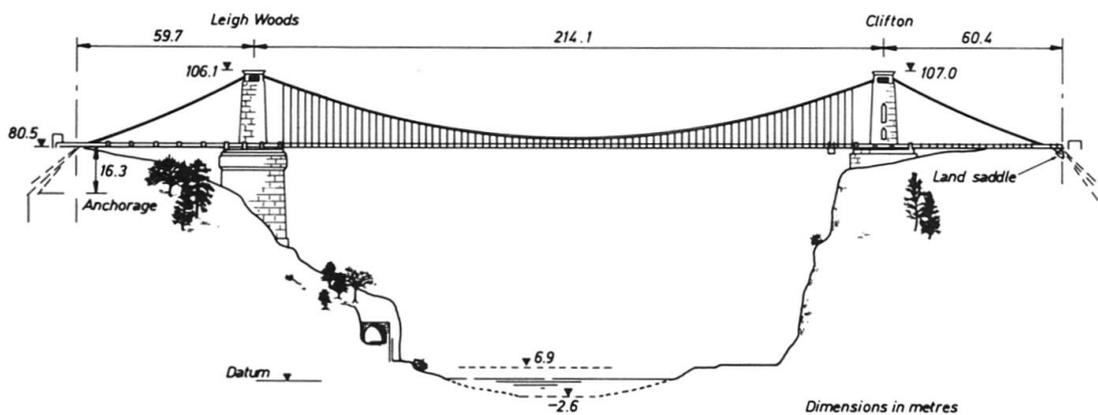
Fig. 1 South elevation of bridge

The promontory from which the bridge springs on the Clifton side is a stable formation of massive blocks of rock. The Leigh Woods masonry abutment is approximately 23m square, rising some 40m from the side of the cliff (Fig. 1). There has been no evidence of any movement at either abutment although there had recently been 'slips' in other parts of the Avon Gorge. Large solution cavities are known to exist in the limestone in this region together with clay layers within the limestone sequence. In view of this and the presence of water seepage in the vicinity, a site investigation of the Leigh Woods abutment was ordered in 1969.

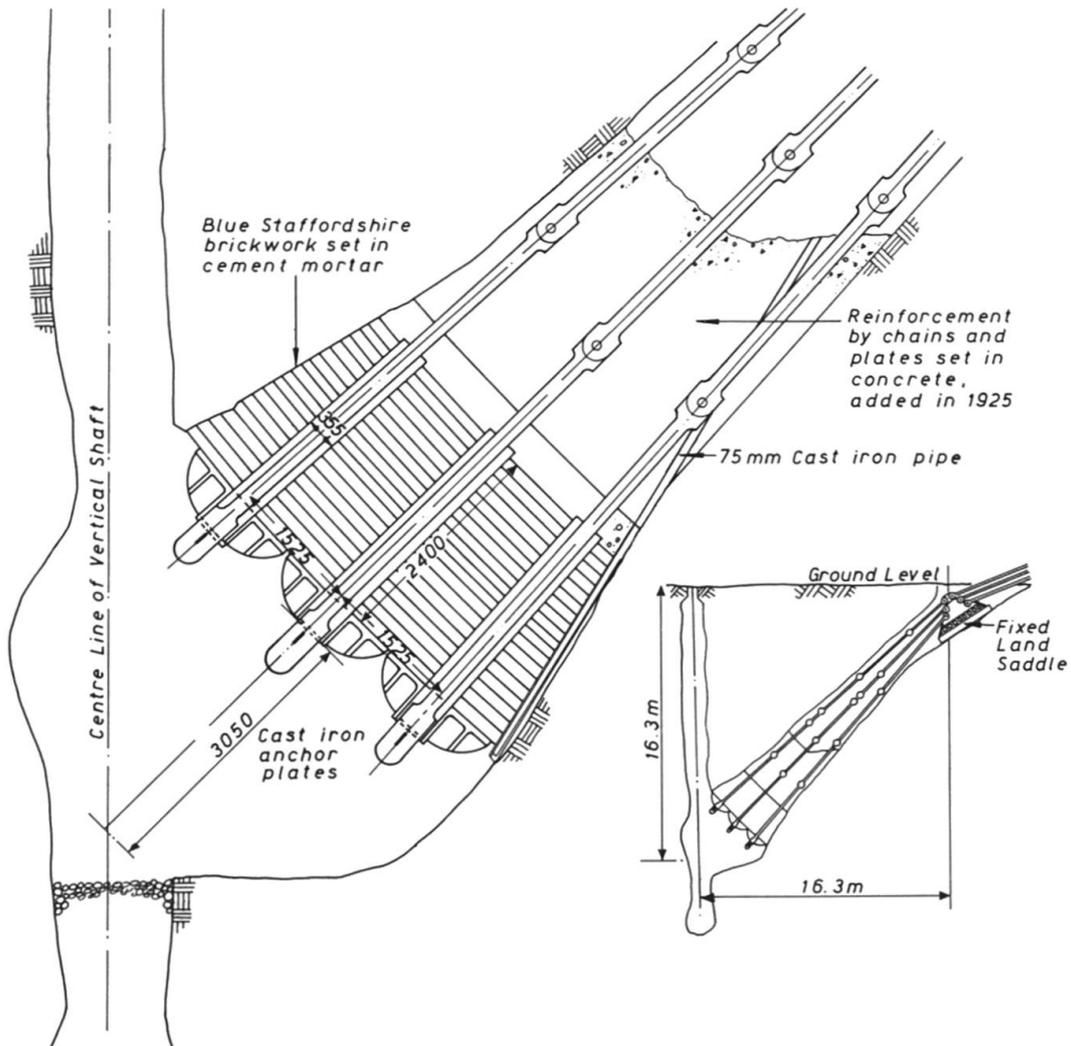
Fig 4 Anchorage

The mass masonry abutments are faced with red sandstone ashlar. The towers, faced in local Pennant stone, have a freestone capping with a cast iron parapet. They carry the saddles and roller beds which also came from the Hungerford bridge and were increased in height to accommodate the third chain. The land chains are attached to the tower saddles and span freely to fixed land saddles just below ground level. From there they dip down at about 45° for 18m separating to pass through separate cast iron anchor plates which are supported by brick arches abutting on the solid rock (Fig. 4).

The ironwork was originally coated with tar and later with bituminous compounds and paints, although no records are available to indicate how frequently painting was necessary in the increasingly aggressive atmosphere caused by developing local industry. However, by 1924, serious corrosion had occurred in the chains at the bottom of the anchorages, particularly in the Leigh side, caused by drainage from the roadway and inadequate ventilation. The chains were strengthened by adding a new link to each chain where it entered the anchorage arch and reinforcing the sections in the anchorage tunnels by open-link chains from below the land saddles outwards to new anchorages in the tunnel walls. The whole was then embedded in concrete. The Clifton anchorages were similarly treated in 1939.
