The Clifton Suspension Bridge – Preservation for Utilisation

M. Stuart CULLIMORE

Deputy Chairman
Clifton Suspension Bridge Trust
Bristol, UK

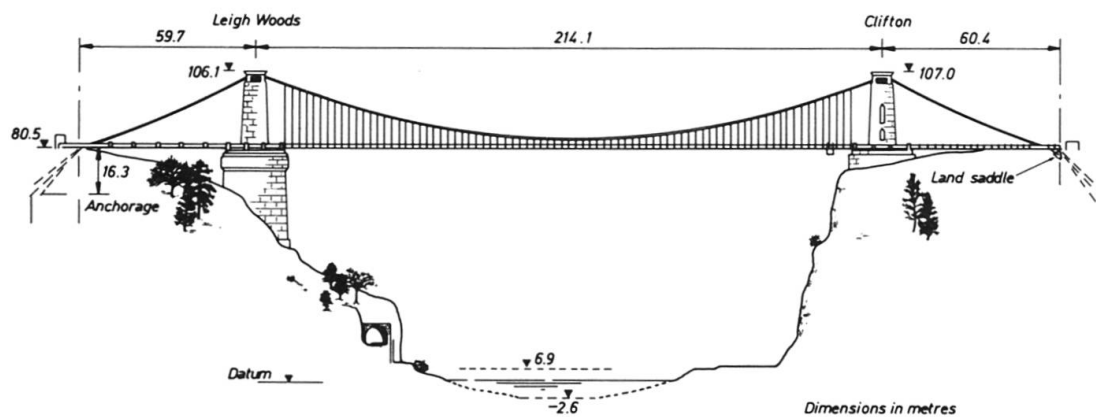
Fig. 1 South elevation of bridge

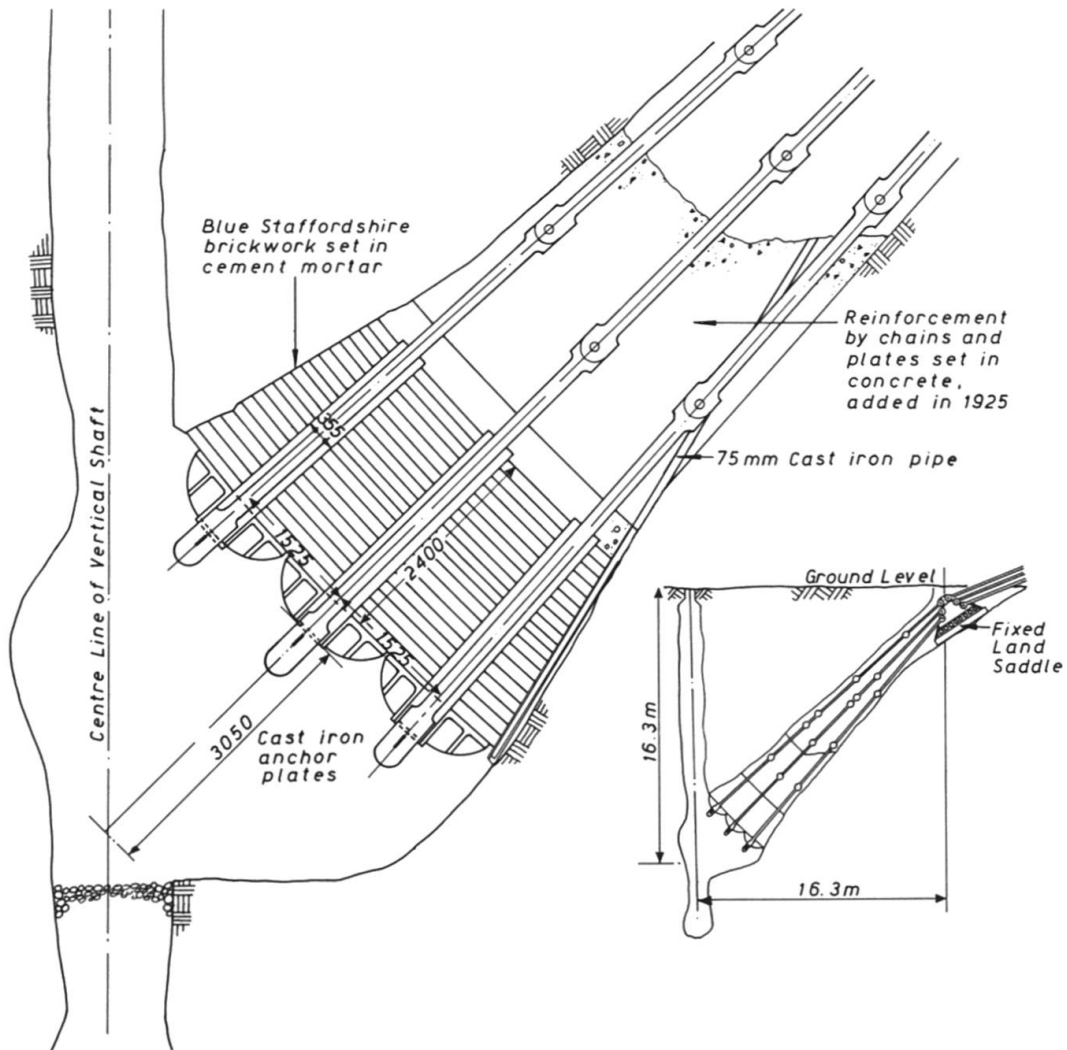
Fig 4 Anchorage

The ironwork was originally coated with tar and later with bituminous compounds and paints, although no records are available to indicate how frequently painting was necessary in the increasingly aggressive atmosphere caused by developing local industry. However, by 1924, serious corrosion had occurred in the chains at the bottom of the anchorages, particularly in the Leigh side, caused by drainage from the roadway and inadequate ventilation. The chains were strengthened by adding a new link to each chain where it entered the anchorage arch and reinforcing the sections in the anchorage tunnels by open-link chains from below the land saddles outwards to new anchorages in the tunnel walls. The whole was then embedded in concrete. The Clifton anchorages were similarly treated in 1939.
