Session III: Effects of recent earthquakes in Italy and other countries

SESSION III

Effects of Recent Earthquakes in Italy and Other Countries

STRUCTURAL BEHAVIOUR OF THE DAMAGED BUILDING DURING THE
FRIULI EARTHQUAKES BETWEEN MAY 6 AND SEPTEMBER 15, 1976

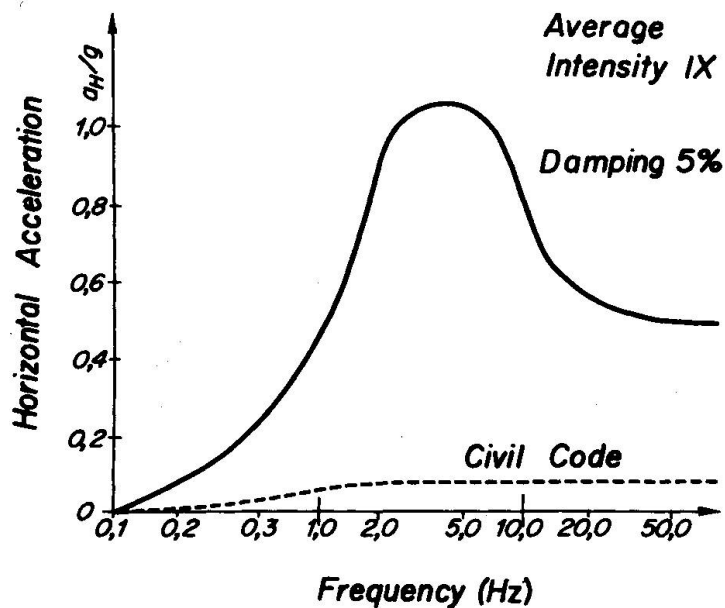
The Italian State Administration has enacted special regulations for earthquake-prone areas and has repeatedly brought them up-to-date. Using the Code, design earthquake loads are determined by statical or dynamic analysis. An average horizontal acceleration will result, which is about 7 percent of the gravity acceleration g . Comparison of horizontal design accelerations given by the Code with those produced by an earthquake with the Intensity IX (Figure 21) shows large discrepancies.

The Code values are significantly smaller because it is assumed that strong energy absorption will occur due to inelastic behaviour of materials and elements. But this means that the structure must be capable of absorbing the appropriate energy. Consequently, plastic deformation and therefore damage or maybe even collapse can result.

Figure 21: Horizontal ground acceleration for earthquakes of intensity IX (MSK) (U.S. Atomic Energy Commission, WASH 1255). The dashed line gives the design ground acceleration according to the conventional aseismic building code.

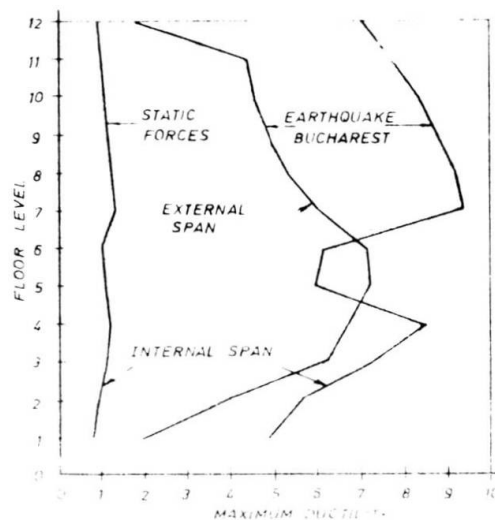
Fig.6 Envelopes of maximum beam ductilities, D₂₋₃

During investigation of the ability of the building to withstand the March 4, 1977 earthquake, the ratio between "the maximum moment at a section from the gravity and seismic loading, divided by the ultimate moment capacity of the section" was required [4]. These relations are shown in Fig.6 as "ductilities" for the beams of the wall D_{2-3} . The maximum moments from the earthquake are

considerably larger than the flexural capacity of the sections, which results in the very high "ductilities".

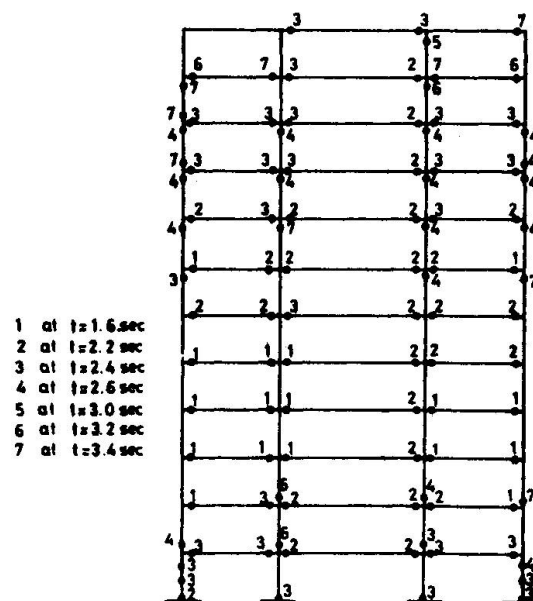
Fig.12 Sequence and location of plastic hinges, D₂₋₃

Fig 12 illustrates the location and the sequence of forming of plastic hinges in the wall D_{2-3} . The plastic hinges indicated did not occur simultaneously, but generally in groups concentrated at a floor level.

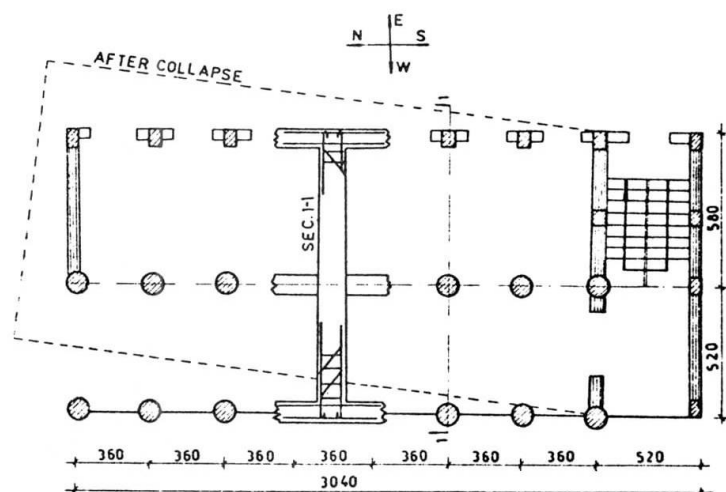
fig. 10

The fifth storey office building (fig. 10) is typical building with flexible first storey. The existing of shear walls at the stairs only develop additional rotational effects and reserve partly only first two storeys at the stairs (fig. 11). The cylindrical columns of the building are well designed (fig. 12) but connections between girders and columns did not form space resisting frame for horizontal excitation. The small length of down girders steel bars into columns (fig. 10 b) was not capable to bear sufficient bending moments from the earthquake. Similar construction had the six storeys public residential building which was collapsed on the same way (fig. 13).

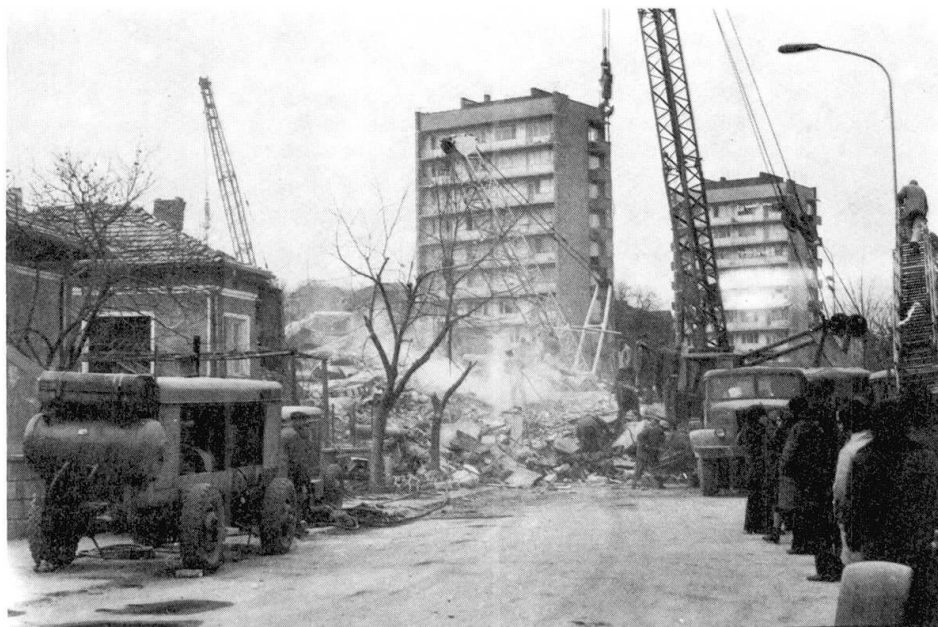
fig. 14

The nine storeys apartment building with shops (without shear walls) into first storey was collapsed as previous two buildings (fig. 14). Another two nine storeys buildings with the same construction but with masonry shear walls in first storey have resisted very well to the earthquake (fig. 15).

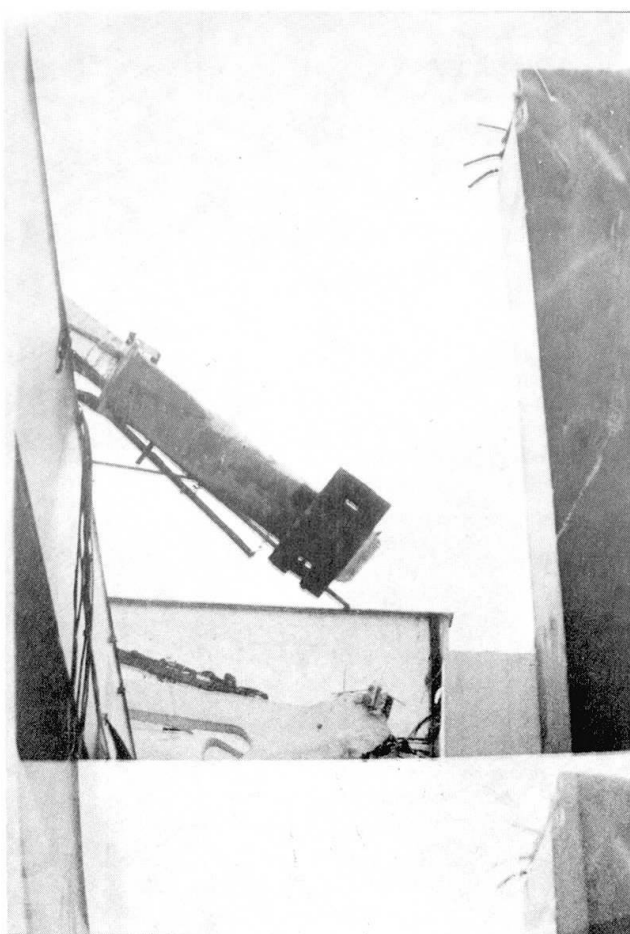
fig. 16

The damages in many industrial buildings were mainly from bed connections between roof trusses and columns (fig.16) between roof ,wall panels and columns.

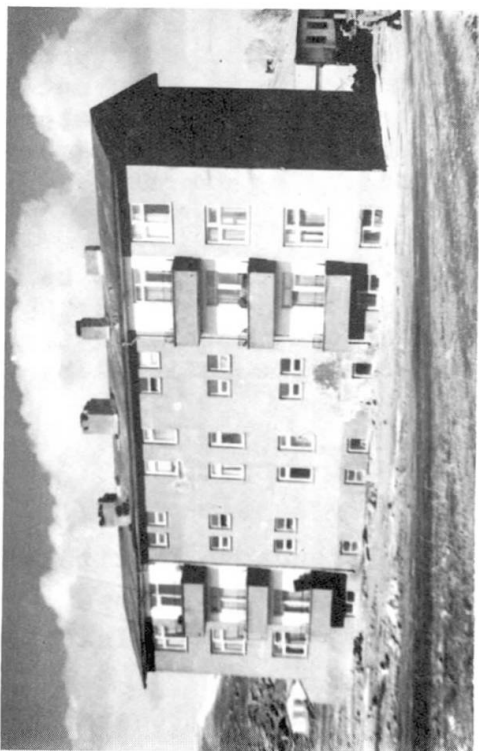
Building	External Wall Opening Ratio %	Wall/Floor Area Ratio cm/m ²	Damage	Remarks
Galdiran Staff Housing				
x-axis	41-37	26	No damage	I = IX
y-axis	0	31	No damage	(Figure-8)
Muradiye Staff Housing				
x-axis	54-55	17	Heavy damage	I = VII
y-axis	0	26	No damage	(Figure-9)
Muradiye Junior High School				
x-axis	15	20	Slight damage	I = VII
y-axis	53-37	12	Heavy damage	(Figure-10)
Palu Monopoly Office				
x-axis	42-35	21	Damage	
y-axis	0-16	24	No damage	I = VI
Palu Local Administration Building				
x-axis	55	25	Heavy Damage	I = VI
y-axis	29	30	No damage	(Figure-11)

Figure-8 Çaldıran Staff Housing

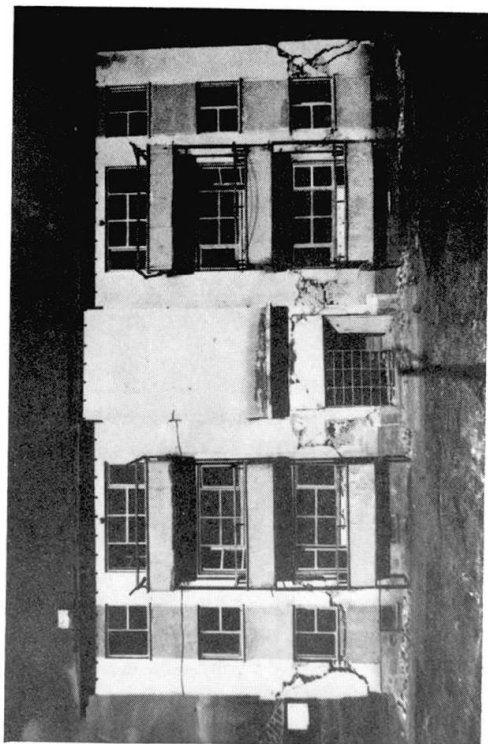
Figure-9 Muradiye Staff Housing

From these observed damage and properties of buildings, it can be seen that an external wall opening ratio more than 40 % causes damage in the walls.

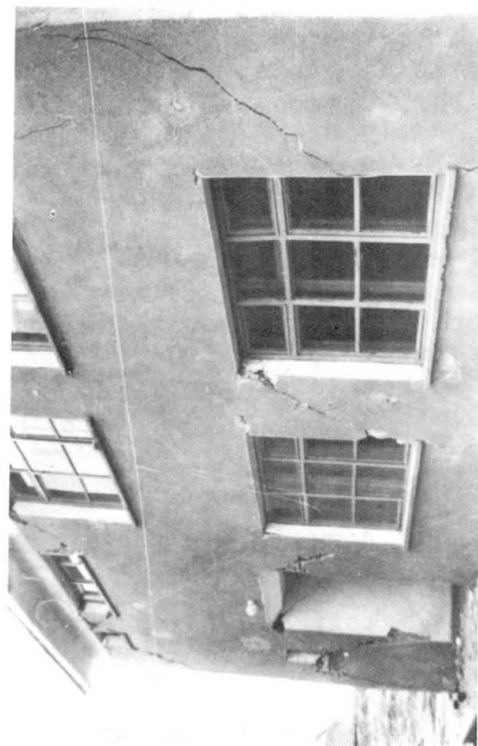
Figure-10 Muradiye Junior High School

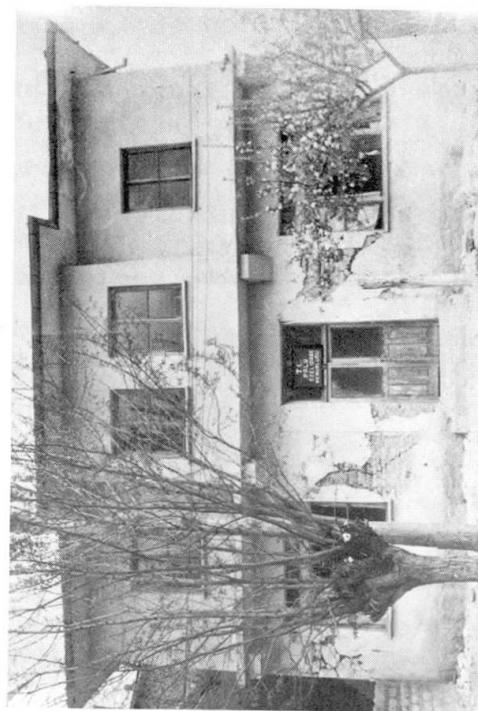
Figure-11 Falu Local Administration Building

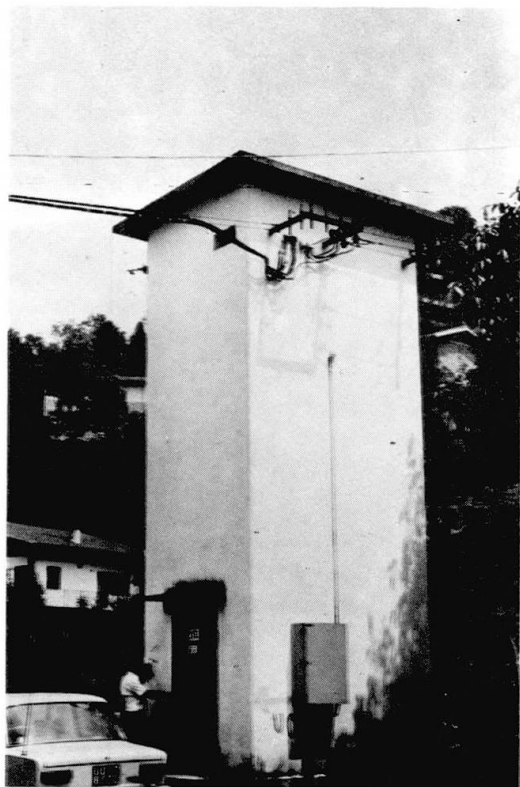
In the epicentral region of the May 6, 1976 Friuli earthquake an extensive network of field indicators was identified with the small distribution transformers of the electricity supply network. These transformers possess instrument characteristics: they are of uniform size, sitting on concrete pads inside uniform cabins (Fig. 1, 2, 3). A log is kept for each cabin at the regional ENEL centre in Udine. The log registers the exact dimensions of the transformers and the exact location of the cabins (an accurate location map is also available.) During the earthquake the transformers moved and left clear traces on the concrete platforms. The distribution network does not necessarily follow the population density, since transformers were allocated to isolated consumers i.e. farms. It is thought that a uniform density network of field indicators could have been selected from the network of distribution trans-

Fig 2. Distribution cabin at Bilerio.

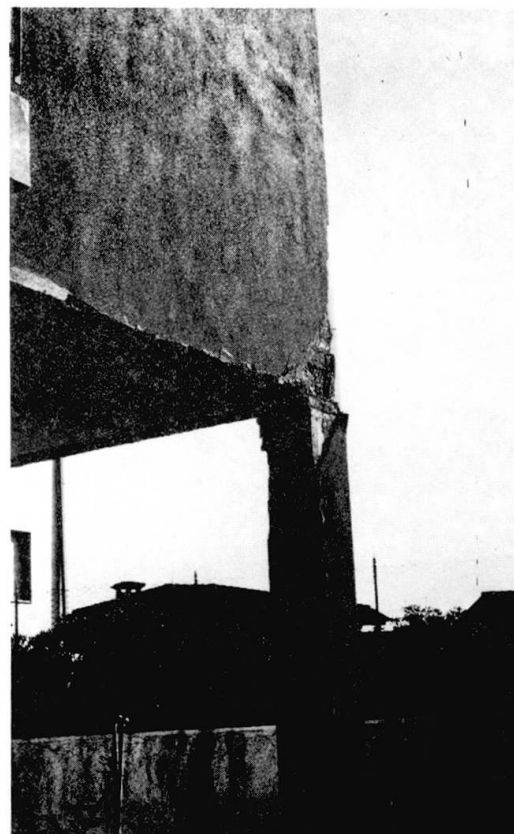
Dislocations along joints in prefabricated buildings may be critical in their earthquake performance as shown on Figure 11. The building is in Majano across the road from another building that collapsed. A variation of the joint strength in one direction could have set up the collapse mechanism.

Fig. 11 (right) Slip at the joint of a prefabricated building at Majano.

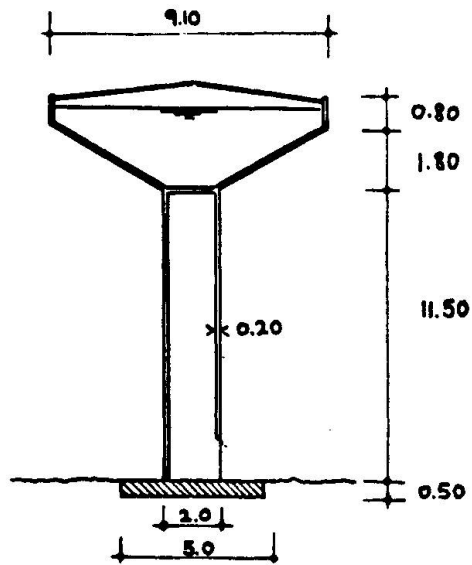
Figure 4: Watertower at Gemona railway station

Secondly it is shown that the Gemona watertower had to fail because the calculated maximum moment at the base exceeds the ultimate moment by about 20 %.

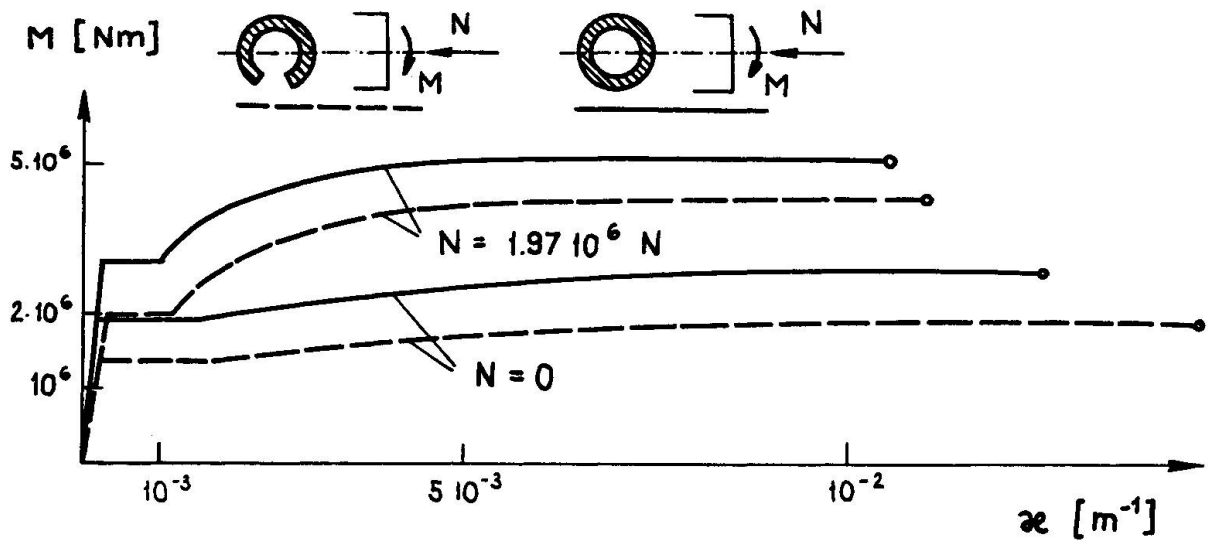
First, the momentum-curvature-relationship of the reinforced concrete column is evaluated. As may be seen (Figure 5), the existing normal force increases the ultimate moment at ductile failure considerably.

Figure 5: Momentum-curvature-relationship for the reinforced concrete column. The normal force $N = 1.97 \cdot 10^6$ N is the result of water and structure weight.

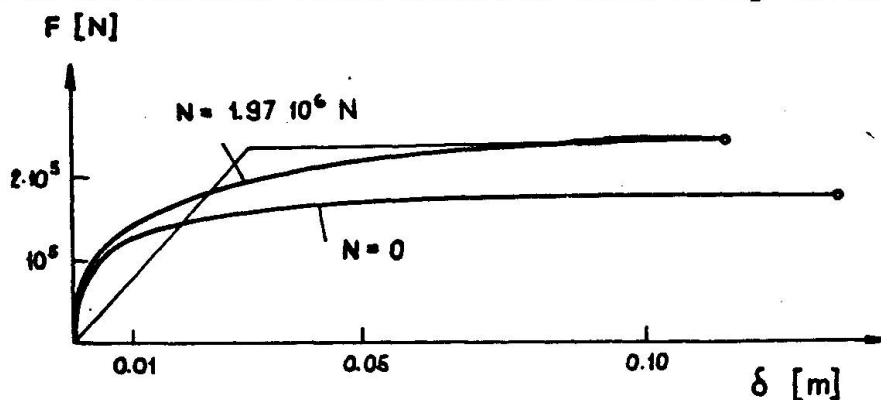
Figure 7: Force-deflection-relationship for the structural system of Gemona watertower

While the $P-\Delta$ -effect, which reduces the ultimate force F by approximately 10%, cannot be neglected, the decrease of stiffness due to the shear force may be disregarded.

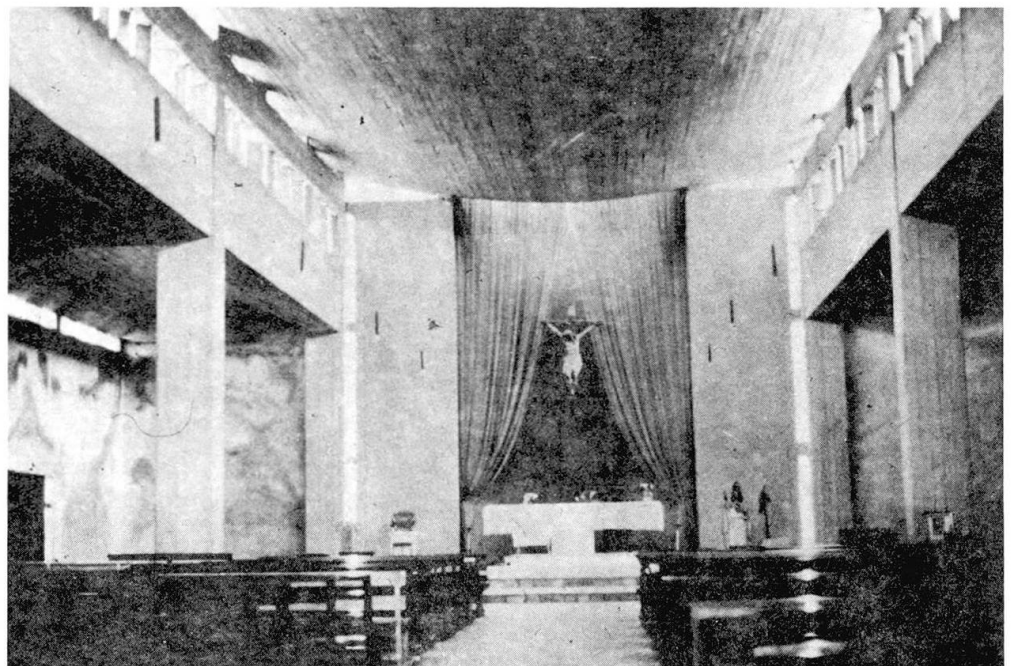
Fig. 2 - Central Nave

Building examination after the earthquake reveals no damage in the reinforced concrete elements. The front brick walls show limited cracks, while there are no apparent cracks in lateral walls, but inner plaster spalled in wide areas. Some glass breakage in windows occurred (approx. 10 %), and light damages in masonry can be seen at both sides of apse, where roof shell touches the wall.

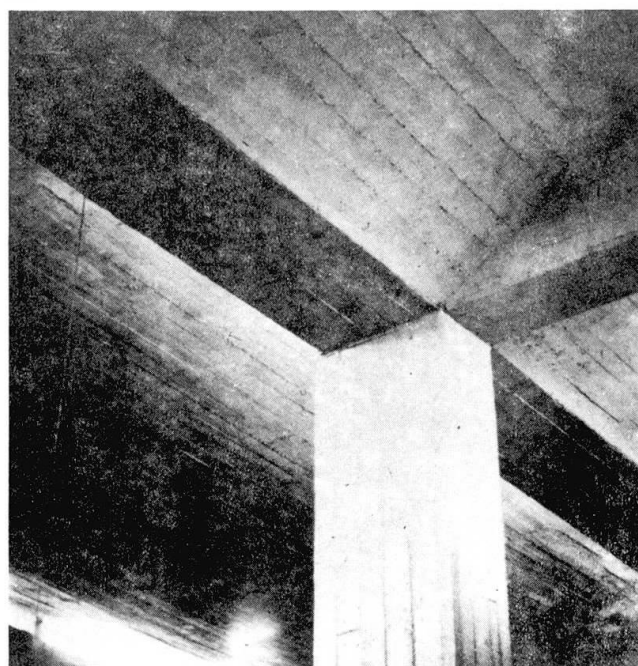
Fig. 7 - Detail of main frame joint

- Maximum displacement of highest points is 3.9 cm.
- Maximum horizontal acceleration of the same point is 0.89 g.
- Bending moments at joints, of columns and beams, are much larger than ultimate moments of that sections.

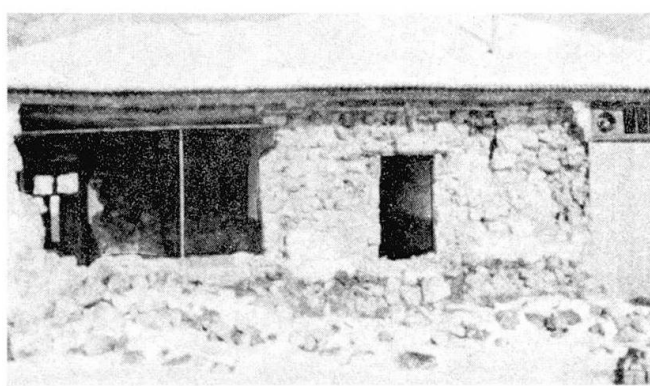
The earthquake of 1970 with magnitude $M = 6.6$ and focal depth $H = 13$ Km spreaded over an area of about 600 Km^2 with intensity 8 (MSK scale). It was accompanied by rockfalls and landslides along river banks and steep mountain slopes. The volume of landslides in some places exceeded 1 million m^3 , the extent of the breaches reached several hundred meters [1, 2]. Some of the stone buildings in the settlements, located on the epicentral area, were collapsed (fig. 1). The quake of 1975 had intensity 7. It caused heavy damages to rubble buildings (fig. 2).

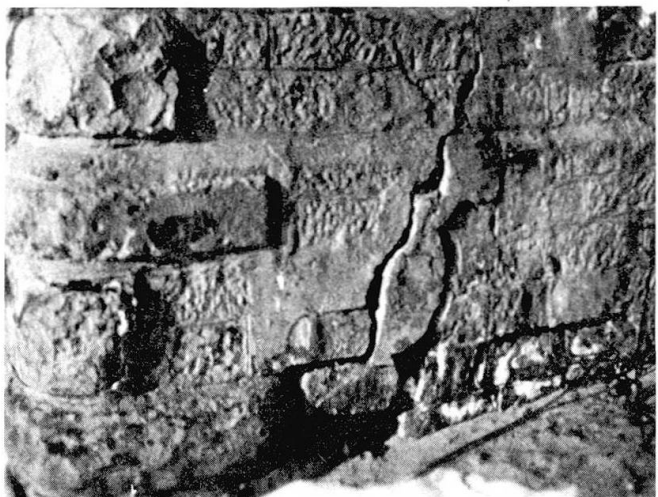
In 1970 most of girder and arch railway bridges, constructed in 1914 (fig. 3), suffered moderate damages such as deep cracks in wing walls of abutments (fig. 4), ice-breakers (fig. 5), bridge seats and concrete arches. Among massive structures the least damages were received by simple-span bridges with reinforced concrete slab superstructures, anchored in the abutment masonry.
