Zeitschrift: IABSE reports of the working commissions = Rapports des commissions de travail AIPC = IVBH Berichte der Arbeitskommissionen

Rubrik: Session III: Effects of recent earthquakes in Italy and other countries

Effects of Recent Earthquakes in Italy and Other Countries

STRUCTURAL BEHAVIOUR OF THE DAMAGED BUILDING DURING THE
FRIULI EARTHQUAKES BETWEEN MAY 6 AND SEPTEMBER 15, 1976

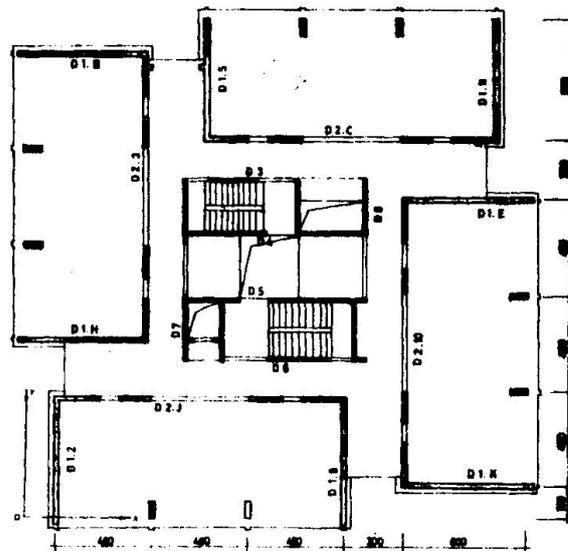
Fig. 1 Typical floor plan

During the earthquake the main structural system suffered moderate damage. Many cracks in corridor walls and wing walls ($D_{2.3}$ and $D_{1.5}$ in Fig.1) were observed and less in core walls (D_3 to D_8 in Fig.1). Cracks in walls and deep beams were inclined, whereas flexural cracks at the ends of the shallow beams appeared. Also, some cracks in the floor slabs, near the openings, were observed. Cracks in walls with openings were distributed over all height of the building, whereas in walls without openings were limited to the bottom part only.

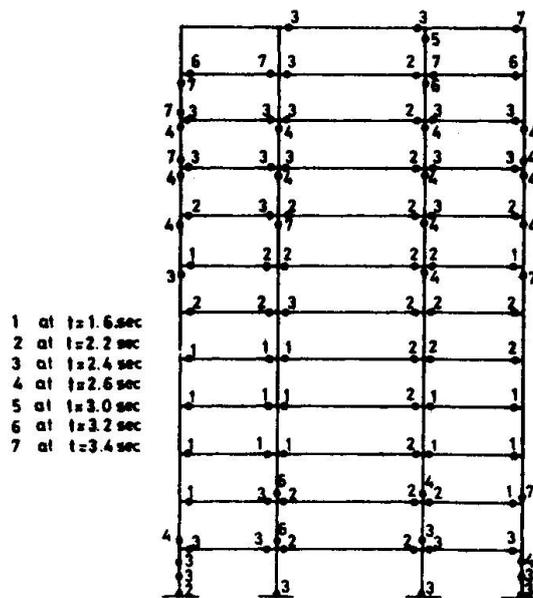
Fig.12 Sequence and location of plastic hinges, D₂₋₃

Fig 12 illustrates the location and the sequence of forming of plastic hinges in the wall D₂₋₃. The plastic hinges indicated did not occur simultaneously, but generally in groups concentrated at a floor level.

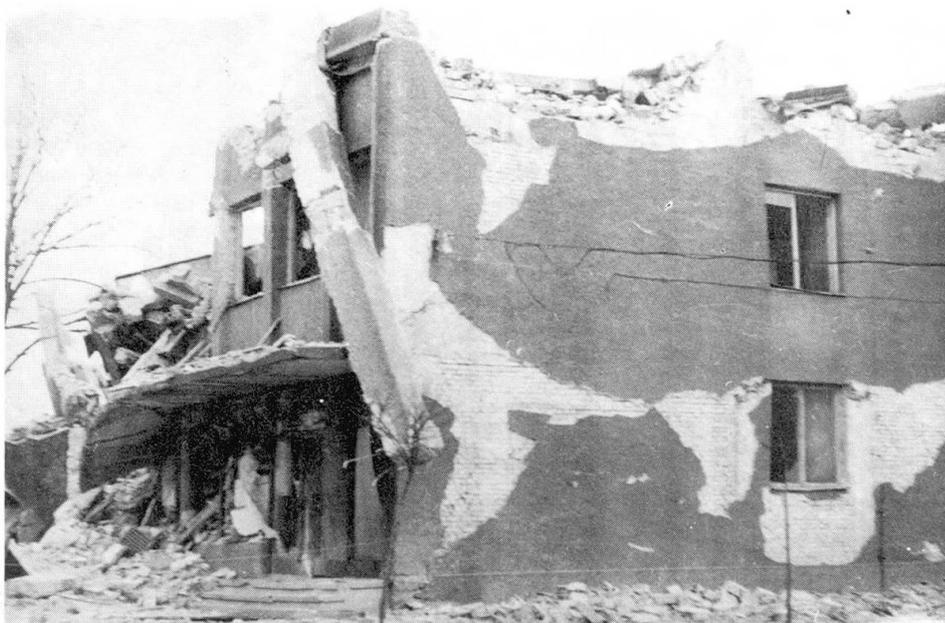
fig. 11

The fifth storey office building (fig. 10) is typical building with flexible first storey. The existing of shear walls at the stairs only develop additional rotational effects and reserve partly only first two storeys at the stairs (fig. 11). The cylindrical columns of the building are well designed (fig. 12) but connections between girders and columns did not forme space resisting frame for horizontal exitation. The small length of down girders steel bars into columns (fig. 10 b) was not capable to bear sufficient bending moments from the earthquake. Similar construction had the sixt storeys public residential building wich was colapsed on the same way (fig. 13).

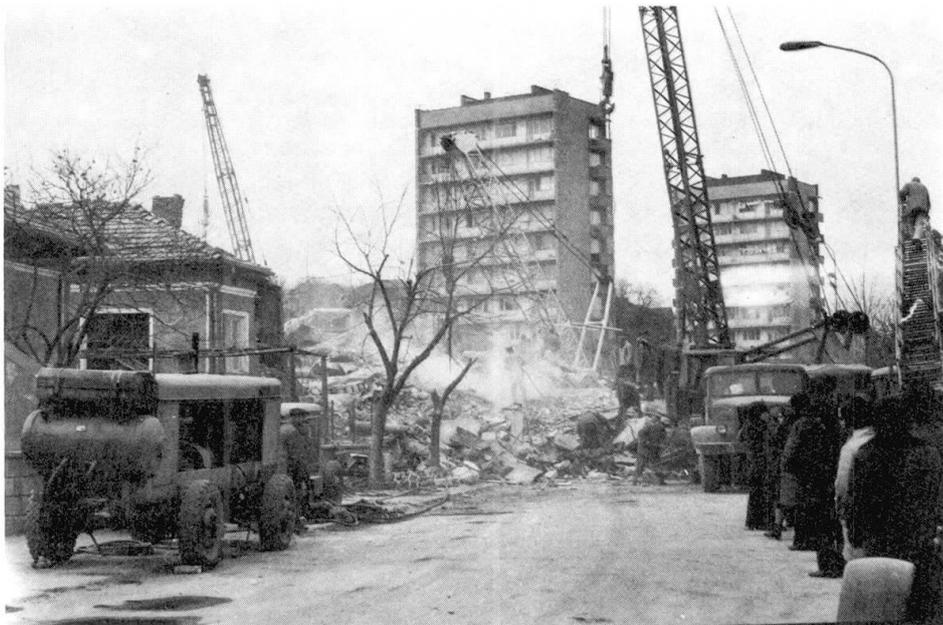
fig. 14

The nine storeys apartment building with shops (without shear walls) into first storey was colapsed as previous two buildings (fig. 14). Another two nine storeys buildings with the same construction but with masonry shear walls in first storey have resisted very well to the earthquake (fig. 15).

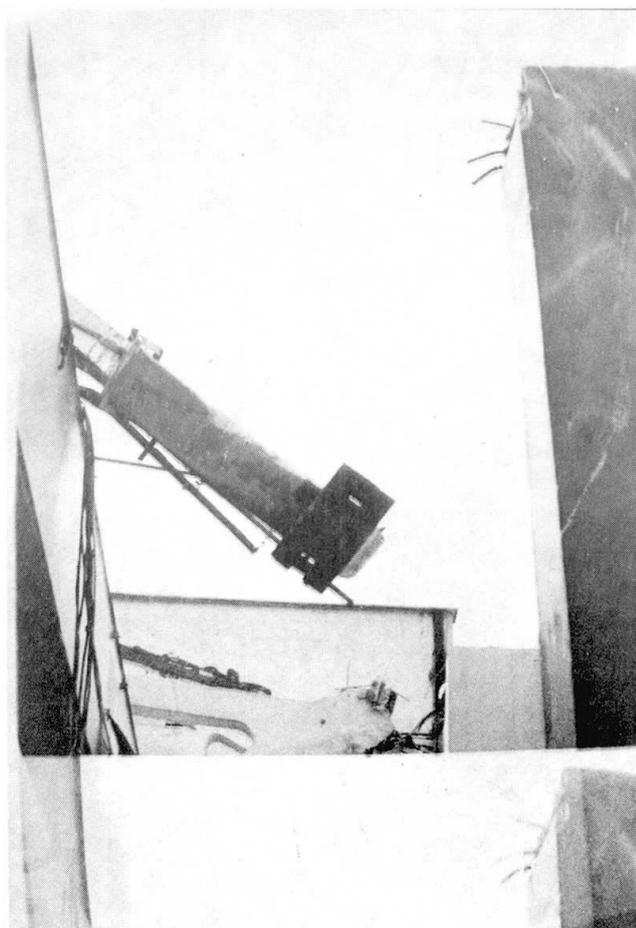
fig. 16

The damages in many industrial buildings were mainly from bed connections between roof trusses and columns (fig.16) between roof ,wall panels and columns.

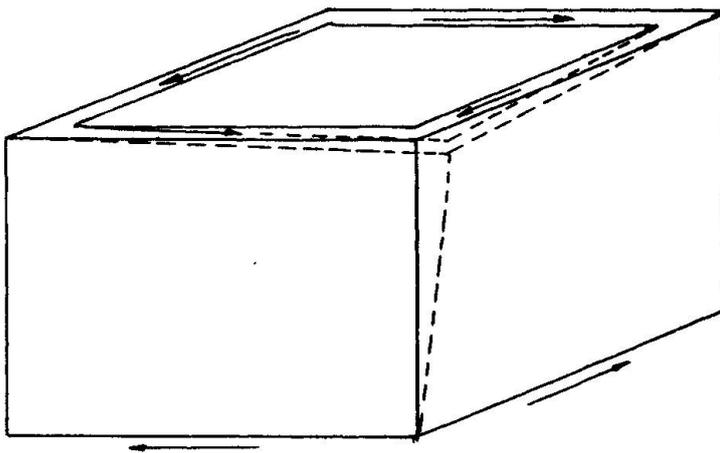
Since the earthquake forces will act in the two principal directions of the building, the corners of the building will be very critical. Figure-2

Figure-2 Corner Behaviour of Masonry Buildings.

Another critical condition occurs at the corners of external walls, under the action of earthquake forces, the cross walls tend to displace each other outwards at the corners. This could be prevented by providing vertical reinforced concrete columns at the corners. This detail is widely followed and commonly executed in Turkey even in one story high houses. Presence of reinforced concrete slabs at floor and roof levels will prevent outward displacement of corners by exerting a vertical restraint.

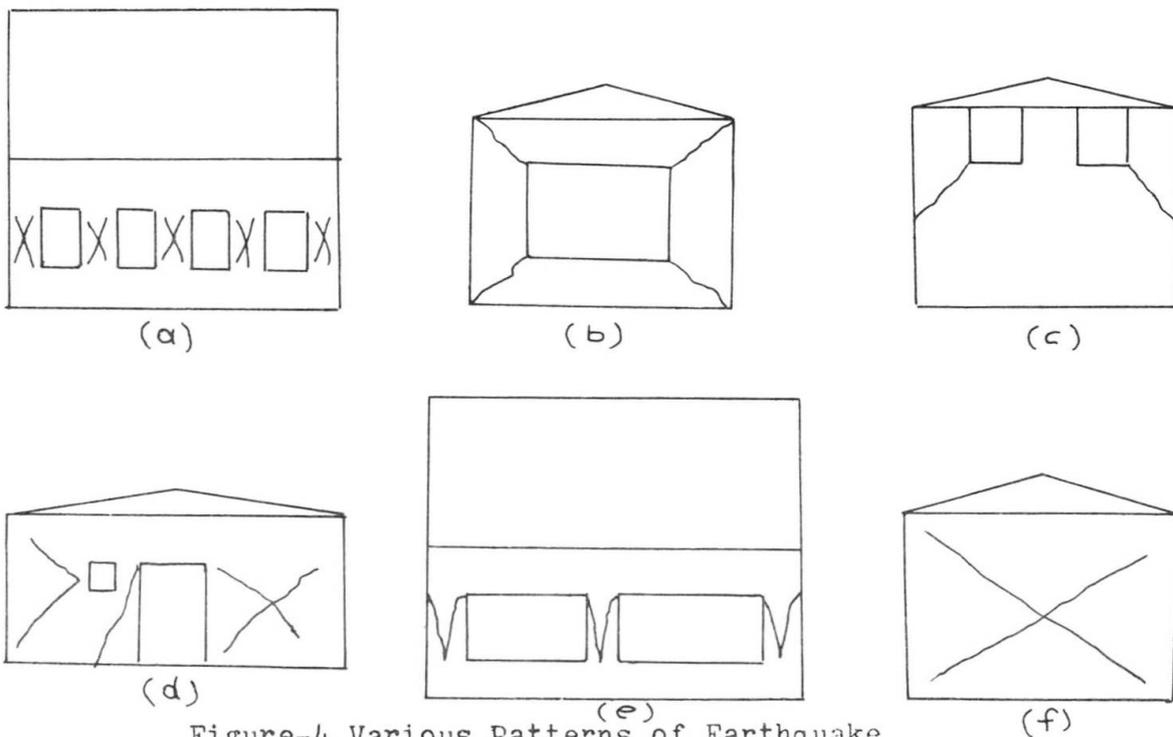
Due to action of shearing forces on the walls of brick masonry, various forms of diagonal tension failures occur. However the walls are also subject to compressive stresses due to the weight of the wall and weight of upper stories. Thus the diagonal tension cracks will deviate from 45° and the angle between the cracks and vertical direction will be smaller than 45° degrees. Apart from the angle of cracks, the extension of the

Figure-4 Various Patterns of Earthquake Cracking in Masonry Buildings

of the cracks will be influenced by the height to width ratio of the wall and location and size of the window and door openings. Figure-4.

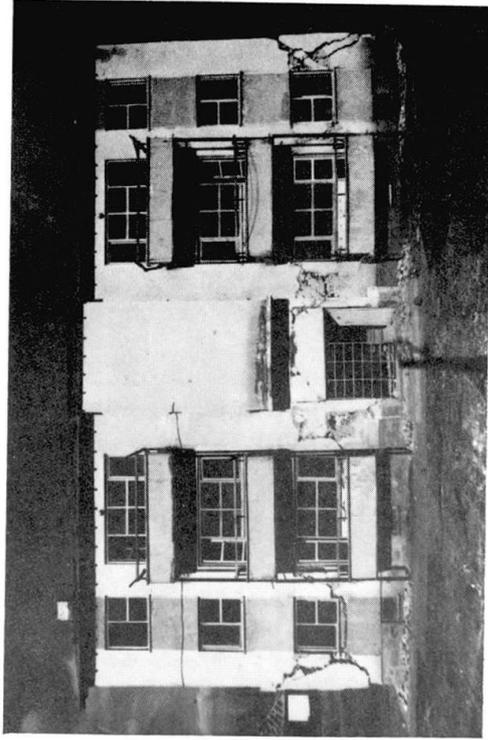
Figure-9 Muradiye Staff Housing

Building	External Wall Opening Ratio %	Wall/Floor Area Ratio cm/m ²	Damage	Remarks
Çaldıran Staff Housing				
x-axis	41-37	26	No damage	I = IX
y-axis	0	31	No damage	(Figure-8)
Muradiye Staff Housing				
x-axis	54-59	17	Heavy damage	I = VII
y-axis	0	26	No damage	(Figure-9)
Muradiye Junior High School				
x-axis	15	20	Slight damage	I = VII
y-axis	53-37	12	Heavy damage	(Figure-10)
Palu Monopoly Office				
x-axis	42-35	21	Damage	
y-axis	0-16	24	No damage	I = VI
Palu Local Administration Building				
x-axis	55	25	Heavy Damage	I = VI
y-axis	29	30	No damage	(Figure-11)

From these observed damage and properties of buildings, it can be seen that an external wall opening ratio more than 40 % causes damage in the walls.

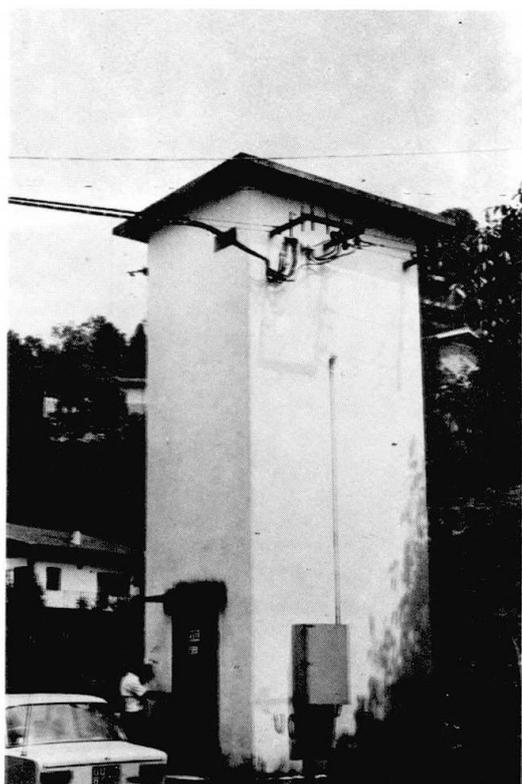
In the epicentral region of the May 6, 1976 Friuli earthquake an extensive network of field indicators was identified with the small distribution transformers of the electricity supply network. These transformers possess instrument characteristics: they are of uniform size, sitting on concrete pads inside uniform cabins (Fig. 1, 2, 3). A log is kept for each cabin at the regional ENEL centre in Udine. The log registers the exact dimensions of the transformers and the exact location of the cabins (an accurate location map is also available.) During the earthquake the transformers moved and left clear traces on the concrete platforms. The distribution network does not necessarily follow the population density, since transformers were allocated to isolated consumers i.e. farms. It is thought that a uniform density network of field indicators could have been selected from the network of distribution trans-

Fig 2. Distribution cabin at Bilerio.

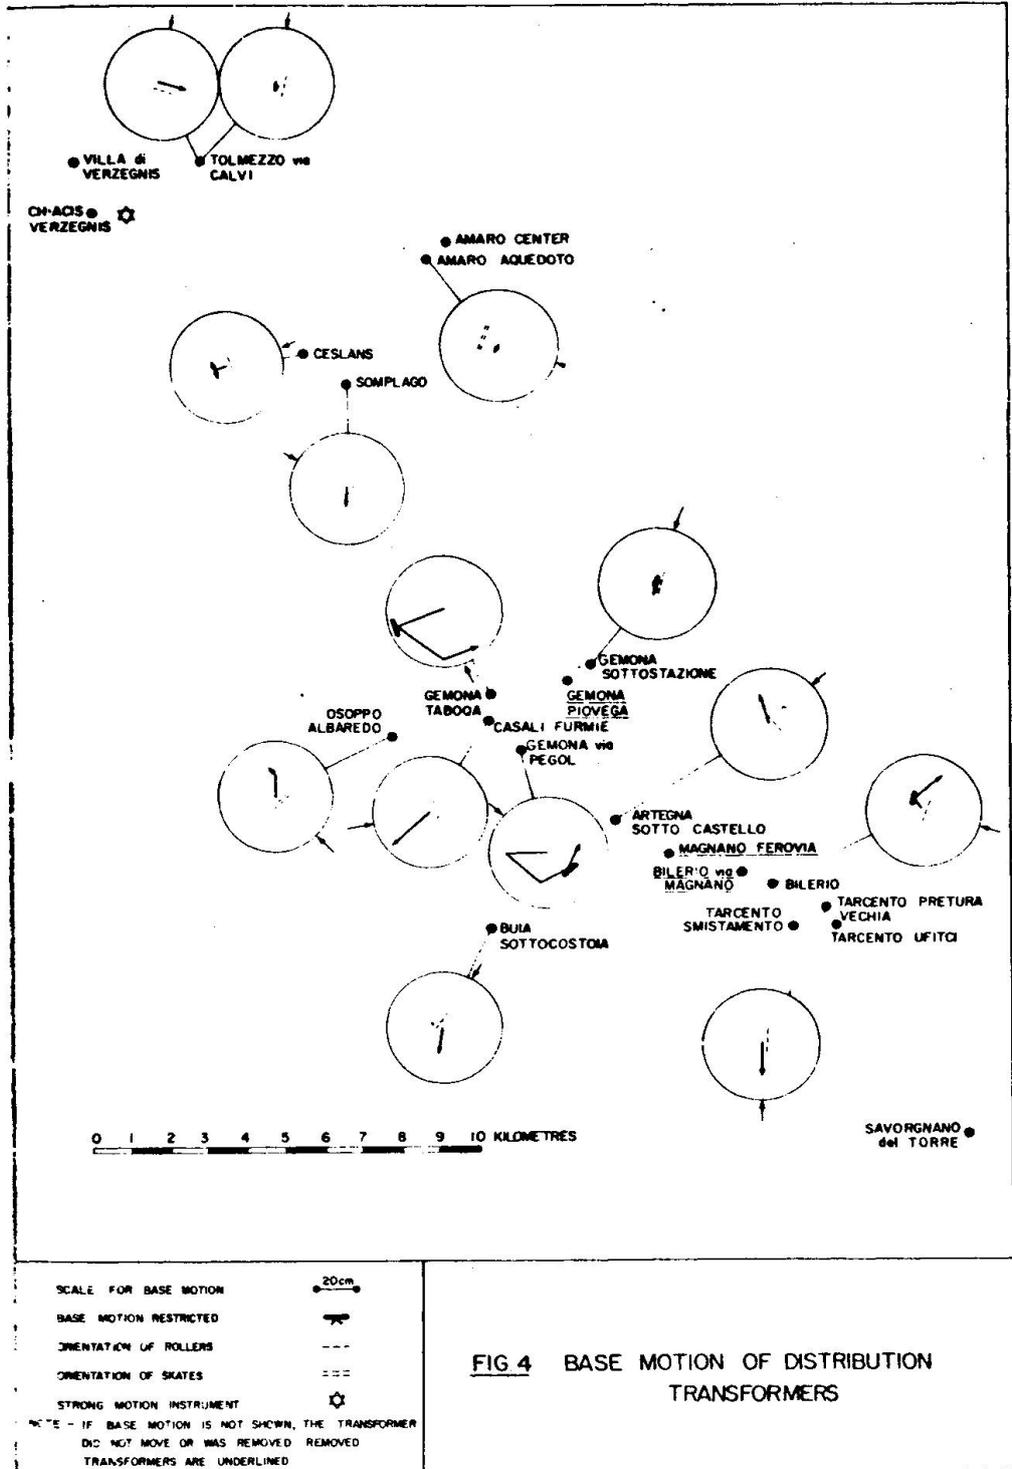
Field measurements in the epicentral area of the May 6, 1976 earthquake were restricted in a zone running NW-SE. The slip vectors of the transformers that were studied in this zone are shown on Fig. 4. The transformers at the NW end of the zone surround the nearest strong motion instrument that recorded the main shock at Diga de l' Ambiesta. The measurements have been described elsewhere (1,2). The transformers, in general, moved in a N-S direction. Exceptions were found on recent alluvium where motion was in both directions. Displacements were also larger on recent alluvium.

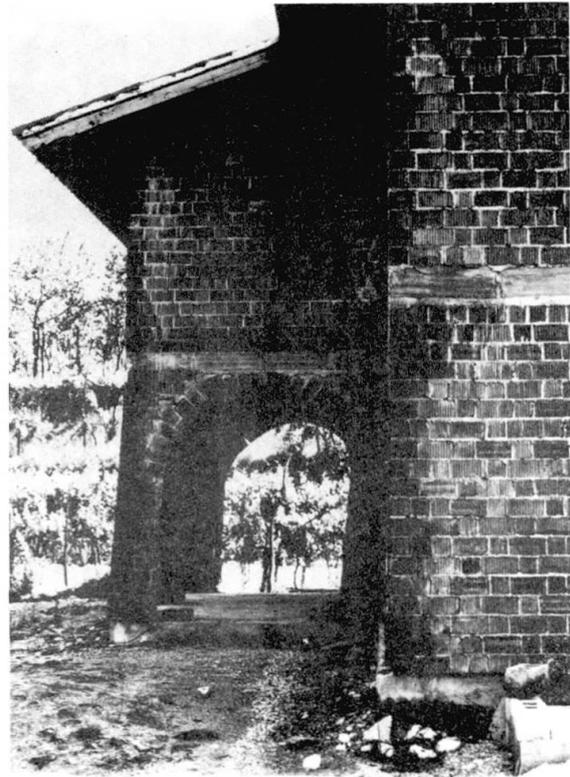
Fig. 9 Gemona; the building moved back and forth on the concrete base.

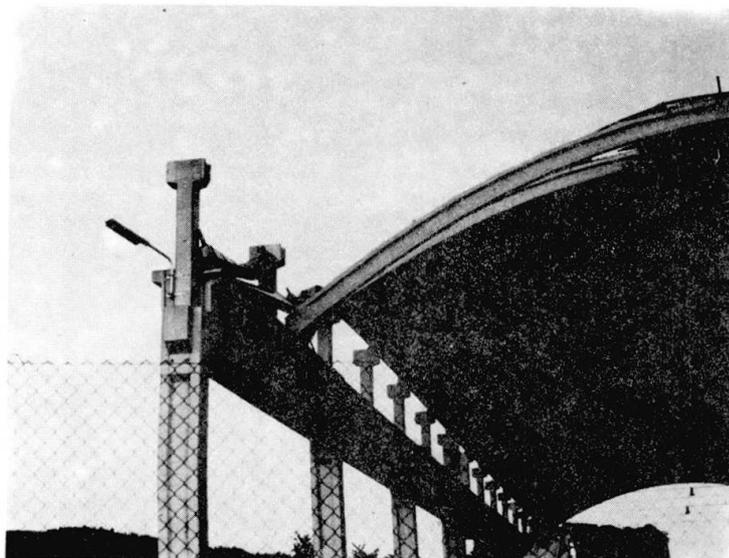
Figure 10 shows the mode of collapse of an industrial hangar. In this case the relatively small slip vector measured on the ground was amplified by the elastic deformation of the column.

Fig. 10 (above) Industrial hangar at Magnano; collapse mechanism.

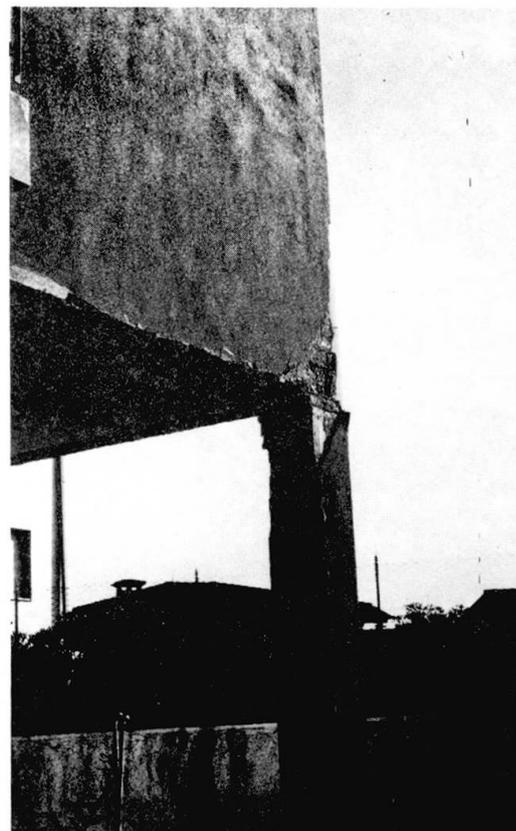
Dislocations along joints in prefabricated buildings may be critical in their earthquake performance as shown on Figure 11. The building is in Majano across the road from another building that collapsed. A variation of the joint strength in one direction could have set up the collapse mechanism.

Fig. 11 (right) Slip at the joint of a prefabricated building at Majano.

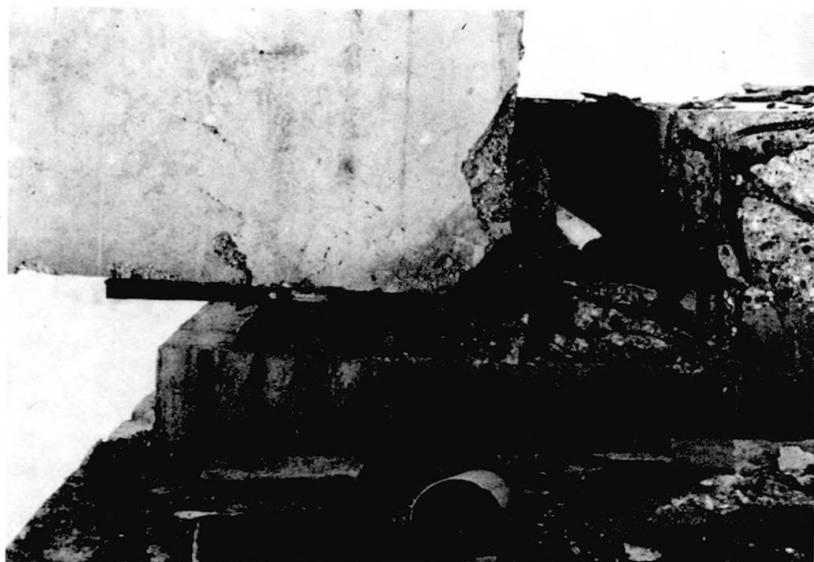
On the recent alluvium the transformers showed large displacements. The same large dislocations could be seen along the supports of the prestressed bridge across the Tagliamento River (Figure 12).

Fig. 12 Prestressed bridge over the Tagliamento River; slip of the supports.

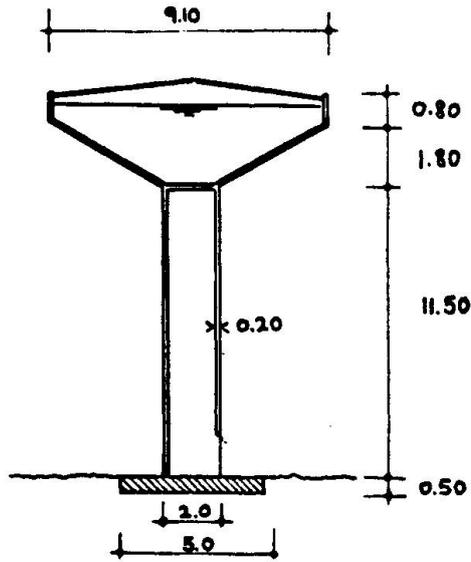
Figure 4: Watertower at Gemona railway station

Secondly it is shown that the Gemona watertower had to fail because the calculated maximum moment at the base exceeds the ultimate moment by about 20 %.

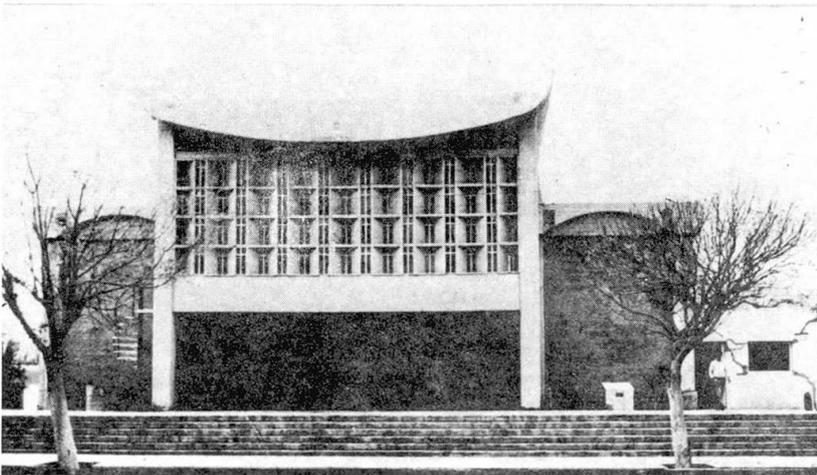
Fig. 1 - Front of the Church

Building examination after the earthquake reveals no damage in the reinforced concrete elements. The front brick walls show limited cracks, while there are no apparent cracks in lateral walls, but inner plaster spalled in wide areas. Some glass breakage in windows occurred (approx. 10 %), and light damages in masonry can be seen at both sides of apse, where roof shell touches the wall.

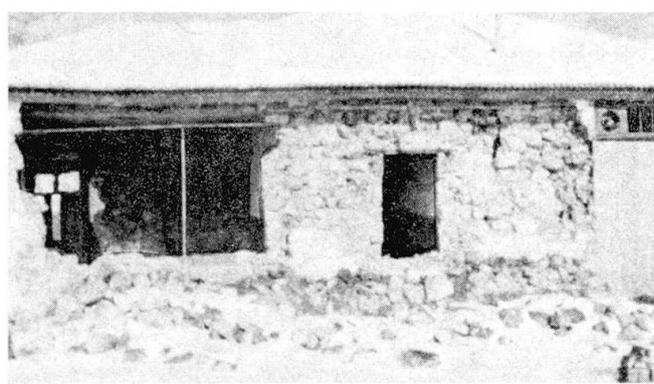
The earthquake of 1970 with magnitude $M = 6.6$ and focal depth $H = 13$ Km spreaded over an area of about 600 Km^2 with intensity 8 (MSK scale). It was accompanied by rockfalls and landslides along river banks and steep mountain slopes. The volume of landslides in some places exceeded 1 million m^3 , the extent of the breaches reached several hundred meters [1, 2]. Some of the stone buildings in the settlements, located on the epicentral area, were collapsed (fig. 1). The quake of 1975 had intensity 7. It caused heavy damages to rubble buildings (fig. 2).

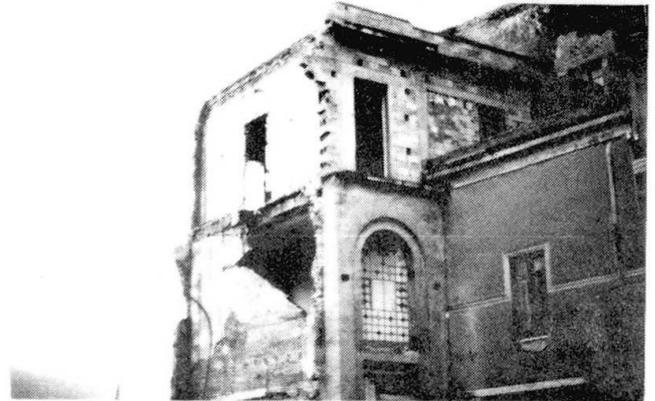
Fig. 6: Patti Cathedral: the left wing.

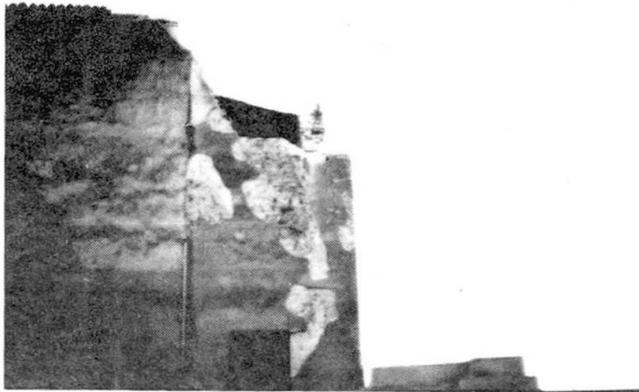
Fig. 7: Patti Cathedral: the corner of the main nave.
