STRUCTURAL BEHAVIOUR OF THE DAMAGED BUILDING DURING THE
FRIULI EARTHQUAKES BETWEEN MAY 6 AND SEPTEMBER 15, 1976

by Ewald Heimgartner, Structural Engineer ETHZ/SIA

BASLER & HOFMANN

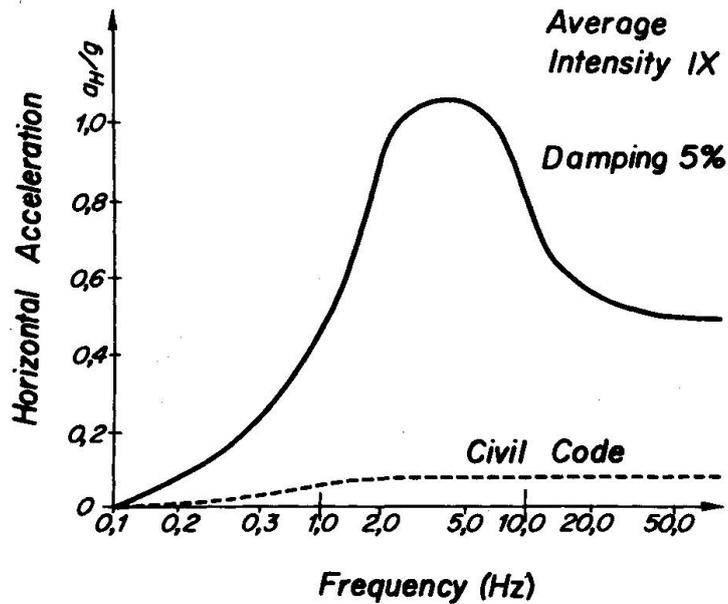
The Italian State Administration has enacted special regulations for earthquake-prone areas and has repeatedly brought them up-to-date. Using the Code, design earthquake loads are determined by statical or dynamic analysis. An average horizontal acceleration will result, which is about 7 percent of the gravity acceleration g . Comparison of horizontal design accelerations given by the Code with those produced by an earthquake with the Intensity IX (Figure 21) shows large discrepancies.

The Code values are significantly smaller because it is assumed that strong energy absorption will occur due to inelastic behaviour of materials and elements. But this means that the structure must be capable of absorbing the appropriate energy. Consequently, plastic deformation and therefore damage or maybe even collapse can result.

Figure 21: Horizontal ground acceleration for earthquakes of intensity IX (MSK) (U.S. Atomic Energy Commission, WASH 1255). The dashed line gives the design ground acceleration according to the conventional aseismic building code.
