**Artikel:** Structural behaviour of the damaged building during the Friuli earthquakes between May 6 and September 15, 1976

**Autor:** Heimgartner, Ewald

STRUCTURAL BEHAVIOUR OF THE DAMAGED BUILDING DURING THE  
FRIULI EARTHQUAKES BETWEEN MAY 6 AND SEPTEMBER 15, 1976

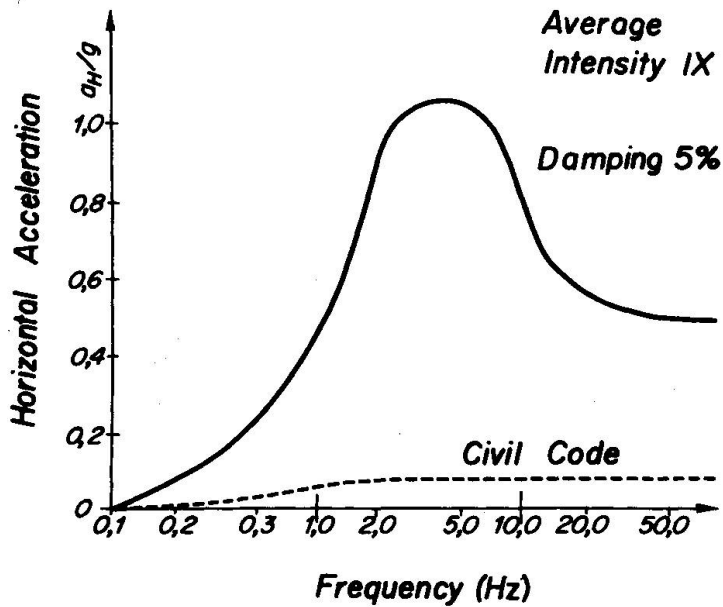
The Italian State Administration has enacted special regulations for earthquake-prone areas and has repeatedly brought them up-to-date. Using the Code, design earthquake loads are determined by statical or dynamic analysis. An average horizontal acceleration will result, which is about 7 percent of the gravity acceleration  $g$ . Comparison of horizontal design accelerations given by the Code with those produced by an earthquake with the Intensity IX (Figure 21) shows large discrepancies.

The Code values are significantly smaller because it is assumed that strong energy absorption will occur due to inelastic behaviour of materials and elements. But this means that the structure must be capable of absorbing the appropriate energy. Consequently, plastic deformation and therefore damage or maybe even collapse can result.

Figure 21: Horizontal ground acceleration for earthquakes of intensity IX (MSK) (U.S. Atomic Energy Commission, WASH 1255). The dashed line gives the design ground acceleration according to the conventional aseismic building code.
