STRUCTURAL BEHAVIOUR OF THE DAMAGED BUILDING DURING THE FRIULI EARTHQUAKES BETWEEN MAY $\acute{0}$ AND SEPTEMBER 15, 1976

by Ewald Heimgartner, Structural Engineer ETHZ/SIA BASLER & HOFMANN Consulting Engineers and Planners CH - 8029 Zurich, Switzerland

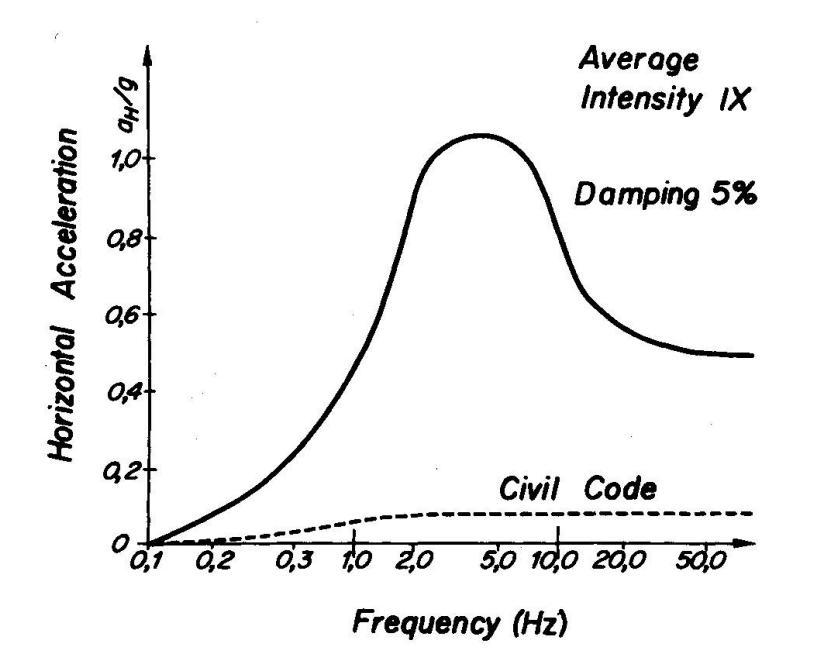
The Italian State Administration has enacted special regulations for earthquakeprone areas and has repeatedly brought them up-to-date. Using the Code, design earthquake loads are determined by statical or dynamic analysis. An average horizontal acceleration will result, which is about 7 percent of the gravity acceleration g. Comparision of horizontal design accelerations given by the Code with those produced by an earthquake with the Intensity IX (Figure 21) shows large discrepancies.

The Code values are significantly smaller because it is assumed that strong energy absorption will occur due to inelastic behaviour of materials and elements. But this means that the structure must be capable of absorbing the appropriate energy. Consequently, plastic deformation and therefore damage or maybe even collapse can result.

Figure 21: Horizontal ground acceleration for earthquakes of intensity IX (MSK) (U.S. Atomic Energy Commission, WASH 1255). The dashed line gives the disign ground acceleration according to the conventional aseimic building code.
