STRUCTURAL BEHAVIOUR OF THE DAMAGED BUILDING DURING THE
FRIULI EARTHQUAKES BETWEEN MAY 6 AND SEPTEMBER 15, 1976

by Ewald Heimgartner, Structural Engineer ETHZ/SIA

BASLER & HOFMANN
Consulting Engineers and Planners
CH - 8029 Zurich, Switzerland

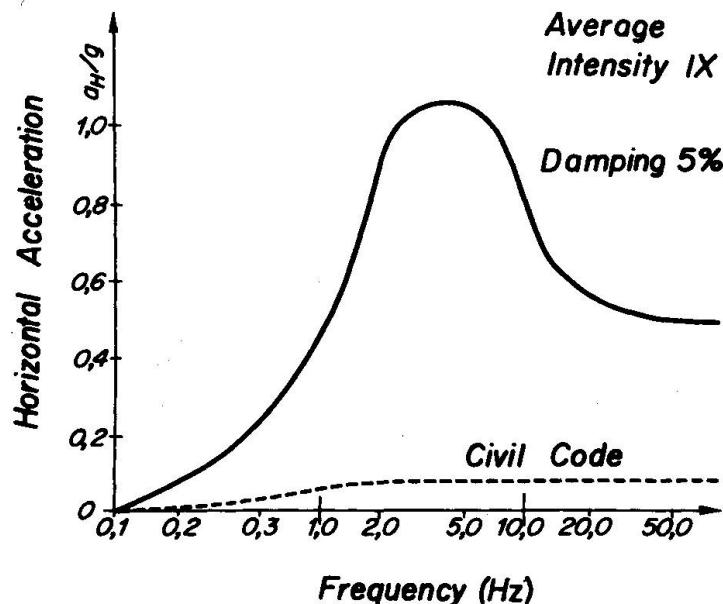
The Italian State Administration has enacted special regulations for earthquake-prone areas and has repeatedly brought them up-to-date. Using the Code, design earthquake loads are determined by statical or dynamic analysis. An average horizontal acceleration will result, which is about 7 percent of the gravity acceleration g . Comparision of horizontal design accelerations given by the Code with those produced by an earthquake with the Intensity IX (Figure 21) shows large discrepancies.

The Code values are significantly smaller because it is assumed that strong energy absorption will occur due to inelastic behaviour of materials and elements. But this means that the structure must be capable of absorbing the appropriate energy. Consequently, plastic deformation and therefore damage or maybe even collapse can result.

Figure 21: Horizontal ground acceleration for earthquakes of intensity IX (MSK) (U.S. Atomic Energy Commission, WASH 1255). The dashed line gives the design ground acceleration according to the conventional aseismic building code.

On present day standards, this is not good enough. Originally, Codes were drawn up merely to prevent the collapse of a structure and thus save lives. Today, our more highly developed society demands that at least life-lines (i.e., hospitals, water supplies, electricity, etc.) continue to function after an earthquake. As a result, it is imperative that a Code be introduced incorporating design specifications which distinguish between the various functions for which structures are built.
