Rubrik: Short communications

BEHAVIOUR OF AN ASEISMIC STRUCTURE DURING CAUCETE EARTHQUAKE OF NOVEMBER 23, 1977

DAMAGE TO BRIDGES DURING THE NORTH CAUCASUS EARTHQUAKES

A FIRST GEOTECHNICAL ASSESSMENT OF THE RECENT PATTI EARTHQUAKE (SICILY)

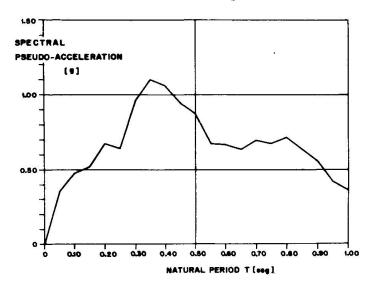
Fig. 3 - Pseudo-accelerations spectrum of Caucete 23.11.77 earthquake

To investigate this behaviour we used the spectrum shown on fig. 3, which was obtained from the spectrum calculated by IDIA, by multiplying its ordinates by the ratio between the records of two seismoscopes, one located in Caucete town, about 200 m distant from the structure, and the other beside the IDIA accelerograph in the city of San Juan,

These spectra are calculated for a damping ratio of 5% of critical damping. This figure is assumed to occur in reinforced concrete structures reaching yield, according to records from San Fernando earthquake of 1971.

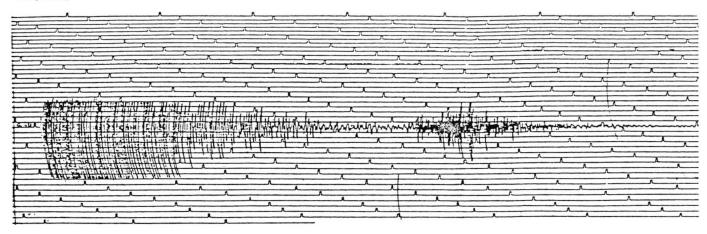
Fig. 3: The Patti earthquake recorded at the University of Catania.

The main shock was preceded by a small shock a few minutes before. Its record is incomplete because the seismograph at Catania University went off the scale (fig. 3) as did the one at Messina University.

As appears clear from fig. 3 the main shock was very quickly followed by an induced sussultory earthquake.
