Zeitschrift: IABSE reports of the working commissions = Rapports des commissions de travail AIPC = IVBH Berichte der Arbeitskommissionen

BEHAVIOUR OF AN ASEISMIC STRUCTURE
DURING CAUCETE EARTHQUAKE
OF NOVEMBER 23, 1977

DAMAGE TO BRIDGES DURING THE NORTH CAUCASUS EARTHQUAKES

A FIRST GEOTECHNICAL ASSESSMENT OF THE RECENT PATTI EARTHQUAKE
(SICILY)

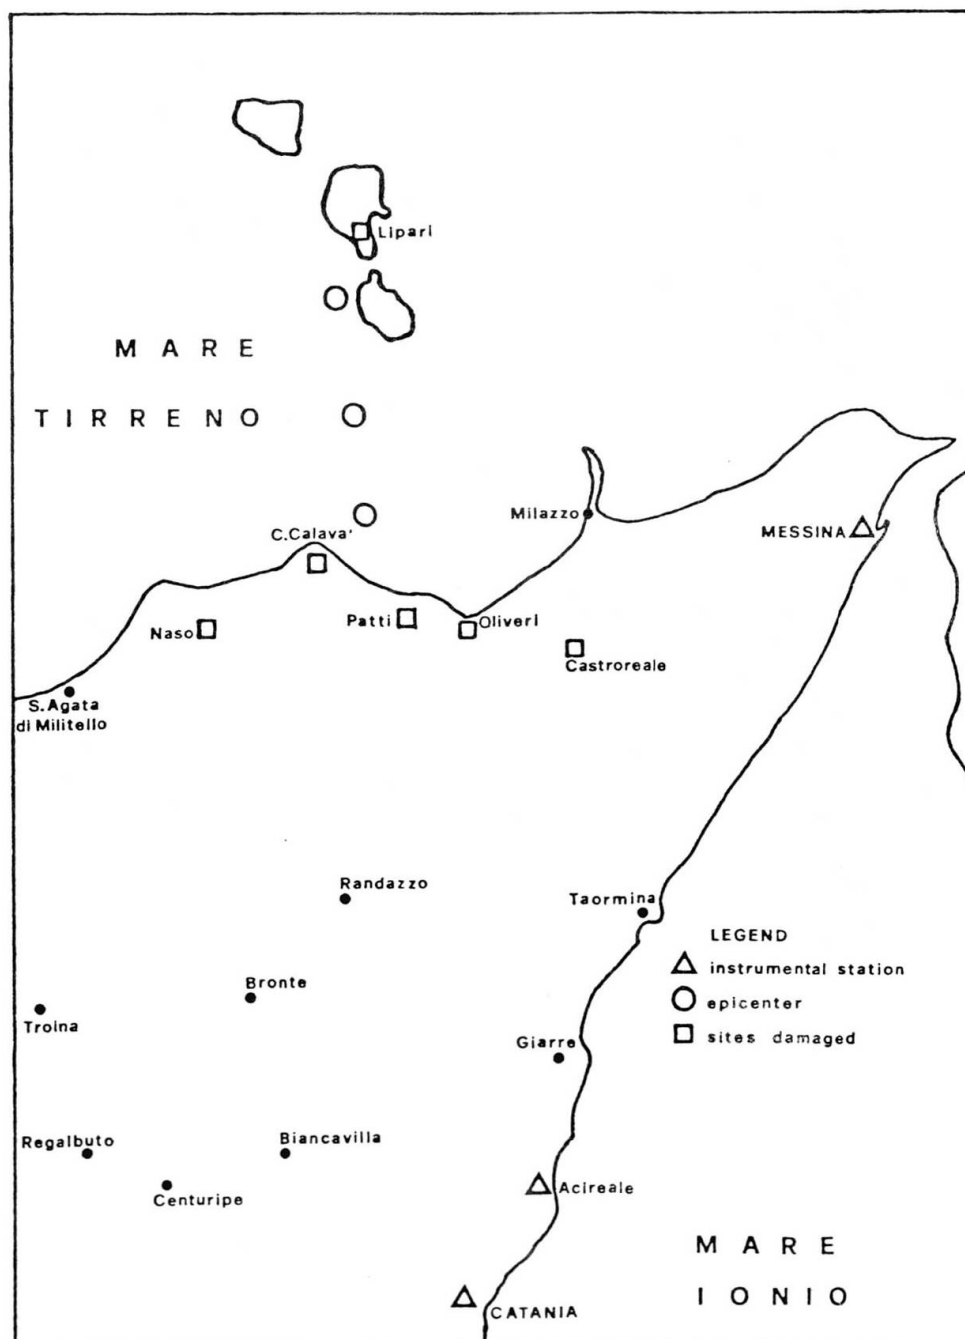
Fig. 1: Patti Earthquake, April 15, 1978.

On Saturday 15th April 1978, at about half past midnight (local time), a 5.5 magnitude earthquake occurred in the Aeolian Islands between Lipari and Vulcano, opposite Marina di Patti, a small coastal township in the Commune of Patti (fig. 1).

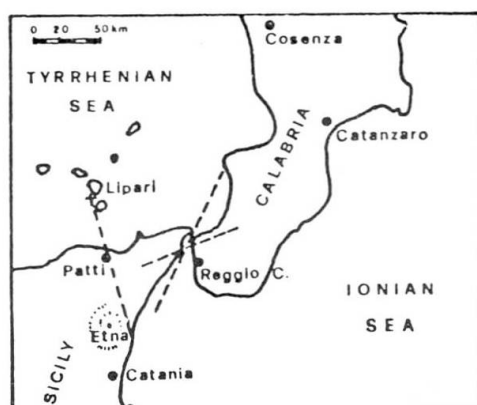
Fig. 2: Sketch of fault probably related to earthquake

The earthquakes appeared to be of tectonic origin and several faults are present in the region, as sketched schematically in fig. 2. It is interesting to note the presence of a fault passing by Mt Etna through Patti till it reaches the Island of Vulcano, which probably was active during the earthquake.

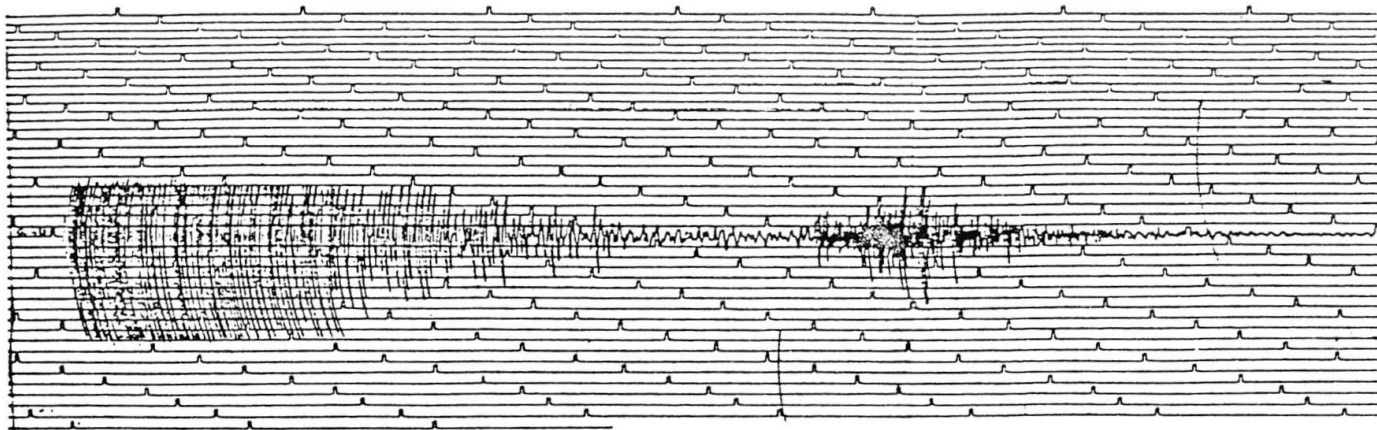
Fig. 3: The Patti earthquake recorded at the University of Catania.

The main shock was preceded by a small shock a few minutes before. Its record is incomplete because the seismograph at Catania University went off the scale (fig. 3) as did the one at Messina University.

As appears clear from fig. 3 the main shock was very quickly followed by an induced sussultory earthquake.

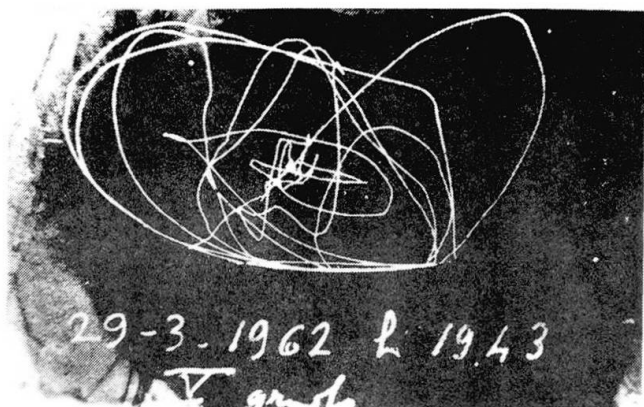
Fig. 5: Seismoscope record of a 4.3 magnitude earthquake.

By way of comparison, the record with the same historical seismoscope (called Vicentini) of a 4.3 magnitude earthquake which occurred on 28th March 1962 at 3km from the Acireale station (Costa, 1977) is represented in fig. 5.
