Zeitschrift:	IABSE reports of the working commissions = Rapports des commissions de travail AIPC = IVBH Berichte der Arbeitskommissionen
Band:	30 (1978)
Rubrik:	Short communications

B E H A V I O U R O F A N A S E I S M I C S T R U C T U R E
D U R I N G C A U C E T E E A R T H Q U A K E
O F N O V E M B E R 2 3, 1 9 7 7

DAMAGE TO BRIDGES DURING THE NORTH CAUCASUS EARTHQUAKES

A FIRST GEOTECHNICAL ASSESSMENT OF THE RECENT PATTI EARTHQUAKE
(SICILY)

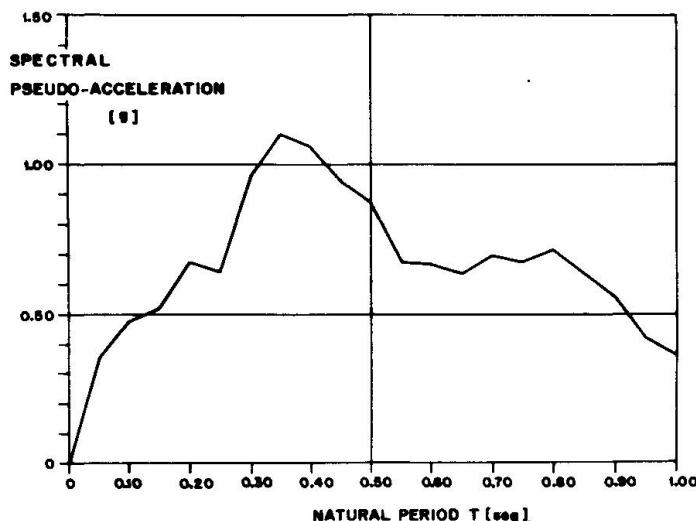
Fig. 3 - Pseudo-accelerations spectrum of Caucete 23.11.77 earthquake

To investigate this behaviour we used the spectrum shown on fig. 3, which was obtained from the spectrum calculated by IDIA, by multiplying its ordinates by the ratio between the records of two seismoscopes, one located in Caucete town, about 200 m distant from the structure, and the other beside the IDIA accelerograph in the city of San Juan,

$$\frac{R_{\text{seism. Caucete}}}{R_{\text{seism. San Juan}}} = \frac{0.52}{0.26} = 2$$

These spectra are calculated for a damping ratio of 5% of critical damping. This figure is assumed to occur in reinforced concrete structures reaching yield, according to records from San Fernando earthquake of 1971.

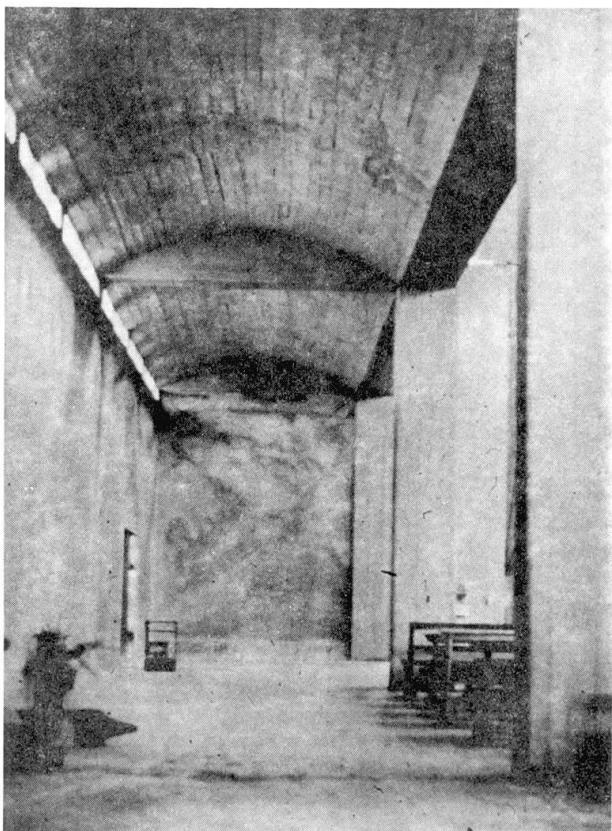
Fig. 6 - Lateral aisle

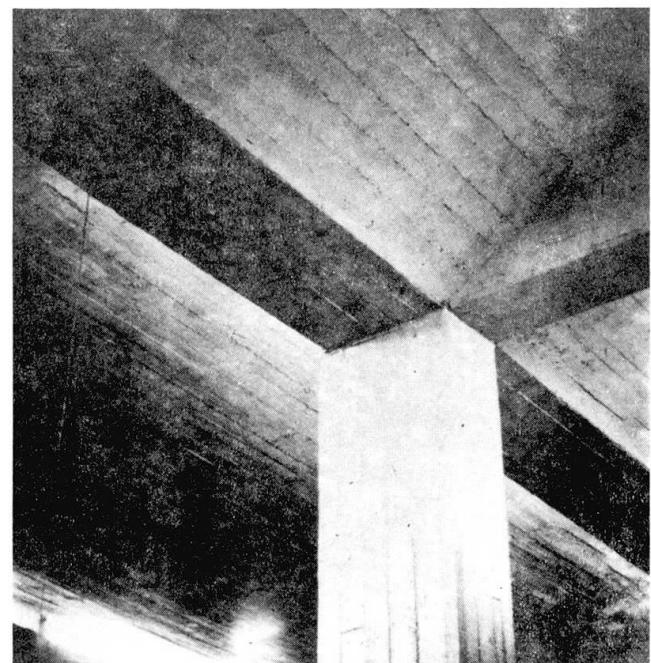
Fig. 7 - Detail of main frame joint

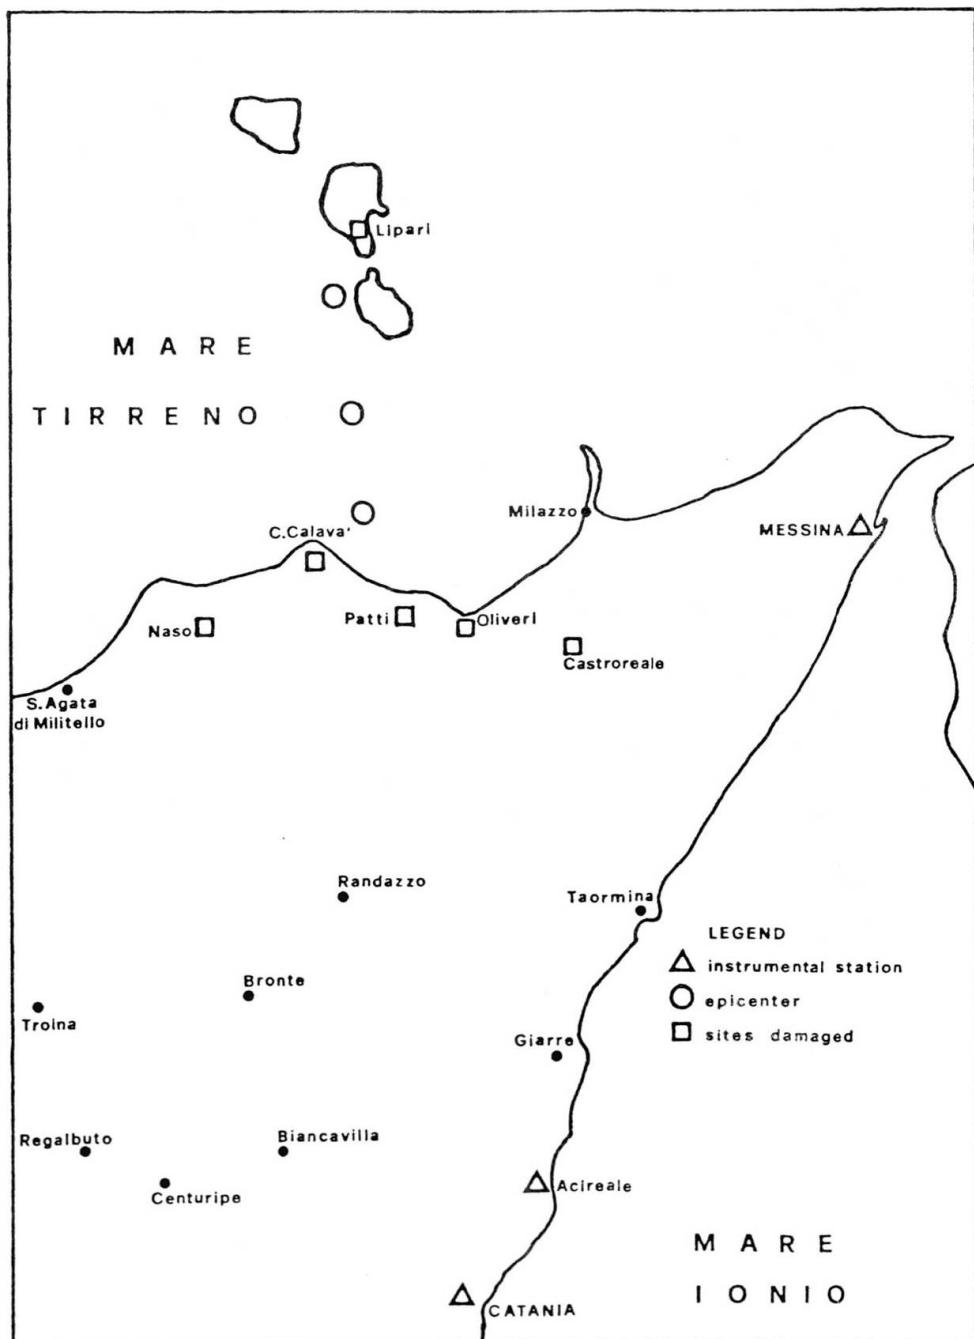
On Saturday 15th April 1978, at about half past midnight (local time), a 5.5 magnitude earthquake occurred in the Aeolian Islands between Lipari and Vulcano, opposite Marina di Patti, a small coastal township in the Commune of Patti (fig. 1).

Fig. 1: Patti Earthquake, April 15, 1978.

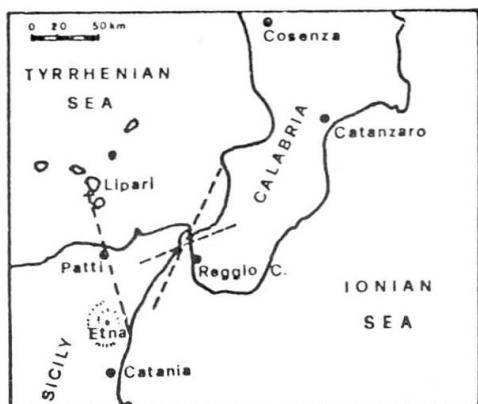
The earthquakes appeared to be of tectonic origin and several faults are present in the region, as sketched schematically in fig. 2. It is interesting to note the presence of a fault passing by Mt Etna through Patti till it reaches the Island of Vulcano, which probably was active during the earthquake.

Fig. 2: Sketch of fault probably related to earthquake

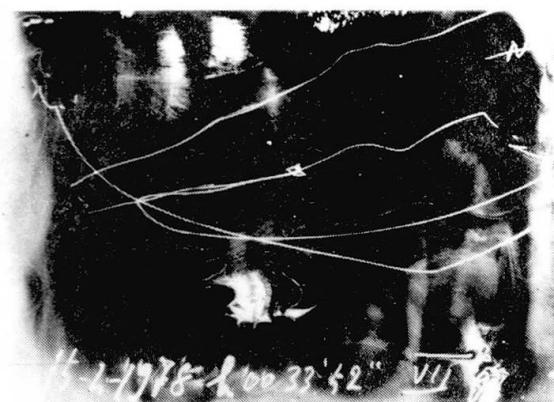
Fig. 4: Seismoscope record at Collegio Pennisi of Patti earthquake.

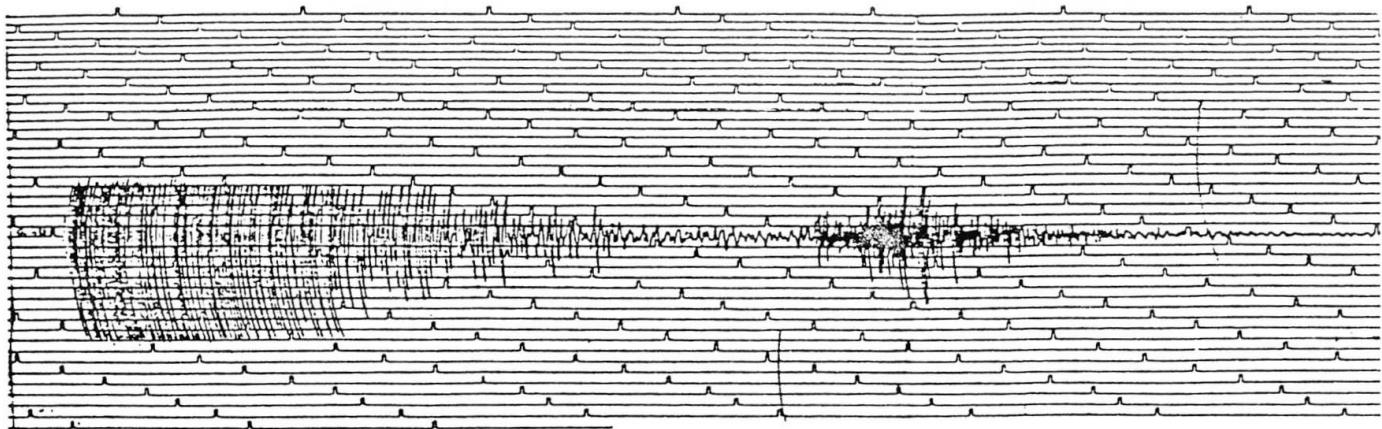
The main shock was preceded by a small shock a few minutes before. Its record is incomplete because the seismograph at Catania University went off the scale (fig. 3) as did the one at Messina University.

As appears clear from fig. 3 the main shock was very quickly followed by an induced sussultory earthquake.

Fig. 3: The Patti earthquake recorded at the University of Catania.

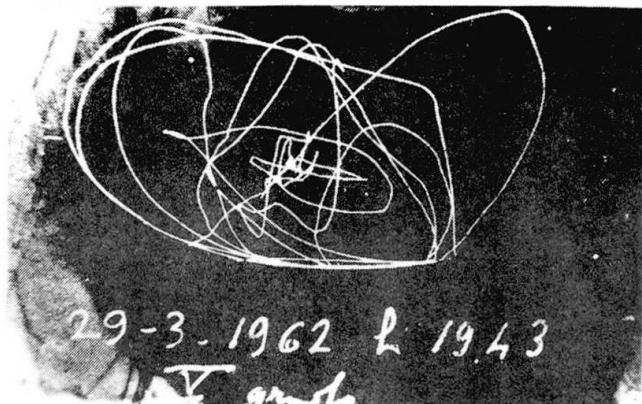
By way of comparison, the record with the same historical seismoscope (called Vicentini) of a 4.3 magnitude earthquake which occurred on 28th March 1962 at 3km from the Acireale station (Costa, 1977) is represented in fig. 5.

Fig. 5: Seismoscope record of a 4.3 magnitude earthquake.
