SESSION III

Construction, Performance, Renewal Construction, performance, rénovation Bau, Bewährung, Erneuerung

Bridges - Construction techniques and methods (concrete and steel)

Ponts — Procédés de construction (béton et acier)

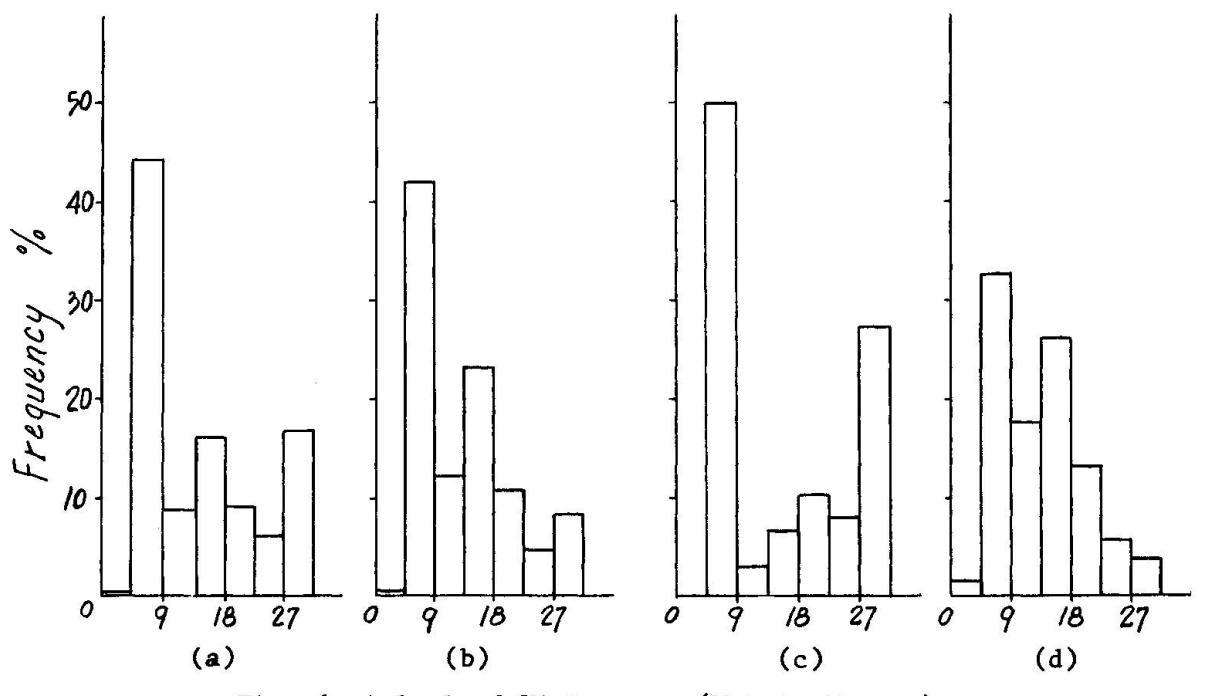
Fig. 1 Axle Load Histograms (Metric Tonnes)

The distribution of current bridge service loadings (Load Spectra) is quite wide as shown in figure 1. The distribution shown in Figure 1(a) represents a line carrying primarily bulk commodities and some small quantities of mixed freight to the west coast port of Vancouver, B.C. [3]. The distribution shown in Figure 1(b) represents a good mix of freight with a predominance of grain traffic just west of Winnipeg, Manitoba, roughly in the middle of Canada. The distribution shown in Figure 1(c) represents an ore carrying line leading from Northern Ontario. Finally, the distribution shown in Figure 1(d), just west of Montreal, shows the influence of relatively dense passenger traffic on the load spectrum.

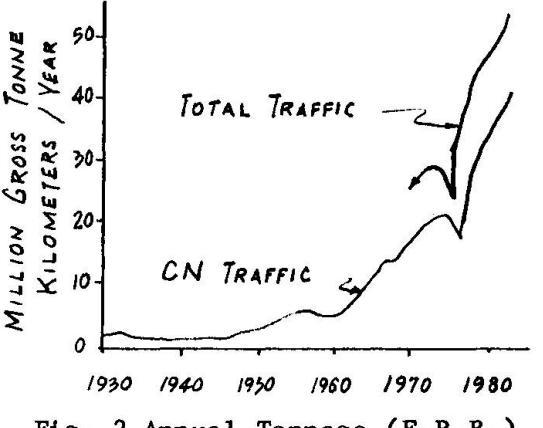
Fig. 2 Annual Tonnage (F.R.B.)

To illustrate the point, we need only consider the gross ton miles carried by the Fraser River Bridge (F.R.B.) at New Westminster, B.C. One can see the tremendous increase in traffic that started in the late 1960's (Figure 2). It is evident that the traffic in this and the next decade will have a predominant bearing on the fatigue life of this bridge.

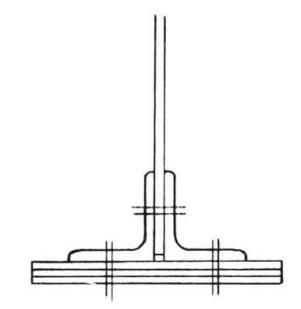
Fig. 3 Built up Member

For many years, cracking of riveted structures was controlled by the inherent crack stoppers between the component parts of built up members (Figure 3) [7]. Inspection intervals were frequent enough to report any cracks, and corrective measures were taken before an adjacent part could develop its own cracks. The historic exception has always been rolled sections which generally did not have serious stress raisers combined with frequent high tensile stress excursions.

Most riveted structures were internally member redundant in that they were fabricated of several components (Figure 3). Their advantage is that cracks do not jump from piece to piece. The chord member of the truss shown in Figure 13 cracked on one side, but not on the other side of the member, and carried rail traffic for some time before detection and repair. In a welded box like member the crack would have propagated all around.

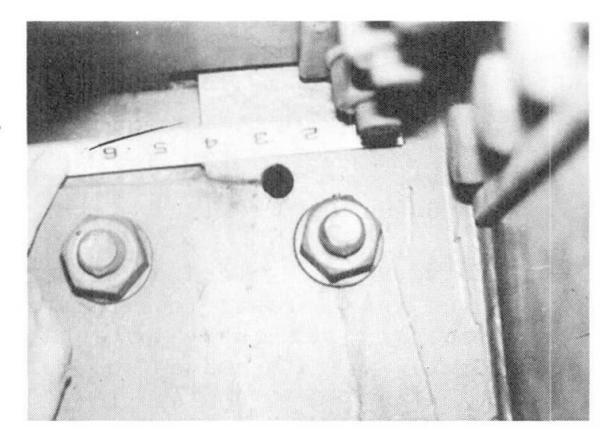
Fig. 7 Zero Radius

Another detail that has given trouble is the connection of brace frame angles to stiffeners (Figure 6) with the gussets groove welded to the stiffener. Referring to Figure 7, the critical detail has a zero radius. The stress causing crack growth is the lateral force from trains. Since maximum lateral impacts often occur due to hunting (side to side snaking) of empty cars, it took less than five years for these cracks to develop.

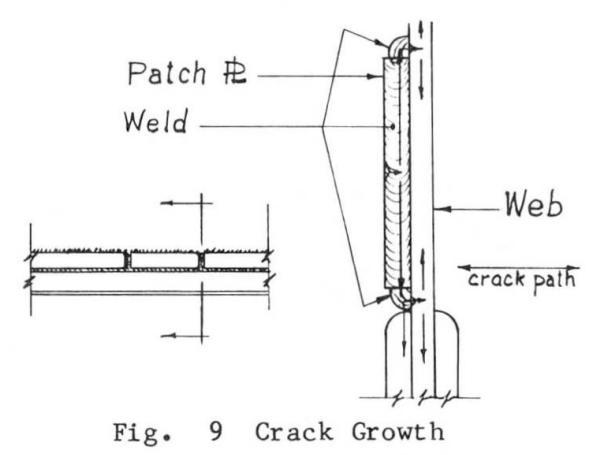
- 1. Crack initiation at a flaw.
- Crack growth (Figure 9) in the weld upward and downward in those welds that did not have full penetration and horizontally into the web for those that did.
- Growth from the level of the horizontal fillet welds into the web and bottom flange leaving multiple cracks.

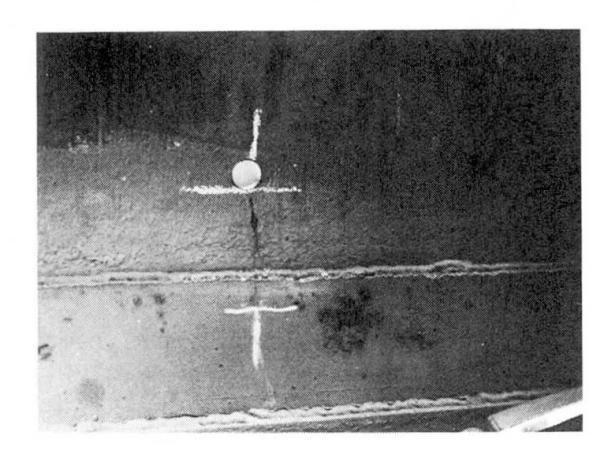
Figure 10 shows the same location looking from the inside of the girder. Note that there is no butt weld on the inside at the location of this crack. The crack has propagated from the opposite side.

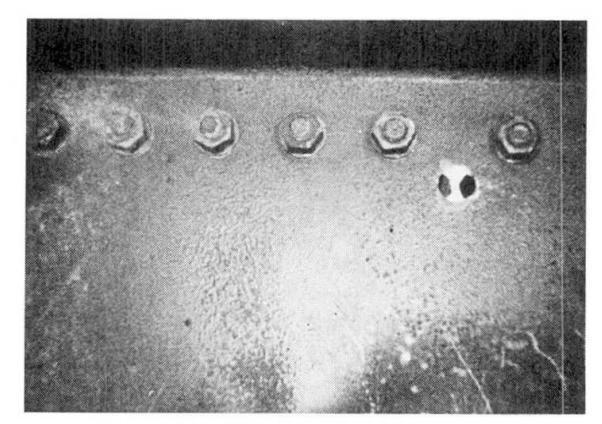
Fig. 12 Other Side

Figure 12 was taken after the two holes drilled from the inside had been reamed to one hole from the outside flush with the stiffener on the inside. The white metal along the vertical centerline of the hole is the stiffener.

1. Drill 7/16 diameter holes on both sides at the stiffener through the web at an approximate angle of 30° away from the stiffener (Figure 11) making sure

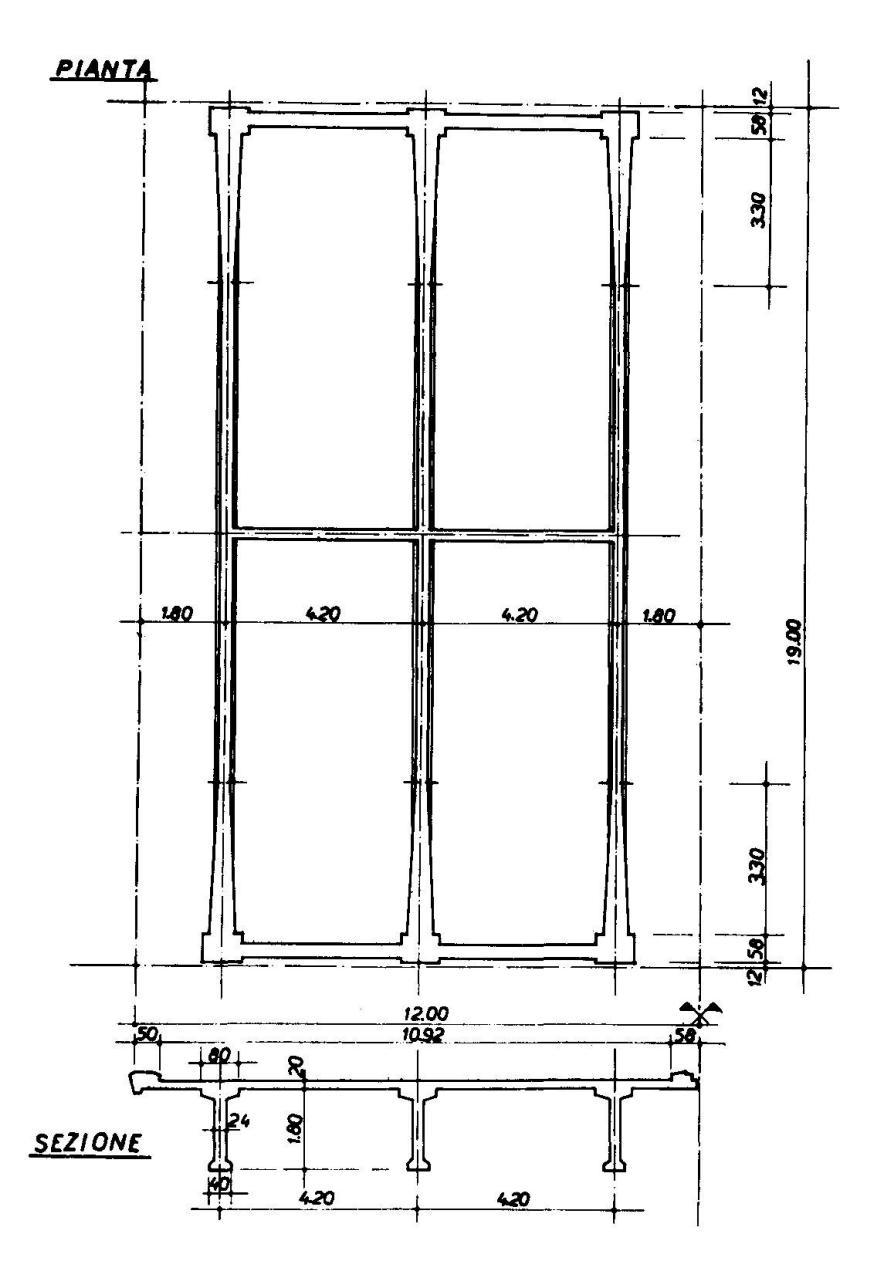
Fig. 1 - Geometry of the standard bay.

Figure 1 illustrates the geometry of the standard bay.

During my visit I found some superficial distress in the paving joints, some excessive crushing of the bearings (although no thing really serious) but, most important of all, that all the parallel beams of the deck showed a diffused pattern of cracks of very similar length, frequency and width on all the bays.

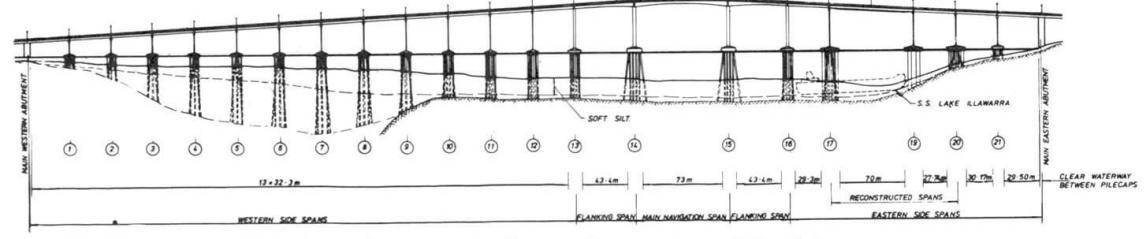
Fig. 2 Elevation of restored bridge

At the bridge site the river is wide and deep, water depths generally being in excess of 30 m. The bridge itself consists of three separate structures (Fig. 2), the navigation spans in mid river, 13 x 42.7 m spans in the western main viaduct and 6 x 42.7 m spans in the eastern main viaduct. The

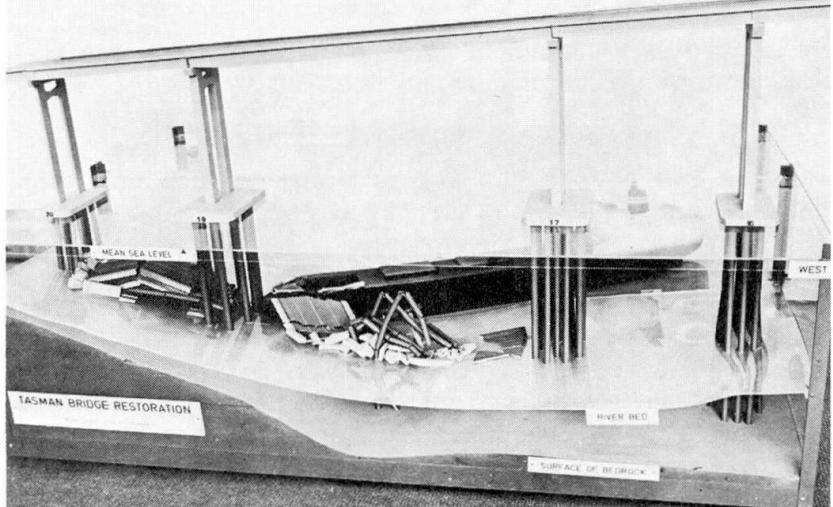
The debris survey took about three months and in the end all the broken bridge pieces were accounted for. A model was built to show the underwater picture (Fig. 3). During the debris survey it is to the credit of the Bridge Commission that pressures to make an early decision on the method of restoration were resisted. Five alternate schemes for reconstruction ranging from a single span scheme to a triple span scheme were examined in some detail. AS the underwater scene unfolded the schemes were discarded one by one because debris prevented the placement of new piles, and the selected scheme only became evident at the end of the survey period when a complete picture was available. The only clear space available to establish a new pier was at the site of the original Pier 19 and this involved placement of new vertical piles between the existing

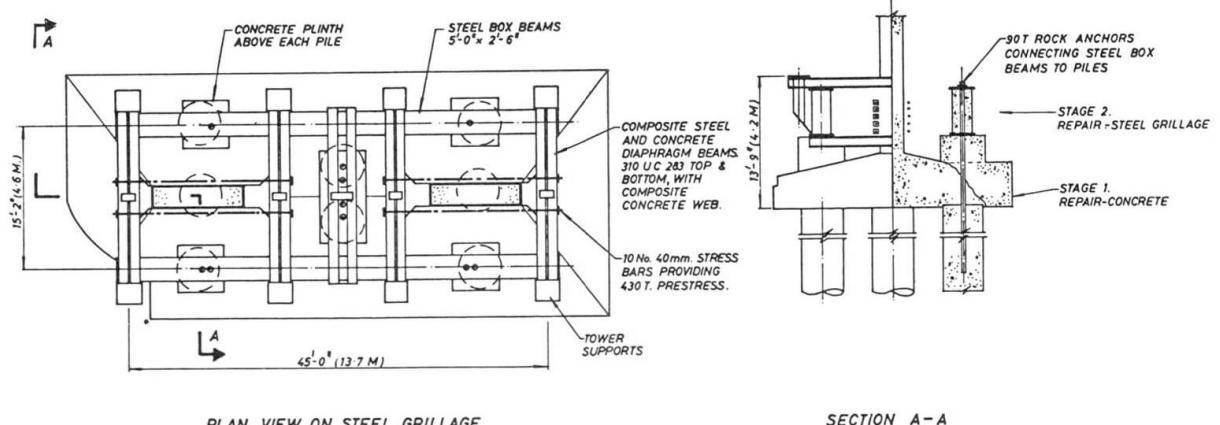
The security of Pile Cap 20 was more difficult as it had lost about one third of its volume (Fig. 5) and the remainder was extensively cracked and in some places crumbled. Its load carrying capacity was unknown and although it had to be replaced later it was decided to do temporary repairs before any major work commenced. These were in two parts:-

Fig. 5 Damage to Pile Cap 20

- Construction of a temporary steel pile cap above the existing cap (Fig. 6). Its purpose was to enable column loads to bypass the existing cap and be transmitted directly into the piles. This action was achieved by stressing the steel cap to the columns and by casting concrete plinths on top of the existing cap, directly above the piles, and stressing the steel cap to the piles by means of rock anchors drilled and grouted into them.

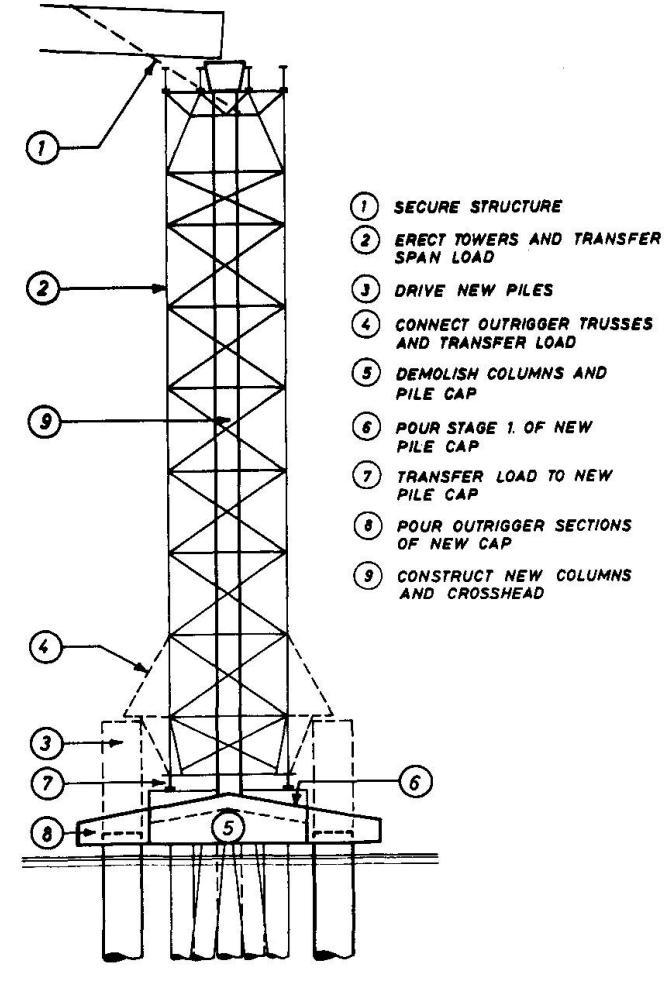
Fig. 8 Pier 17 construction sequence

The steel towers fulfilled many functions, including support of existing spans during column demolition, bracing for new concrete columns during construction, supports for the erection derricks and landing points for the new beams. The construction sequence involved in the use of the tower at Pier 17 is shown in Fig. 8.

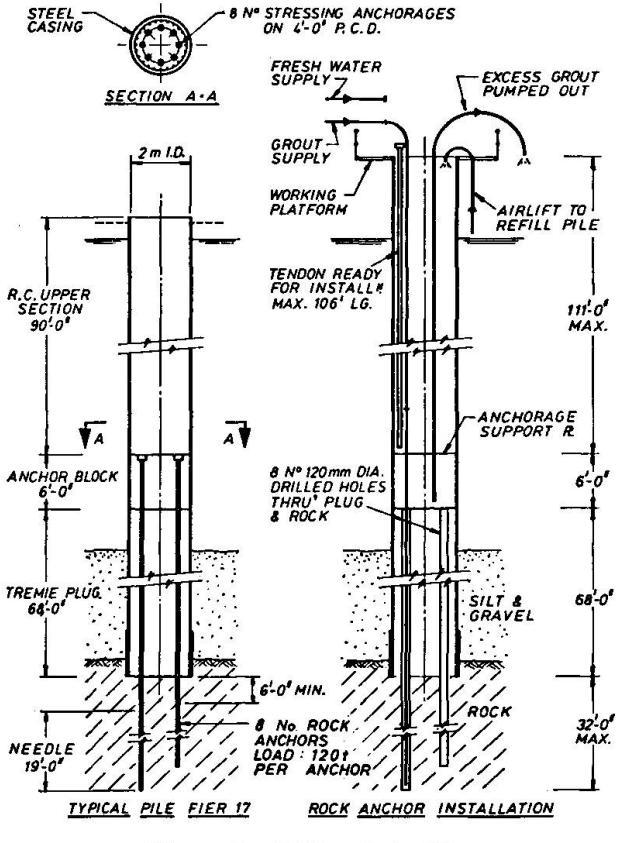
Fig. 7 Pile details

Details of the new vertical piling are shown in Fig. 7. 2 m diameter was selected as being the largest size which could be

reasonably handled. Base fixity to the piles was provided by means of rock anchors. At Pier 19 where all piles are vertical deck deflection under a 45 m/sec. transverse wind is 40 mm being 1 in 1,500 of the deck height above foundation level. The maximum loads per pile at this pier were 10,630 kN and 4,650 kNm.

At Pier 17 due to frequent rock joints the anchor holes could not be sealed and the installation method was modified to enable anchors to be grouted in a flooded pile (Fig. 7). Individual holes were kept grout filled while the grout leaking into adjacent holes was flushed out. A reservoir at the top of the plug enabled the grout quality to be monitored by underwater TV camera while visibility was maintained by downward circulation of fresh water.

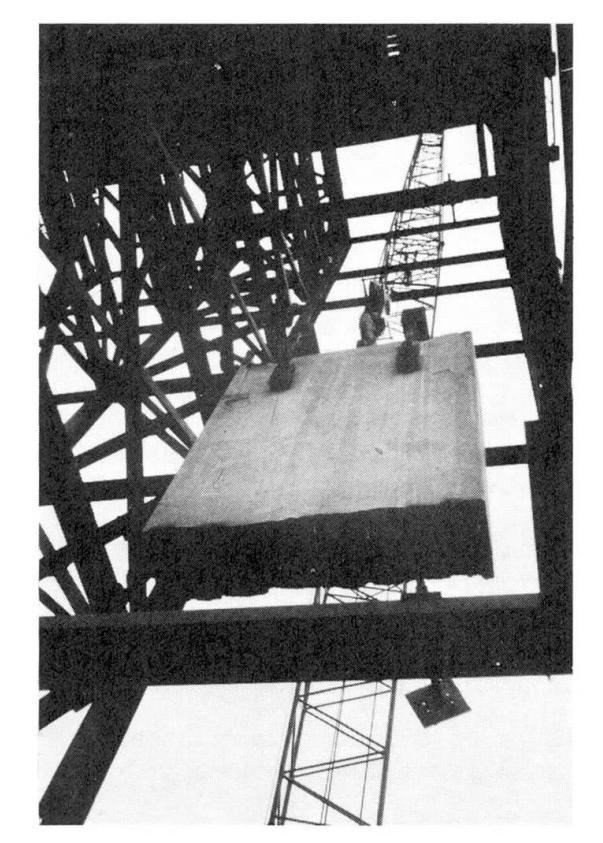
Fig. 9 Column demolition

The original columns were made up of precast concrete blocks, vertically stressed together with Macalloy bars. They had a cross-section of 3 m x 0.75 m and were cut horizontally using a thermic lance and hydraulic wedge splitters. The 25 tonne pieces were lifted out through the top of the falsework tower (Fig. 9). Twelve working days were required to remove the two legs of the Pier 20 column.

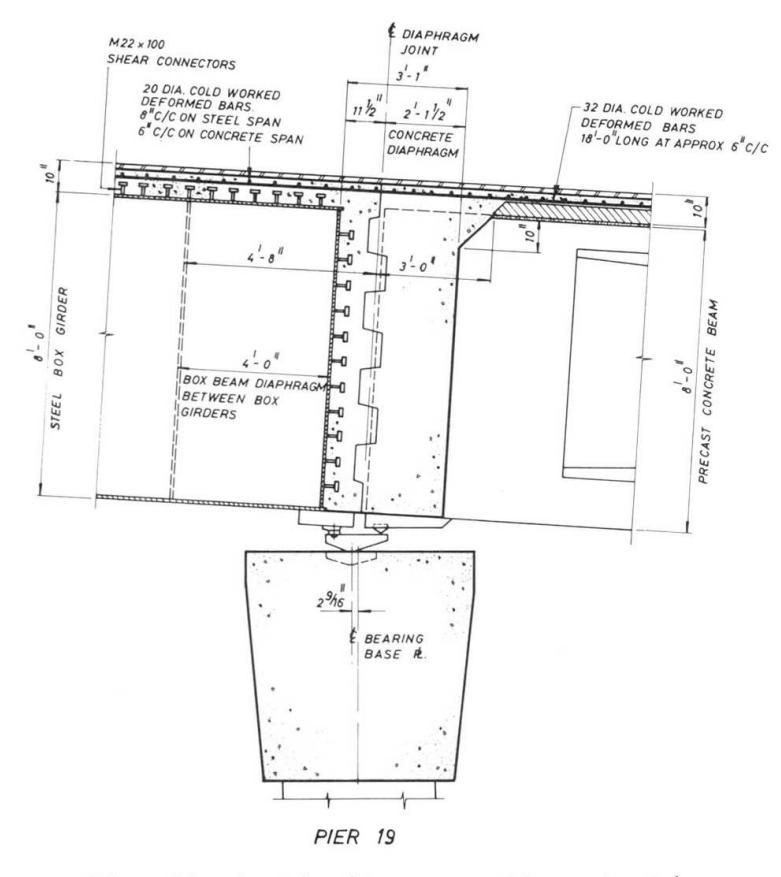
Fig. 10 Continuity connection steel/ concrete spans

the finite element analyses of the end crossbeams. The continuity detail between the steel and concrete spans over the piers (Fig. 10) was similar to that used in the original design.

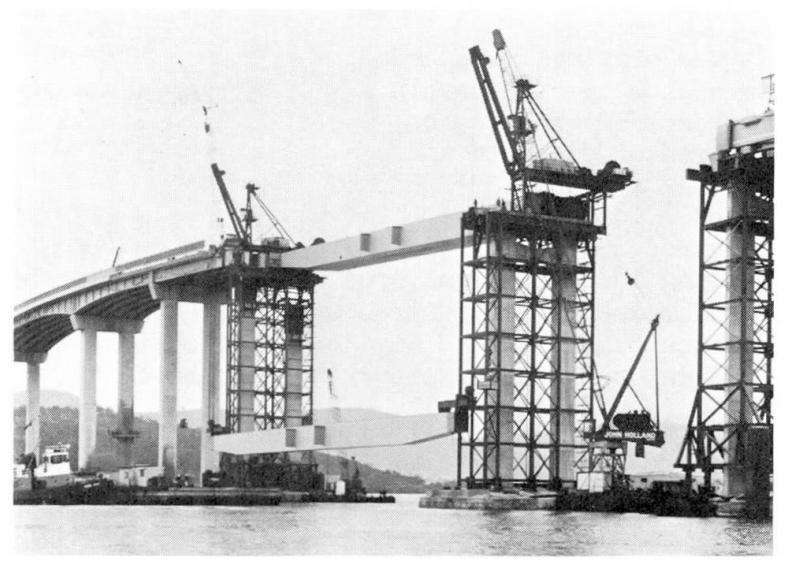
Fig. 11 Box girder erection

The adopted scheme used luffing 'A' frame lifting derricks specifically designed by the Contractor for the purpose (Fig. 11). By using temporary cantilever extensions at the ends of the boxes, they were lifted outboard of the towers as a single unit and positioned

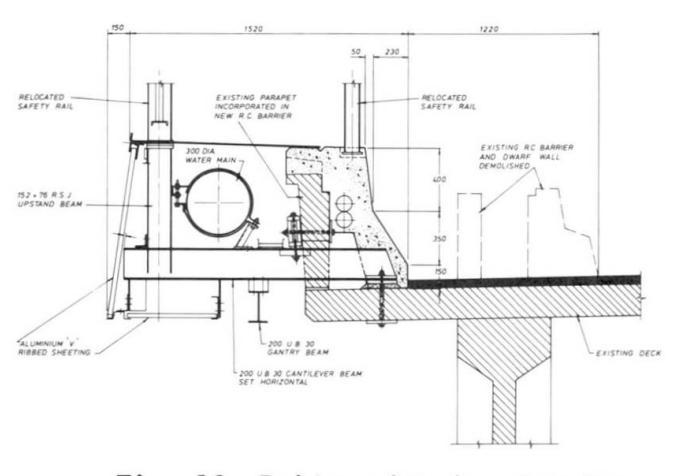
Fig. 12 Bridge widening details

While the bridge was out of service the opportunity was taken to widen it from four to five lanes over its full length. This permitted the operation of a rather more comfortable 3:2 tidal flow system rather than 3:1 as previously. The widening was achieved by cantilevering new footways and using the existing concrete deck for the five lanes (Fig. 12).

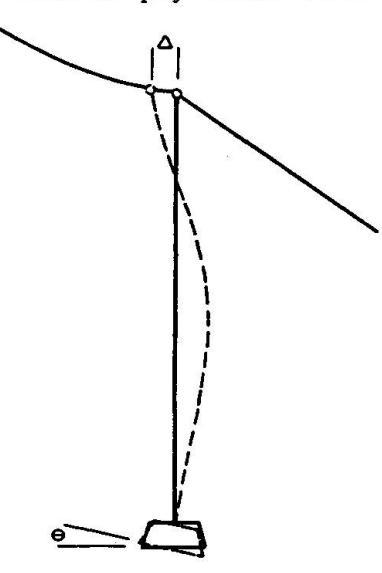
Fig. 5 Schematic View of North Cable Bent

Starting with the foundations, it was discovered that the footing of the North Cable Bent, located at the North end of the Suspension Bridge, had settled unevenly over the years and was inducing large secondary stresses in the tower legs. Furthermore, continued slippage of the main cables in the saddle at the top of this tower had aggravated the situation. See Figure 5.

The stability of this tower is critical to the safety of the entire bridge. Other significant structural defects in the Suspension Bridge included live load bending overstress in the stiffening truss and inelastic stretch in the main cables which caused main tower out of plumb and secondary bending in the stiffening truss. The suspended spans also suffered from the same basic problems as the North Viaduct due to crevice corrosion in the support steelwork and towers plus decay of the deck structure due to corrosion and wear. In this case the deck construction is steel tee grid infilled with concrete. This deck has no wearing surface and is unacceptably slippery when wet. Furthermore, the deck is not waterproof and corrosion between the tees and on the top of the floorbeams tends to cause the tees to pry loose from one another and the support steel.
