Rubrik: Session III: Construction, performance, renewal

SESSION III

Construction, Performance, Renewal

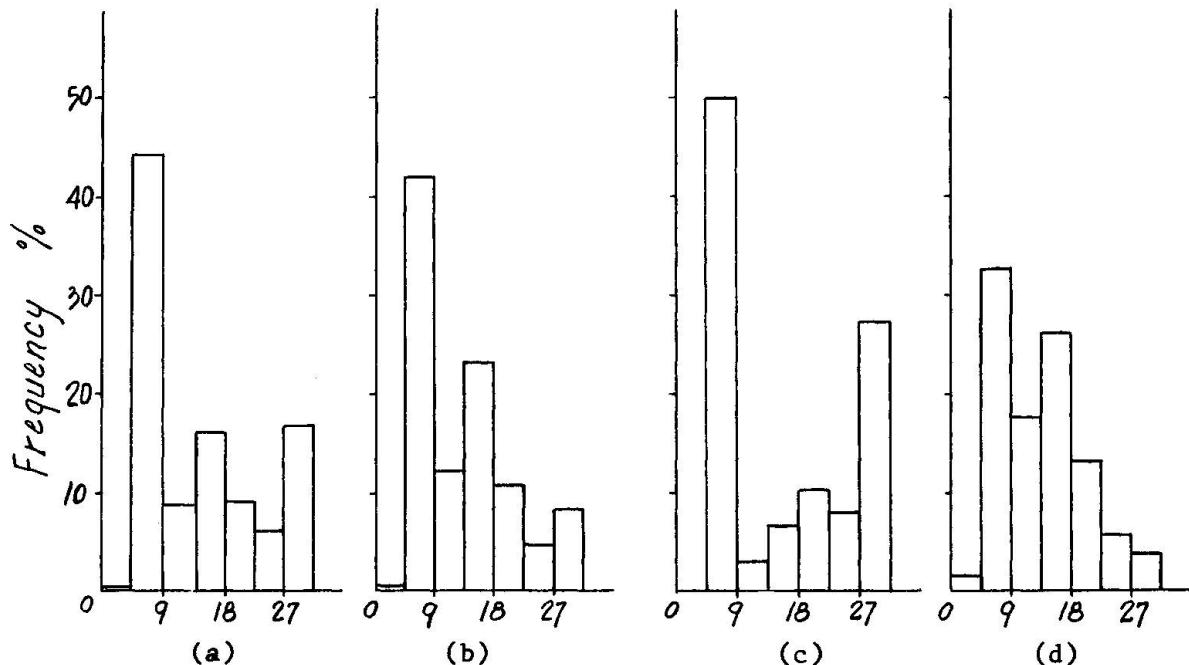
The distribution of current bridge service loadings (Load Spectra) is quite wide as shown in figure 1. The distribution shown in Figure 1(a) represents a line carrying primarily bulk commodities and some small quantities of mixed freight to the west coast port of Vancouver, B.C. [3]. The distribution shown in Figure 1(b) represents a good mix of freight with a predominance of grain traffic just west of Winnipeg, Manitoba, roughly in the middle of Canada. The distribution shown in Figure 1(c) represents an ore carrying line leading from Northern Ontario. Finally, the distribution shown in Figure 1(d), just west of Montreal, shows the influence of relatively dense passenger traffic on the load spectrum.

Fig. 1 Axle Load Histograms (Metric Tonnes)

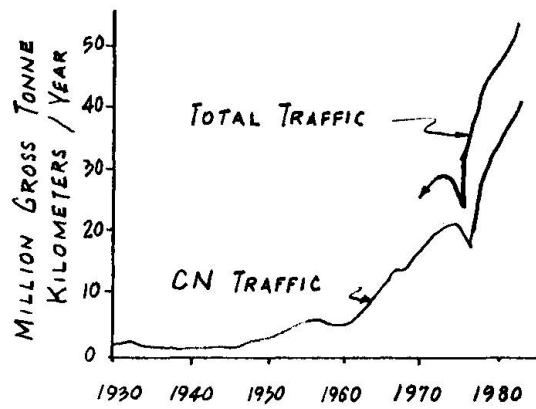
To illustrate the point, we need only consider the gross ton miles carried by the Fraser River Bridge (F.R.B.) at New Westminster, B.C. One can see the tremendous increase in traffic that started in the late 1960's (Figure 2). It is evident that the traffic in this and the next decade will have a predominant bearing on the fatigue life of this bridge.

Fig. 2 Annual Tonnage (F.R.B.)

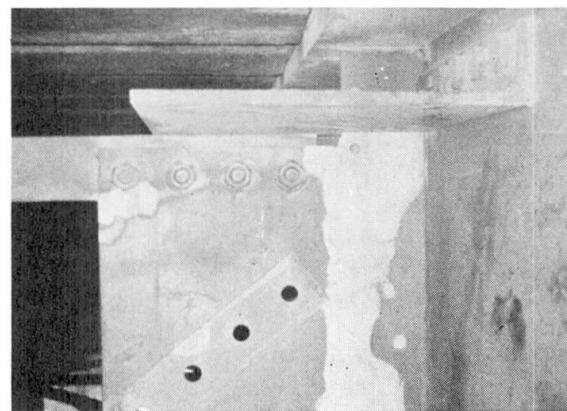
Fig. 6 Gusset to Stiffener

Another detail that has given trouble is the connection of brace frame angles to stiffeners (Figure 6) with the gussets groove welded to the stiffener. Referring to Figure 7, the critical detail has a zero radius. The stress causing crack growth is the lateral force from trains. Since maximum lateral impacts often occur due to hunting (side to side snaking) of empty cars, it took less than five years for these cracks to develop.

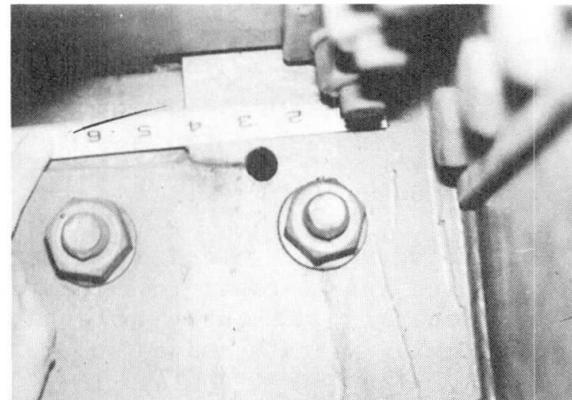
Fig. 7 Zero Radius

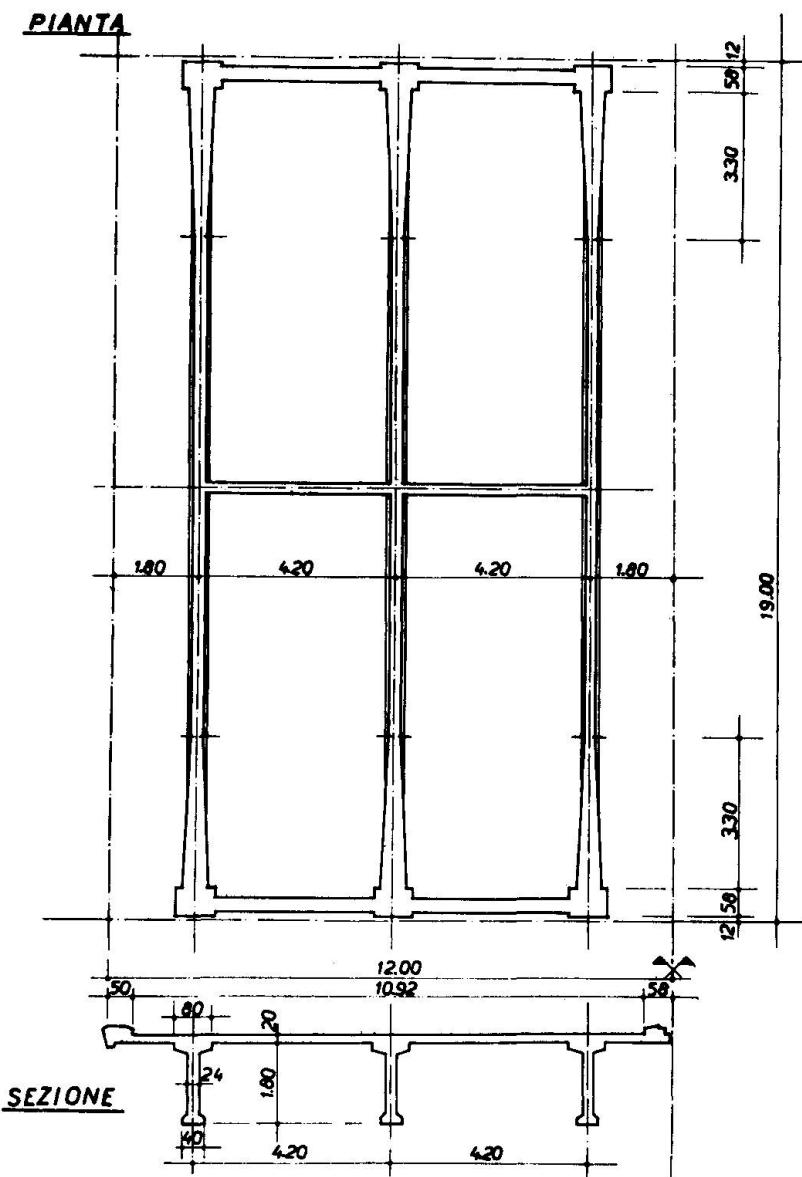
Fig. 1 - Geometry of the standard bay.

During my visit I found some superficial distress in the paving joints, some excessive crushing of the bearings (although nothing really serious) but, most important of all, that all the parallel beams of the deck showed a diffused pattern of cracks of very similar length, frequency and width on all the bays.

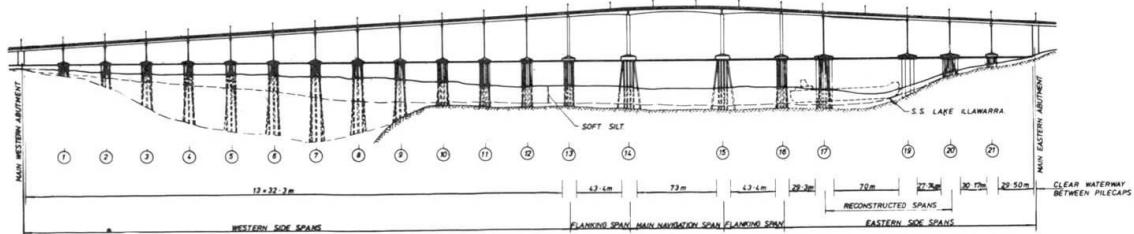
At the bridge site the river is wide and deep, water depths generally being in excess of 30 m. The bridge itself consists of three separate structures (Fig. 2), the navigation spans in mid river, 13 x 42.7 m spans in the western main viaduct and 6 x 42.7 m spans in the eastern main viaduct. The original design recognised the possibility of a ship collision although the

Fig. 2 Elevation of restored bridge

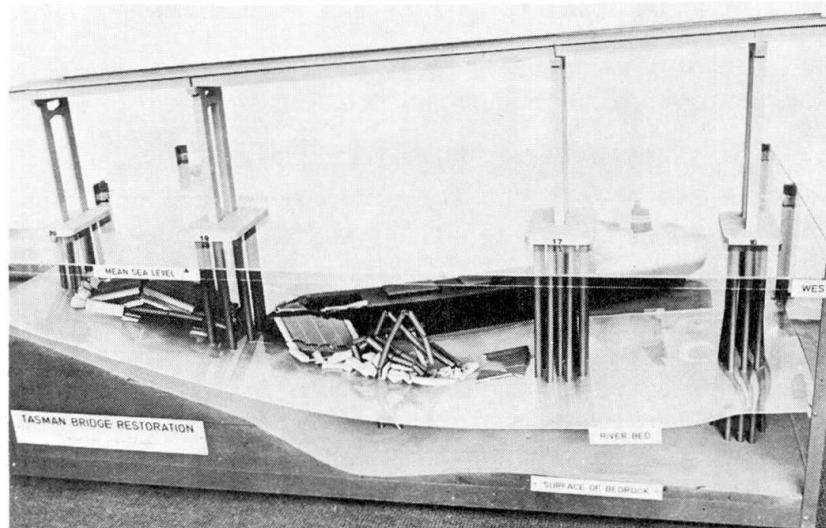
Fig. 3 Debris model

The debris survey took about three months and in the end all the broken bridge pieces were accounted for. A model was built to show the underwater picture (Fig. 3).

broken off raking piles. The decision to delay the selection of a reconstruction method until the survey was completed was vindicated by job performance as no delays occurred due to new piles striking debris.

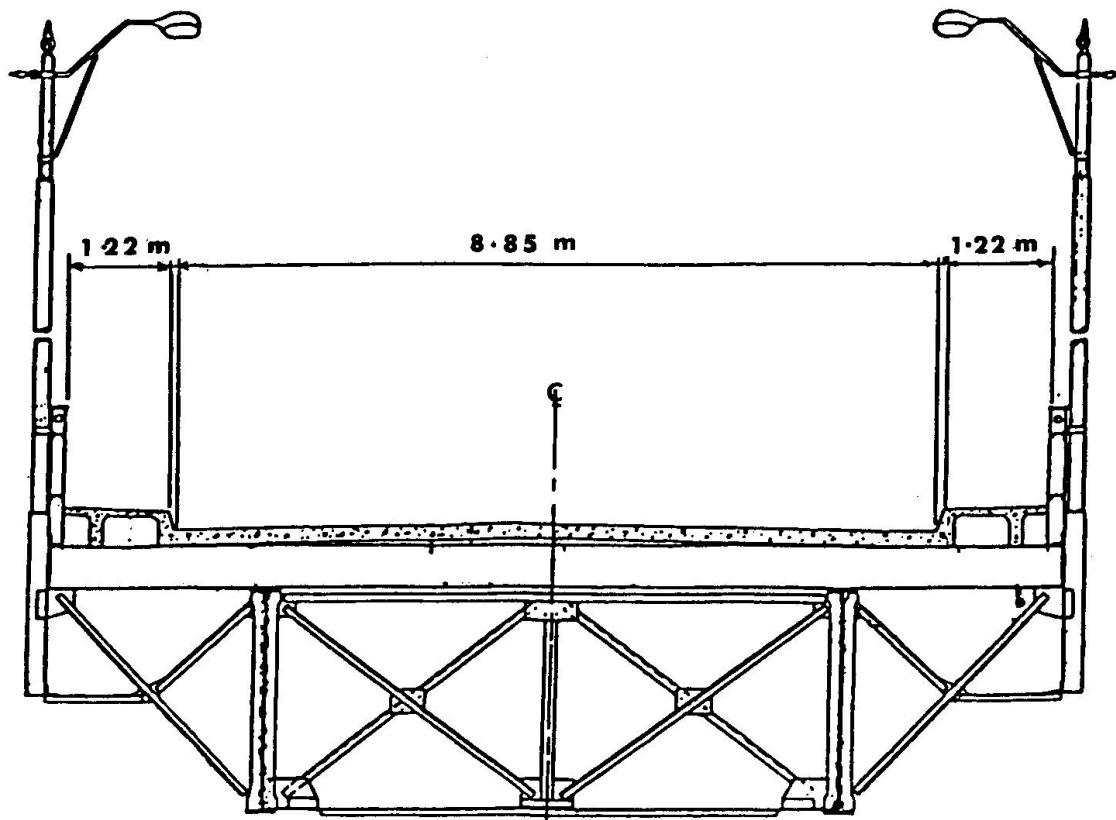
Fig. 2 Cross Section of North Viaduct

The North Viaduct was built of riveted steel construction with a reinforced concrete deck supported on cross beams and longitudinal plate girders. The Suspension Bridge comprised a concrete filled steel grid deck supported by steel stiffening trusses and towers.

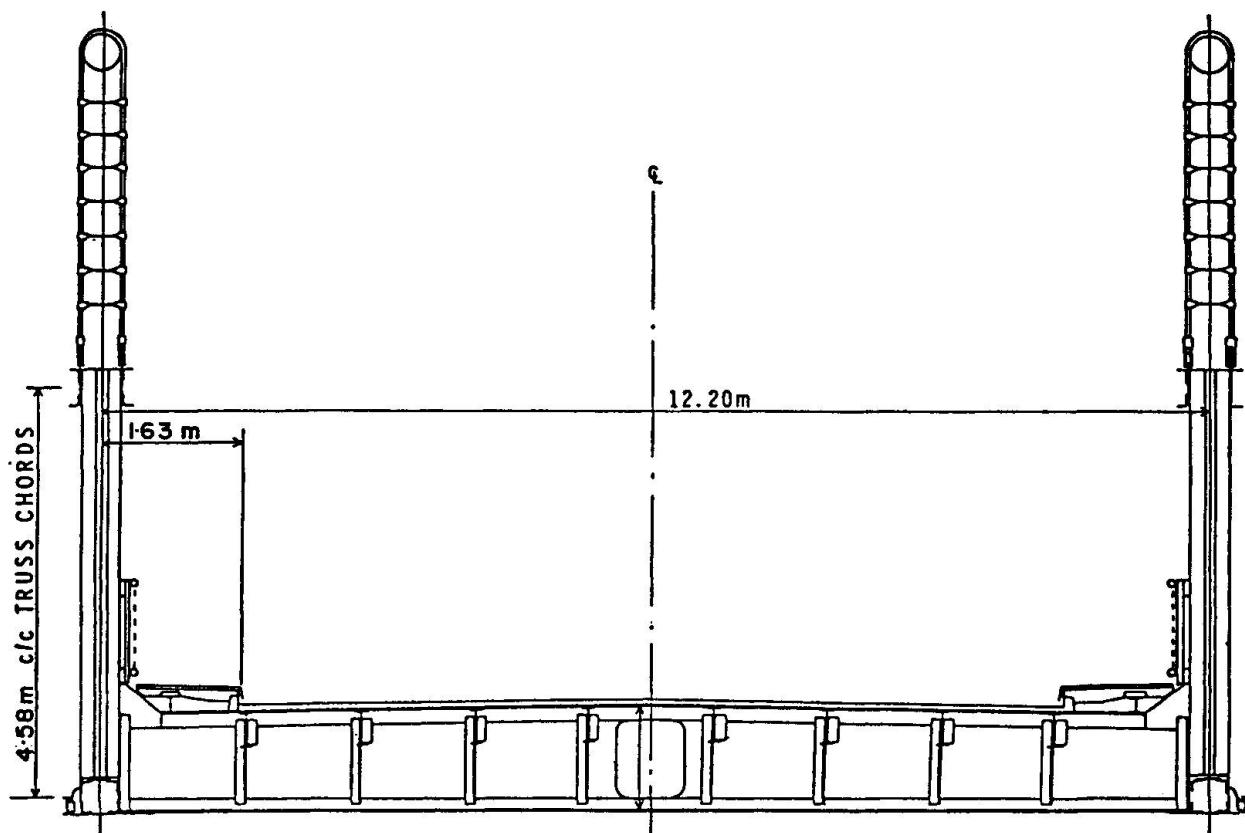
Fig. 3 Cross Section of Suspension Bridge.

The stiffening truss, being of a U shape in cross section (see Figure 3), has a low torsional rigidity. The towers are made of riveted boxes and the girders and bents of the North Viaduct are riveted steel plate girders. The South Main Tower is founded on rock, but all other foundations are spread footings on gravel.

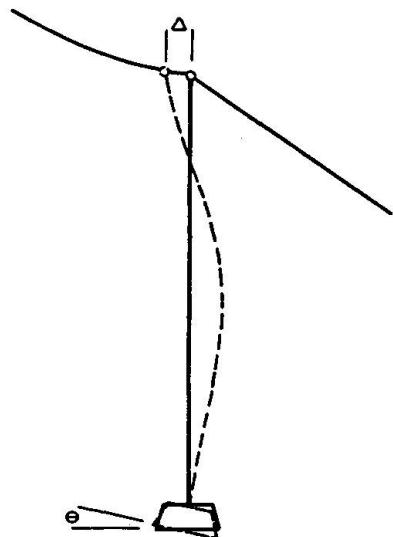
Fig. 5 Schematic View of North Cable Bent

Starting with the foundations, it was discovered that the footing of the North Cable Bent, located at the North end of the Suspension Bridge, had settled unevenly over the years and was inducing large secondary stresses in the tower legs. Furthermore, continued slippage of the main cables in the saddle at the top of this tower had aggravated the situation. See Figure 5.

The stability of this tower is critical to the safety of the entire bridge. Other significant structural defects in the Suspension Bridge included live load bending overstress in the stiffening truss and inelastic stretch in the main cables which caused main tower out of plumb and secondary bending in the
