**Zeitschrift:** IABSE reports of the working commissions = Rapports des commissions de travail AIPC = IVBH Berichte der Arbeitskommissionen

**Band:** 032 (1979)

**Rubrik:** Session III: Construction, performance, renewal

**Construction, Performance, Renewal**

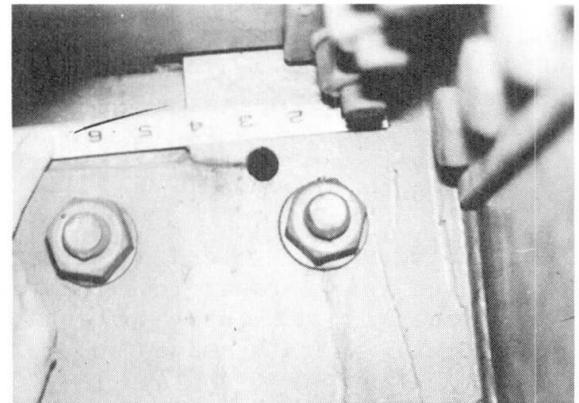
Fig. 7 Zero Radius

Another detail that has given trouble is the connection of brace frame angles to stiffeners (Figure 6) with the gussets groove welded to the stiffener. Referring to Figure 7, the critical detail has a zero radius. The stress causing crack growth is the lateral force from trains. Since maximum lateral impacts often occur due to hunting (side to side snaking) of empty cars, it took less than five years for these cracks to develop.

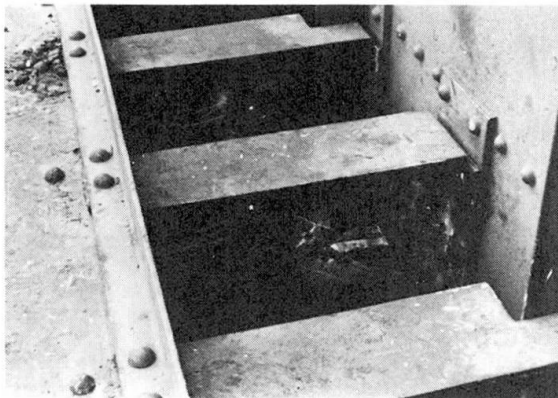
Fig. 17 Torsional loading

This (Figure 17) structure cracked due to torsional loading caused by constant train breaking. Although the floor beams are not welded there is no component redundancy as the beams are rolled. Nevertheless, the redundancy of the deck system has permitted regular train operations for over a year with 4 adjacent floor beams failed.

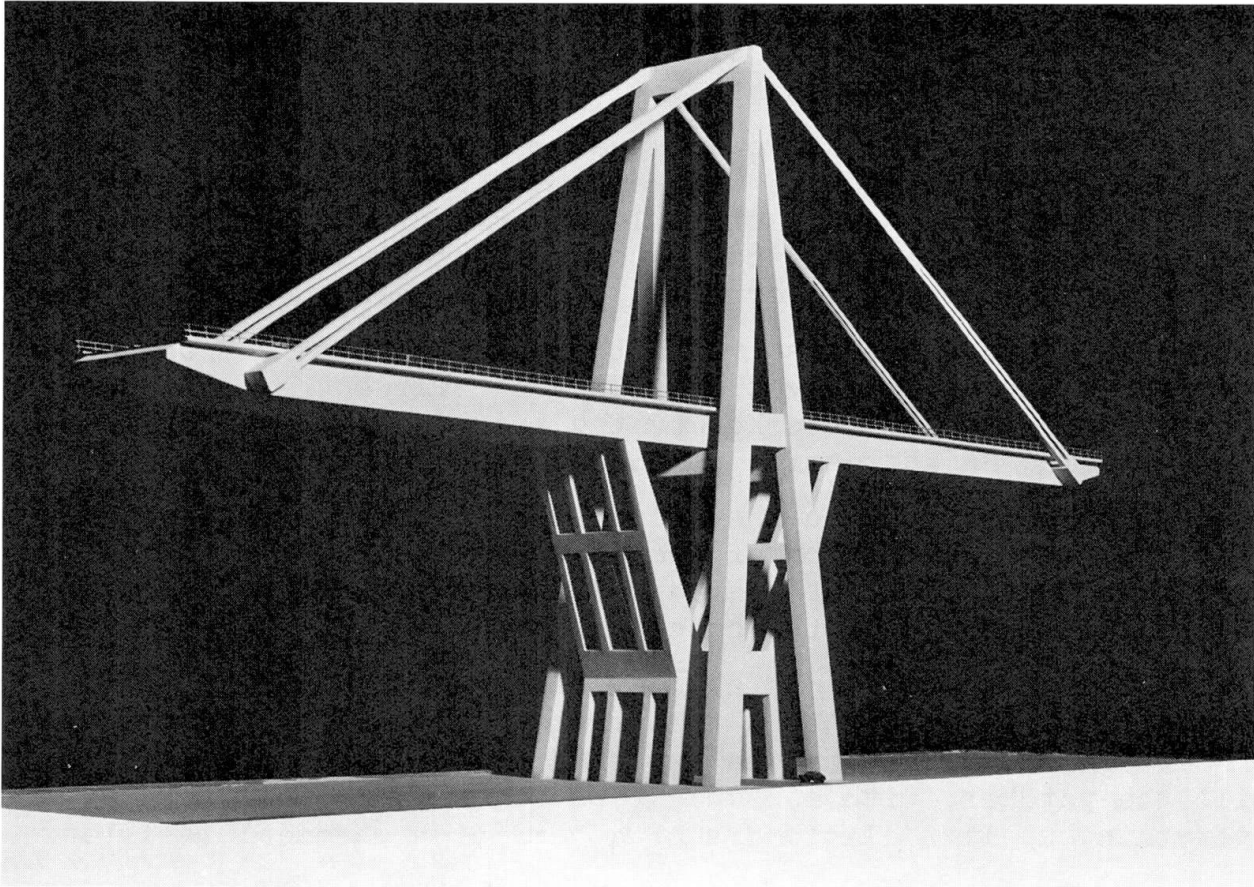
On the other hand, no cracks are noticed on the horizontal elements of the secondary unprestressed "V" piers.

This, evidently, is due to a sufficient distribution of the reinforcement within the concrete and to a non-exceptional shrinkage of the concrete.

Figure 4 - Photo of the model of a balanced system.

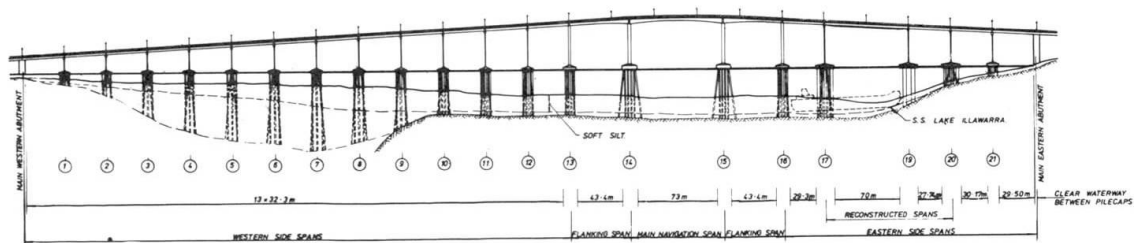
At the bridge site the river is wide and deep, water depths generally being in excess of 30 m. The bridge itself consists of three separate structures (Fig. 2), the navigation spans in mid river, 13 x 42.7 m spans in the western main viaduct and 6 x 42.7 m spans in the eastern main viaduct. The original design recognised the possibility of a ship collision although the

Fig. 2 Elevation of restored bridge

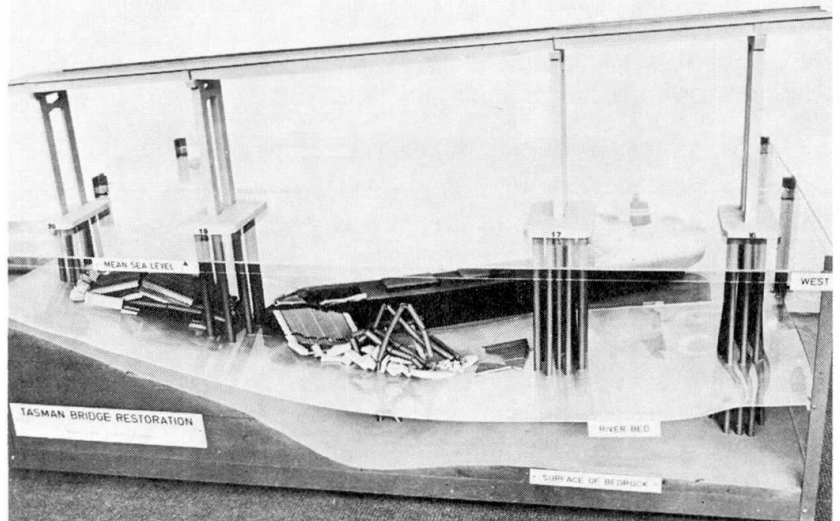
Fig. 3 Debris model

The debris survey took about three months and in the end all the broken bridge pieces were accounted for. A model was built to show the underwater picture (Fig. 3). During the debris survey it is to the credit of the Bridge Commission that pressures to make an early decision on the method of restoration were resisted. Five alternate schemes for reconstruction ranging from a single span scheme to a triple span scheme were examined in some detail. As the underwater scene unfolded the schemes were discarded one by one because debris prevented the placement of new piles, and the selected scheme only became evident at the end of the survey period when a complete picture was available. The only clear space available to establish a new pier was at the site of the original Pier 19 and this involved placement of new vertical piles between the existing broken off raking piles. The method until the survey was delays occurred due to new p

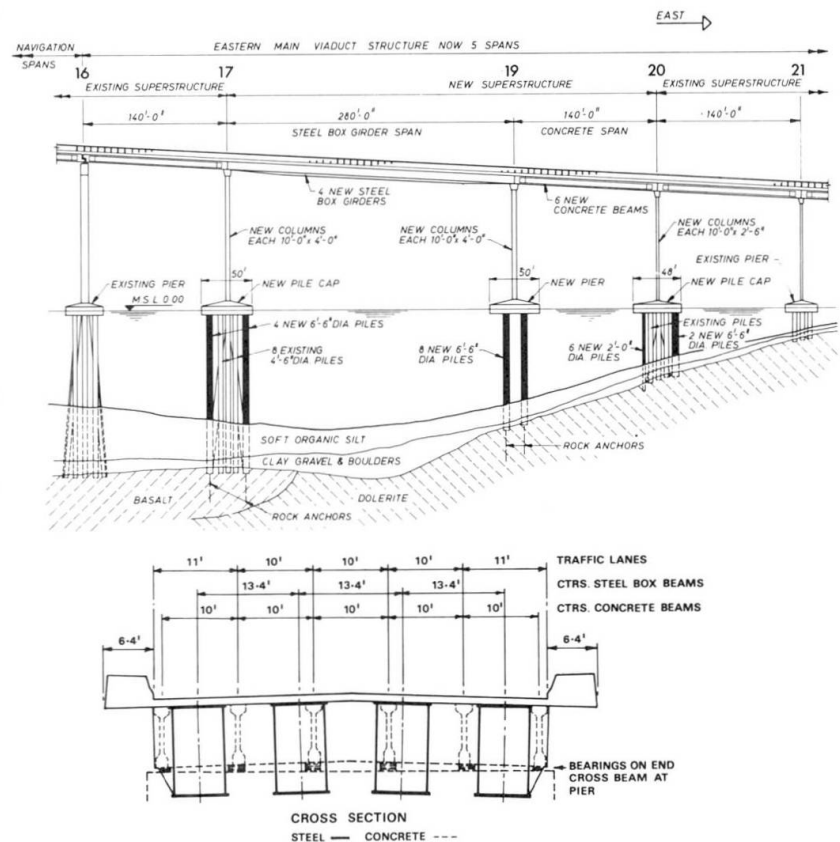
Fig. 4 Details of restoration

The method adopted is shown in Fig. 4 and has been reported on previously by LESLIE [7] and [8]. As the broken 1.4 m diameter piles at Pier 18 (40 m to bed level being the deepest part of the river), rose 15 m above the mud level this pier was omitted and the method involved the replacement of the three fallen spans by two spans; an 85 m steel span 17-19 and 43 m concrete span 19-20. Cross-sections are shown in Figs. 6 and 7. The scheme involved 14 new 2 m diameter vertical piles rock anchored at the base, some of which were to be used both as falsework piles and permanent piles. Foundation conditions were predetermined using one borehole per pile and were good, consisting of almost fresh dolerite at Piers 19 and 20 and partly weathered basalt at Pier 17. At Piers 17 and 20 the existing columns and pile caps had to be demolished and replaced. At Pier 17 additional piles, working in conjunction with the eight existing 1.4 m diameter raking piles, a bigger cap, and heavier columns were required to resist the greater loads from the double span. At Pier 20 there are no additional loads, but it was considered necessary to replace the badly damaged pile cap and columns, and the falsework piles required to achieve this were incorporated into the permanent structure, although not strictly required from a strength viewpoint. As there was a considerable time saving involved, the replacement of the substructure at these two piers was to be undertaken without demolishing the flanking spans (total mass 1,250 tonnes each) supported by them.

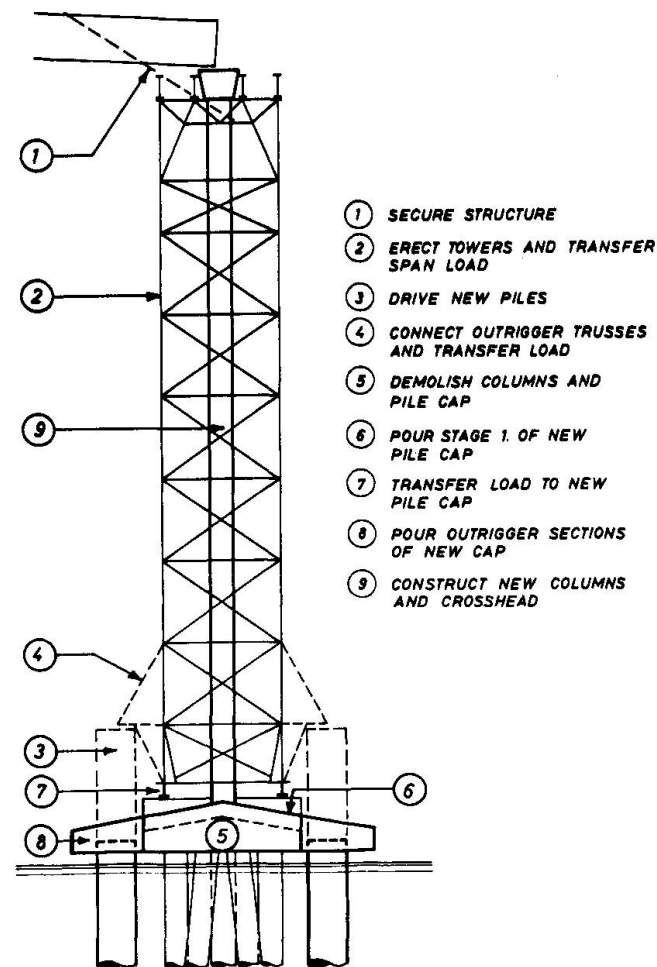
Fig. 8 Pier 17 construction sequence

The steel towers fulfilled many functions, including support of existing spans during column demolition, bracing for new concrete columns during construction, supports for the erection derricks and landing points for the new beams. The construction sequence involved in the use of the tower at Pier 17 is shown in Fig. 8.

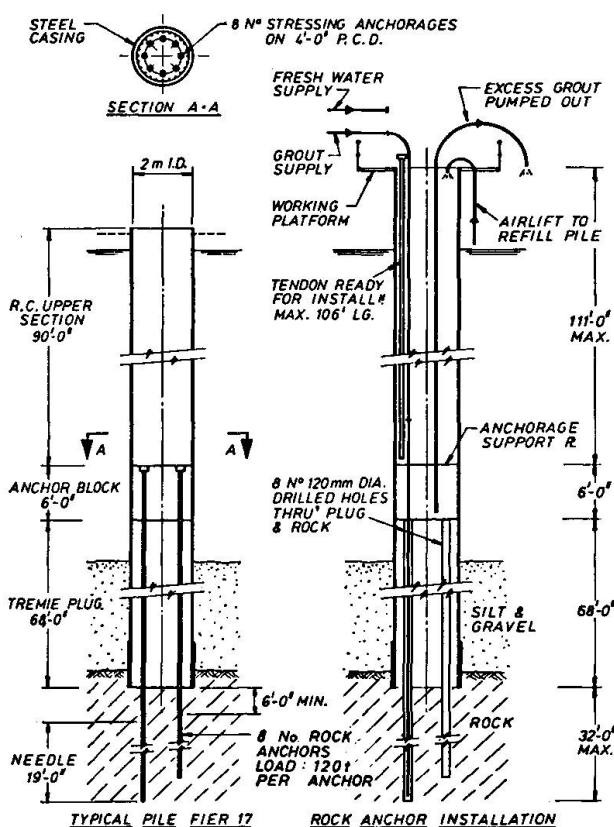
Fig. 7 Pile details

Details of the new vertical piling are shown in Fig. 7. 2 m diameter was selected as being the largest size which could be

At Pier 17 due to frequent rock joints the anchor holes could not be sealed and the installation method was modified to enable anchors to be grouted in a flooded pile (Fig. 7). Individual holes were kept grout filled while the grout leaking into adjacent holes was flushed out. A reservoir at the top of the plug enabled the grout quality to be monitored by underwater TV camera while visibility was maintained by downward circulation of fresh water.

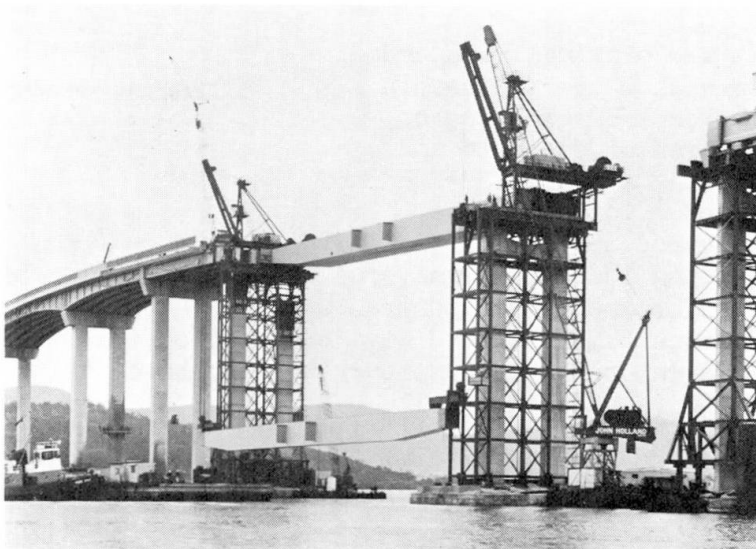
Fig. 11 Box girder erection

The adopted scheme used luffing 'A' frame lifting derricks specifically designed by the Contractor for the purpose (Fig. 11). By using temporary cantilever extensions at the ends of the boxes, they were lifted outboard of the towers as a single unit and positioned on top of the towers. The boxes were towed to site on a barge and then lifted. The operation from mooring of the barge to lifting the girders 40 m, and positioning them on temporary bearings on the falsework towers took about 20 minutes.

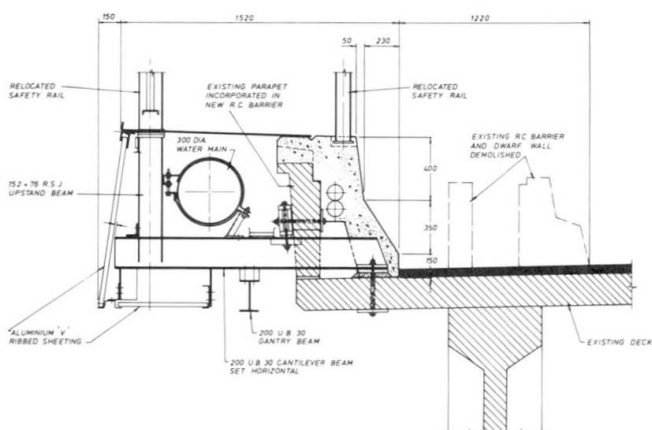
Fig. 12 Bridge widening details

While the bridge was out of service the opportunity was taken to widen it from four to five lanes over its full length. This permitted the operation of a rather more comfortable 3:2 tidal flow system rather than 3:1 as previously. The widening was achieved by cantilevering new footways and using the existing concrete deck for the five lanes (Fig. 12).

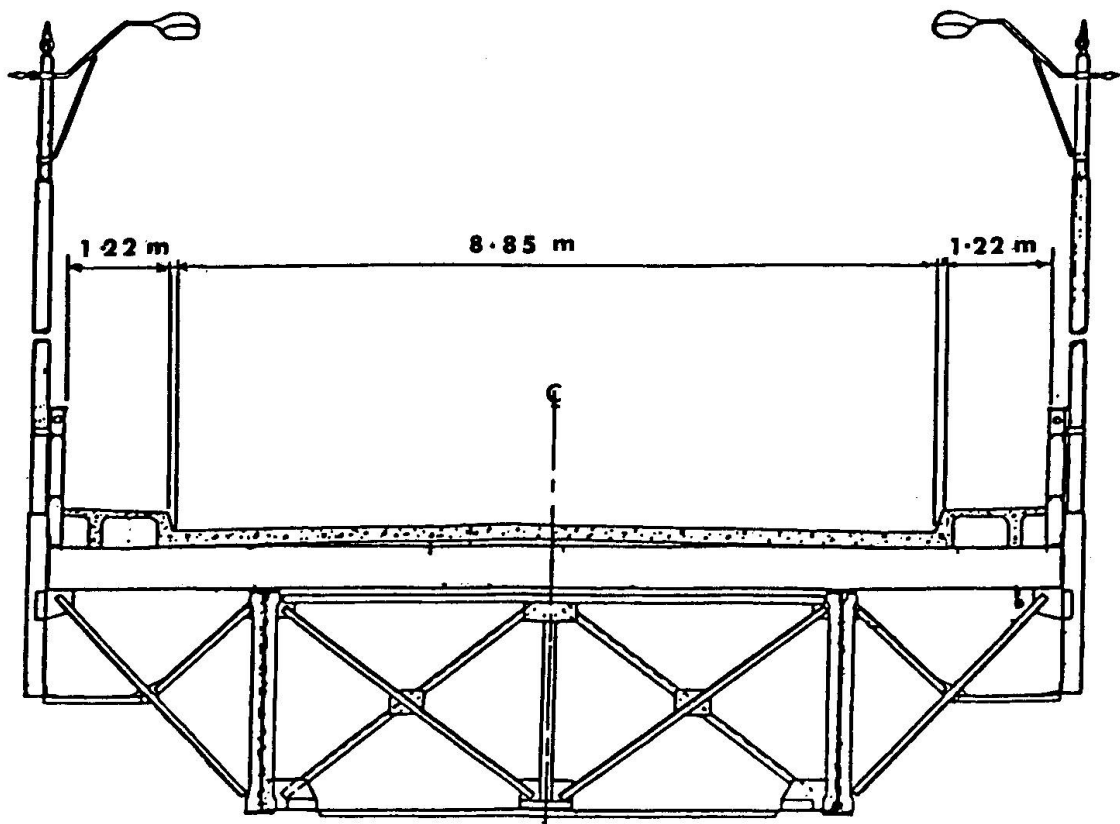
Fig. 2 Cross Section of North Viaduct

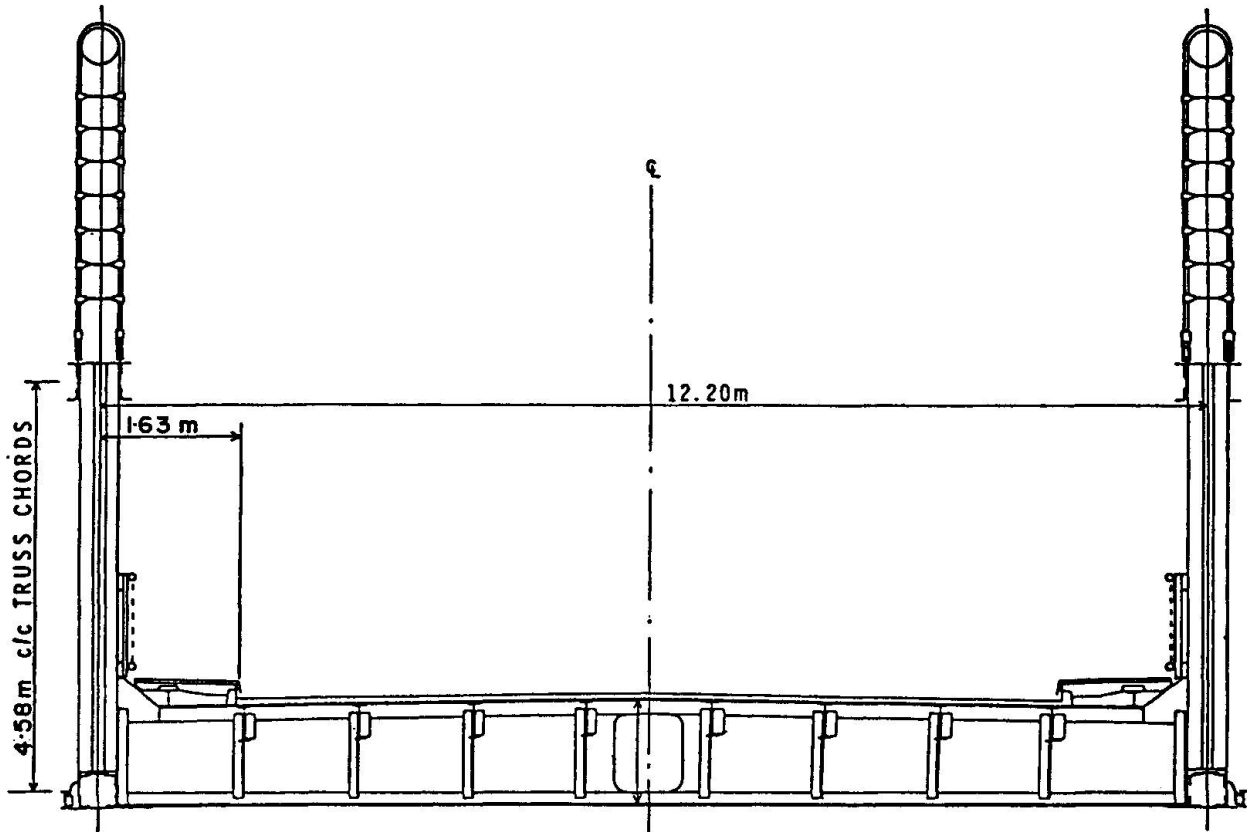
Fig. 3 Cross Section of Suspension Bridge.

The stiffening truss, being of a U shape in cross section (see Figure 3), has a low torsional rigidity. The towers are made of rivetted boxes and the girders and bents of the North Viaduct are rivetted steel plate girders. The South Main Tower is founded on rock, but all other foundations are spread footings on gravel.

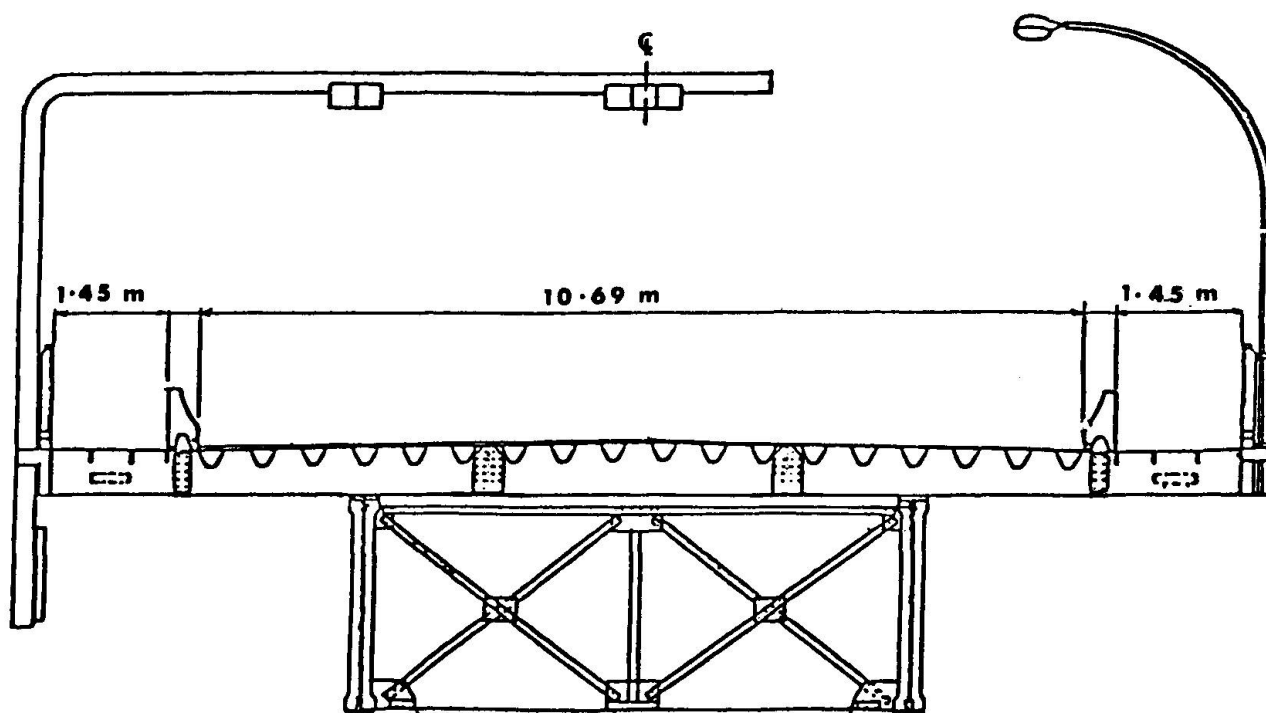
Fig. 4 Cross Section of Renovated North Viaduct

A suitable solution was found in the form of an orthotropic steel deck connected by diaphragms to the existing longitudinal girders in order to ensure composite behaviour under live load. This effectively reduced dead load well below previous values and also reduced girder live load bending stresses.

Fortunately, there was excess shear capacity in the existing girder webs. A 37mm wearing surface of epoxy asphalt was specified in the traffic zone with a 2mm epoxy coating on the sidewalks. A cross section of the renovated North Viaduct is shown in Fig. 4.

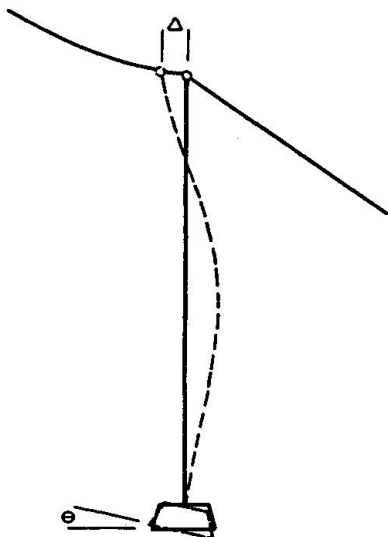
Starting with the foundations, it was discovered that the footing of the North Cable Bent, located at the North end of the Suspension Bridge, had settled unevenly over the years and was inducing large secondary stresses in the tower legs. Furthermore, continued slippage of the main cables in the saddle at the top of this tower had aggravated the situation. See Figure 5.

Fig. 5 Schematic View of North Cable Bent

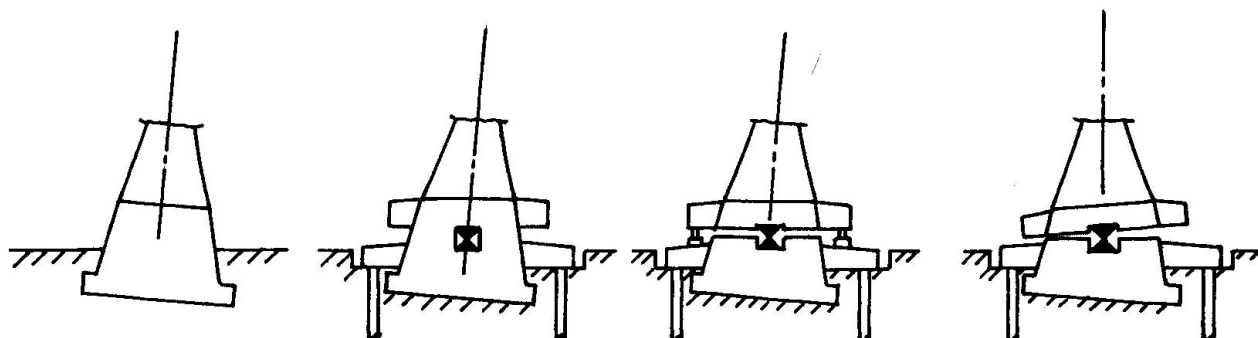
Fig. 6 Stabilization of North Cable Bent

The first objective of this phase of the renovation was to restore the North Cable Bent to a stable condition prior to commencing other work in the suspended spans. Bridge strand tiebacks were installed between the North anchorage and the top of the bent in order to prevent further slippage of the clamp among the main cables. After this was completed, the footing was underpinned to prevent further settlement and then rotated to relieve secondary bending in the column. The steps in this process are illustrated schematically below:-

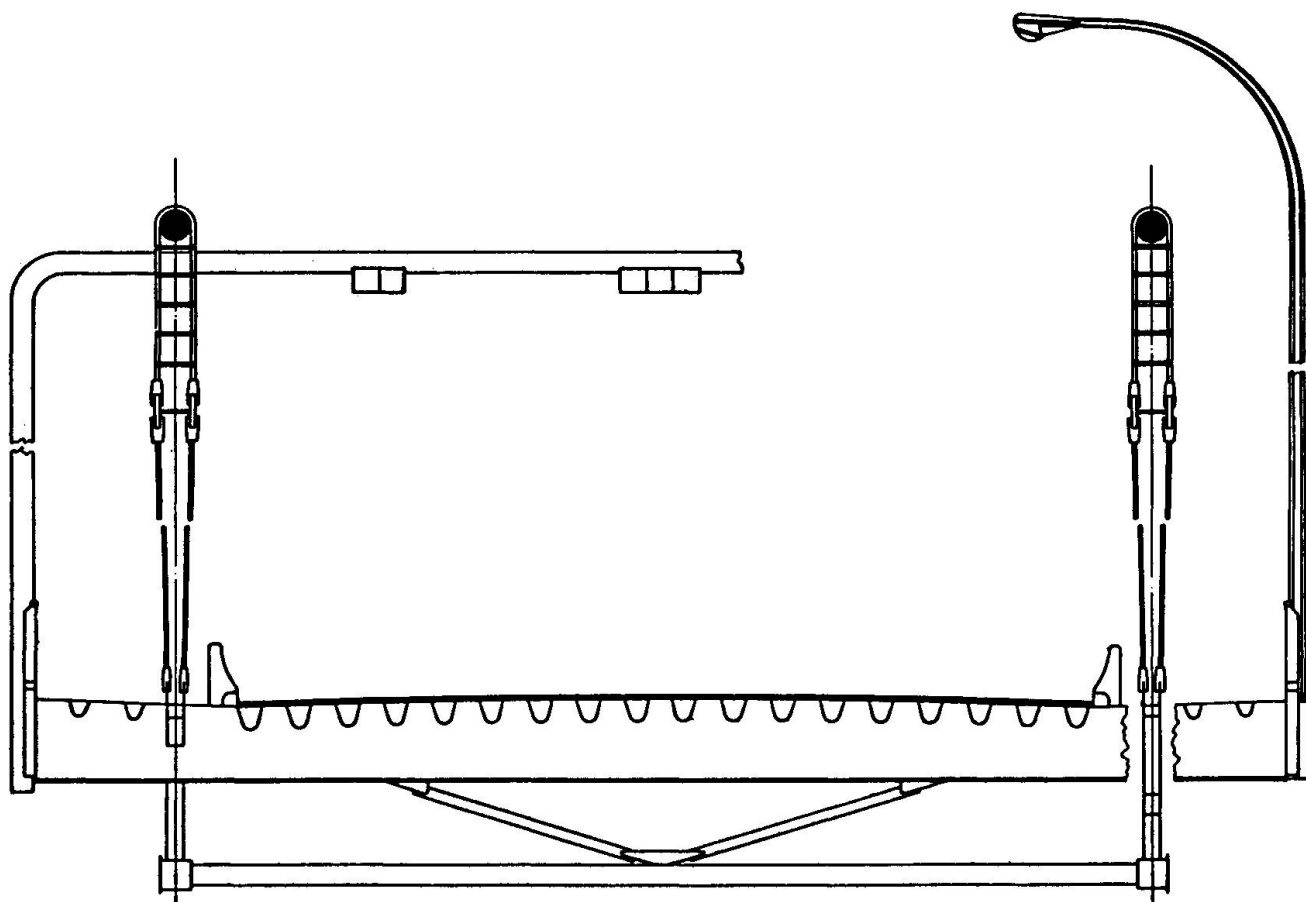
Fig. 7 Suspension Bridge New Stiffening Truss Section

Upon consideration by the Owner of all these factors, including aerodynamics, maintenance, strength, ease of renovation etc., it was decided not to install a renovated deck within the existing truss but to design a new truss integral with a wider orthotropic deck. This decision permitted the new truss to be sized and detailed specifically to suit the requirements of renovation. It was dimensioned sufficiently shallow to fit entirely below the deck, which participates in the vertical bending of the truss. The bending stiffness of the new truss system is less than the original. However, the aerodynamic stability of the new section is made superior to the existing by closing the new truss into a box configuration and thus improving the torsional stiffness by a large factor. A cross section of the new configuration is shown below.

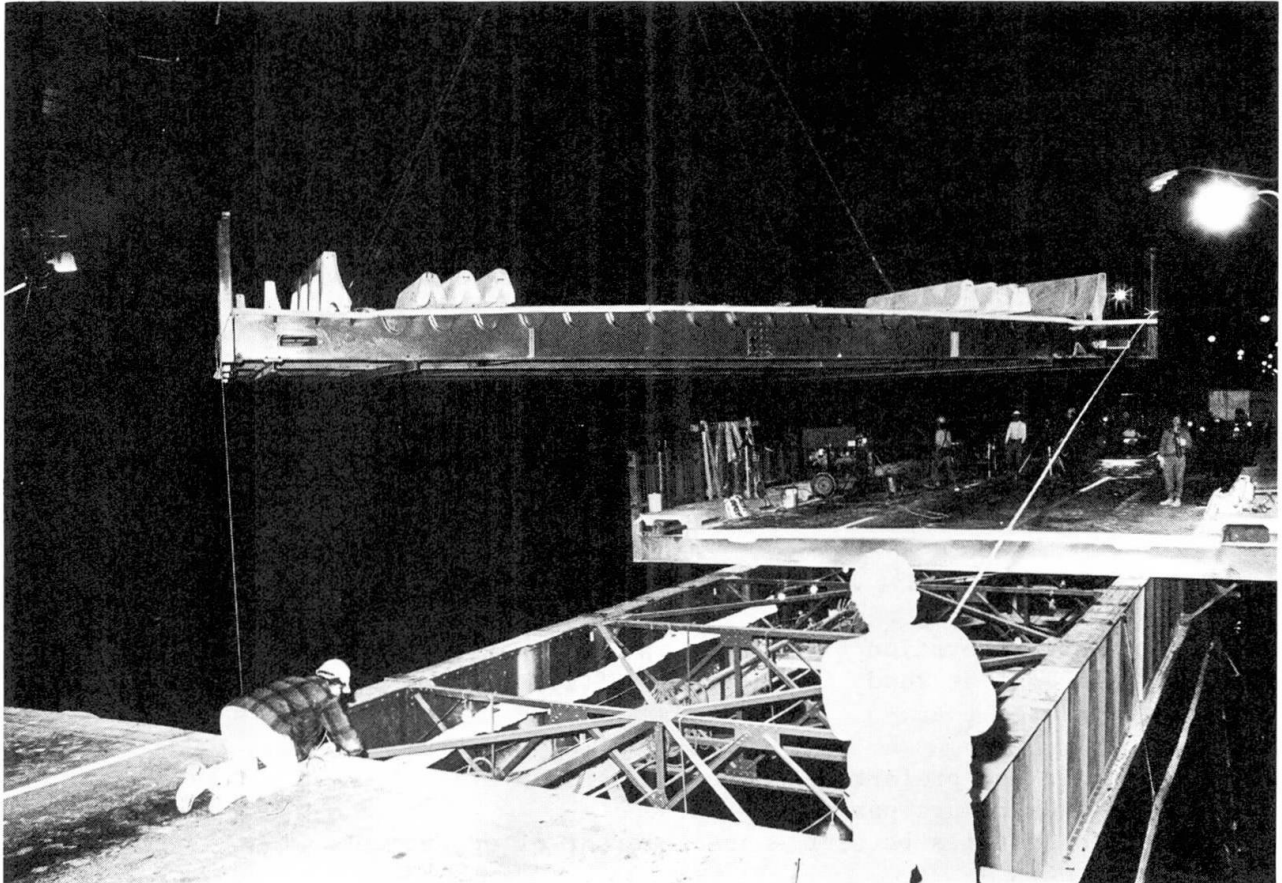
Fig. 8 Section of North Viaduct during Installation.

For the North Viaduct, connection to the top flange of the existing plate girders was made by removing four existing rivets and bolting a nominal 40mm thick shim pack to the top of the girder with countersunk bolts. The height and tilt of the top surface of the shims could be adjusted by adding or removing shims, tapered if necessary. Once at the correct level and bolted down, the countersunk bolts afforded a flat surface, permitting the new deck cross beams to be moved laterally or longitudinally to the appropriate position before welding down. This simple device thus afforded linear and rotational movement in each of the three axes and permitted complete freedom of adjustment.
