**Zeitschrift:** IABSE reports of the working commissions = Rapports des commissions de travail AIPC = IVBH Berichte der Arbeitskommissionen

**Band:** 032 (1979)

## **SESSION III**

**Construction, Performance, Renewal**

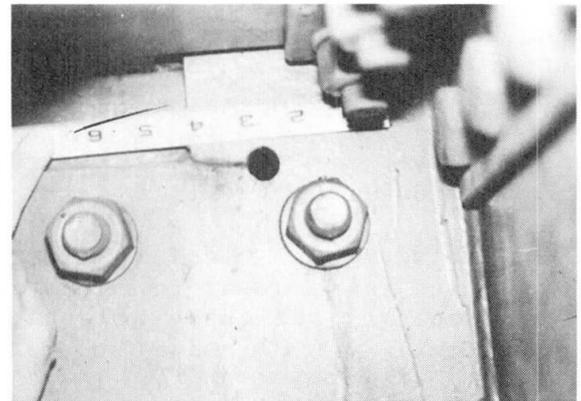
Fig. 7 Zero Radius

Another detail that has given trouble is the connection of brace frame angles to stiffeners (Figure 6) with the gussets groove welded to the stiffener. Referring to Figure 7, the critical detail has a zero radius. The stress causing crack growth is the lateral force from trains. Since maximum lateral impacts often occur due to hunting (side to side snaking) of empty cars, it took less than five years for these cracks to develop.

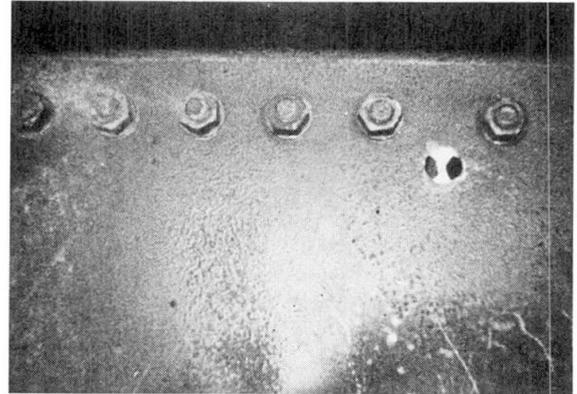
Fig. 12 Other Side

Figure 12 was taken after the two holes drilled from the inside had been reamed to one hole from the outside flush with the stiffener on the inside. The white metal along the vertical centerline of the hole is the stiffener.

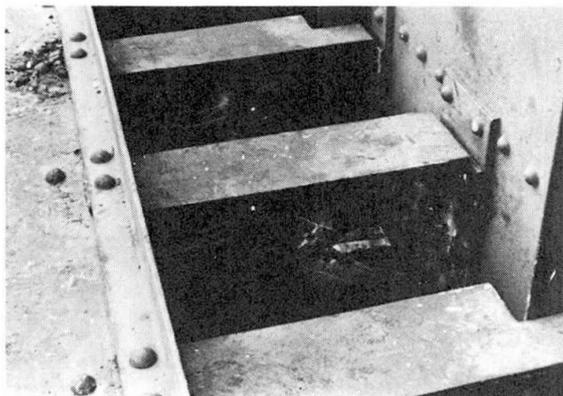
Fig. 17 Torsional loading

This (Figure 17) structure cracked due to torsional loading caused by constant train breaking. Although the floor beams are not welded there is no component redundancy as the beams are rolled. Nevertheless, the redundancy of the deck system has permitted regular train operations for over a year with 4 adjacent floor beams failed.

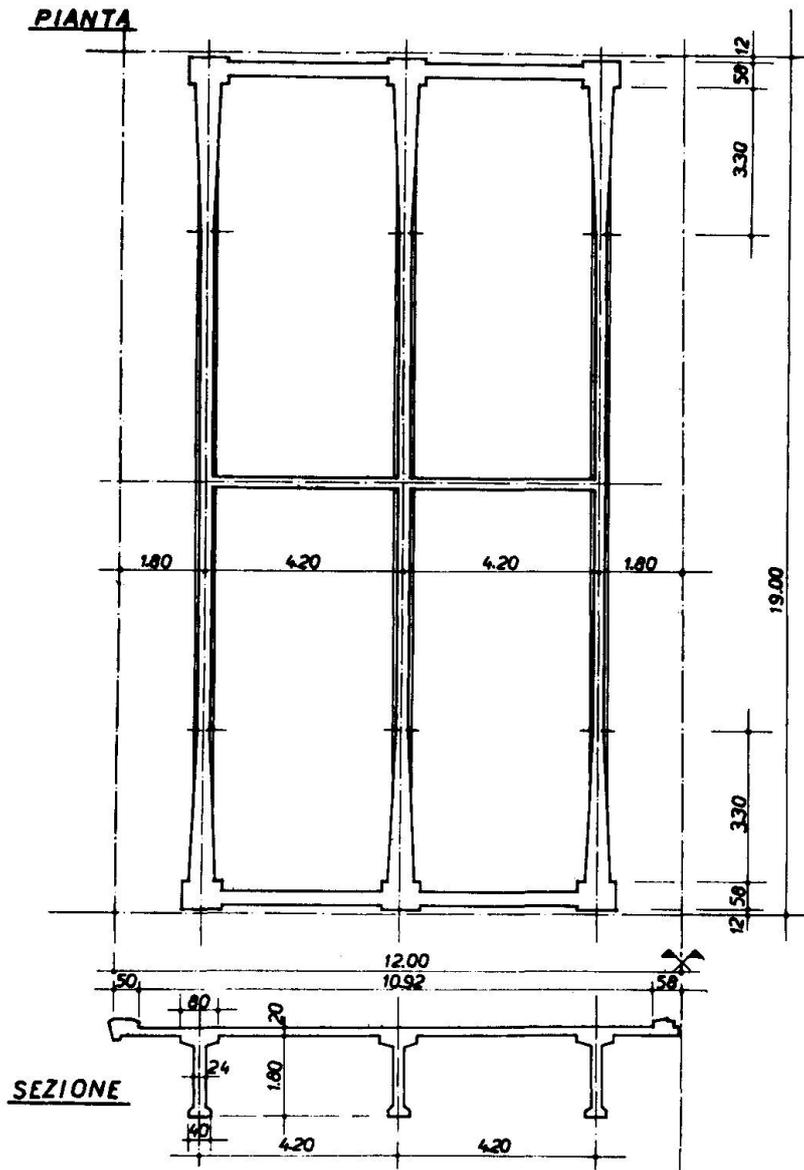
Fig. 1 - Geometry of the standard bay.

During my visit I found some superficial distress in the paving joints, some excessive crushing of the bearings (although nothing really serious) but, most important of all, that all the parallel beams of the deck showed a diffused pattern of cracks of very similar length, frequency and width on all the bays.

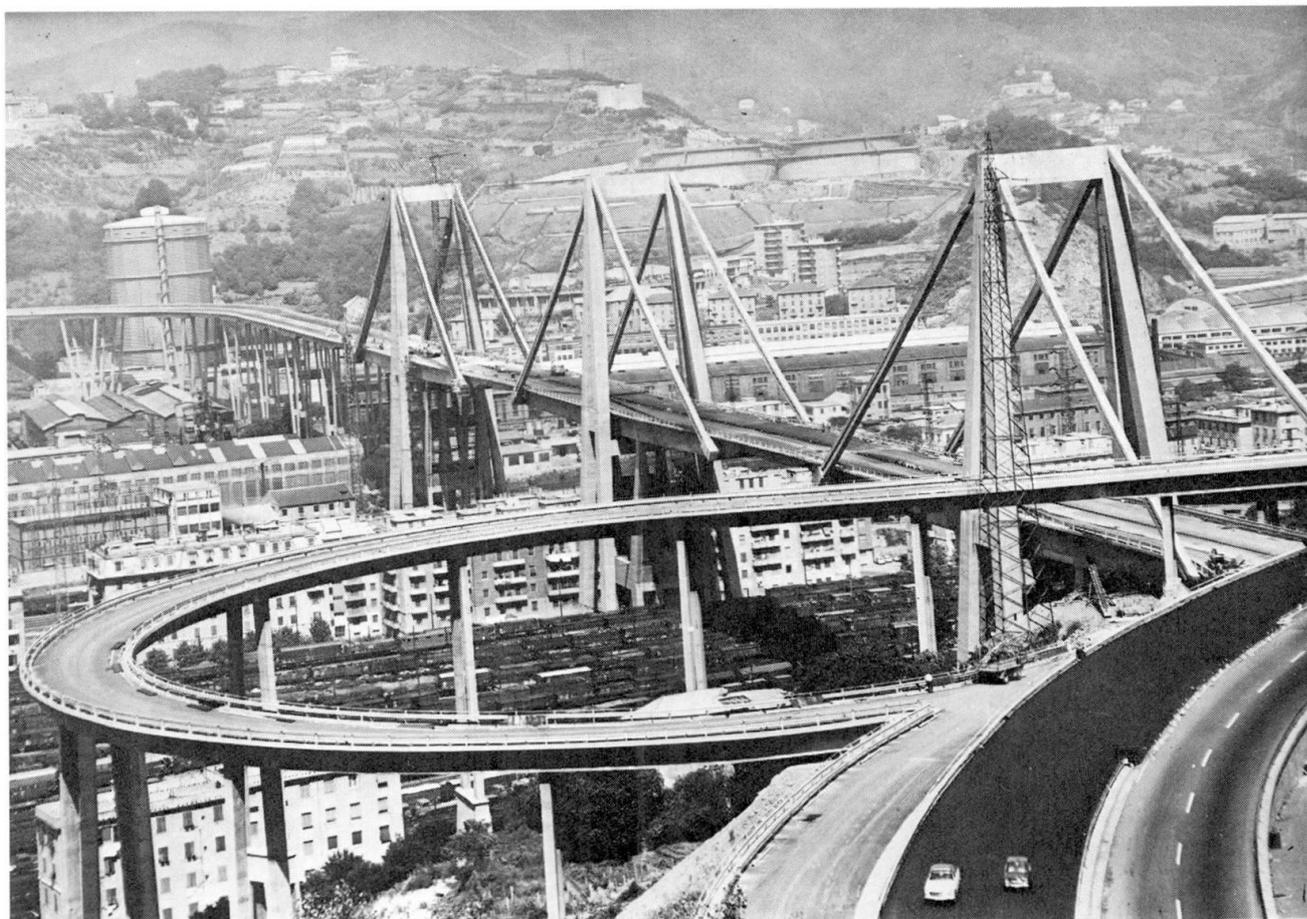
Figure 3 - General view of the structure.

Essentially, it has been ascertained that the structure stands the very heavy traffic to which it is continuously submitted without signs of deterioration or static inadequacy.

The balanced systems are behaving in a regular way and obviously, as far as they are concerned, we must not worry about cracks because we deal with structures the parts of which are practically all in compression under the effect of external loads or prestressing.

Some slight cracks of a very small size (much below 0.2 mm) have been noticed in the secondary connecting cross elements - which obviously had not been prestressed - and which were surely due to the vibration caused by the traffic.

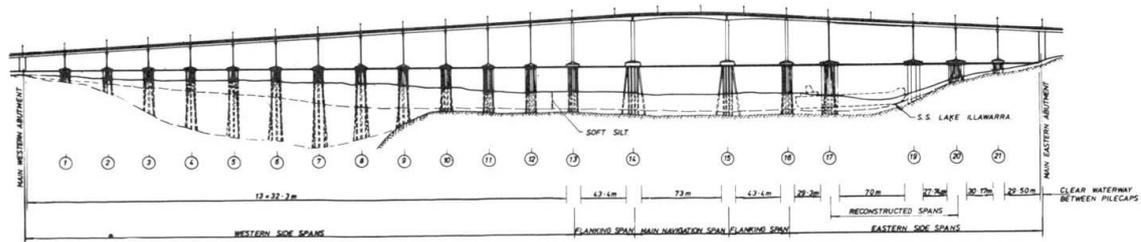
At the bridge site the river is wide and deep, water depths generally being in excess of 30 m. The bridge itself consists of three separate structures (Fig. 2), the navigation spans in mid river, 13 x 42.7 m spans in the western main viaduct and 6 x 42.7 m spans in the eastern main viaduct. The original design recognised the possibility of a ship collision although the

Fig. 2 Elevation of restored bridge

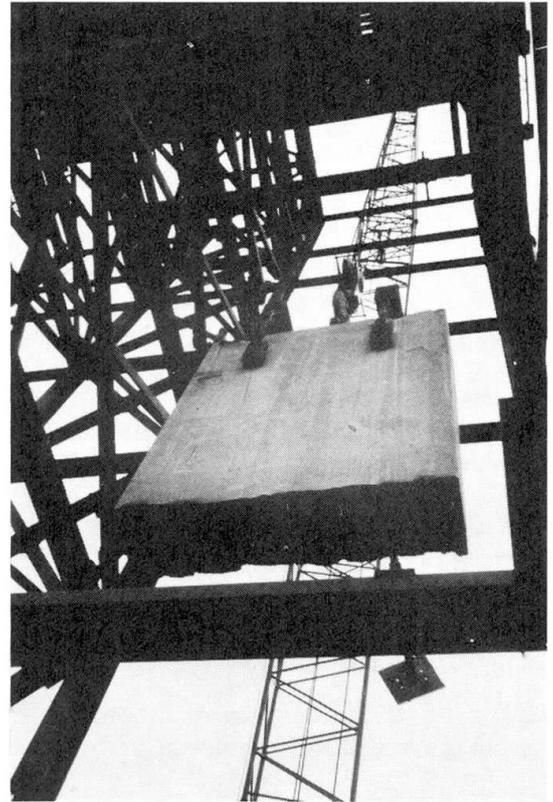
The original columns were made up of precast concrete blocks, vertically stressed together with Macalloy bars. They had a cross-section of 3 m x 0.75 m and were cut horizontally using a thermic lance and hydraulic wedge splitters. The 25 tonne pieces were lifted out through the top of the falsework tower (Fig. 9). Twelve working days were required to remove the two legs of the Pier 20 column.

Fig. 9 Column demolition

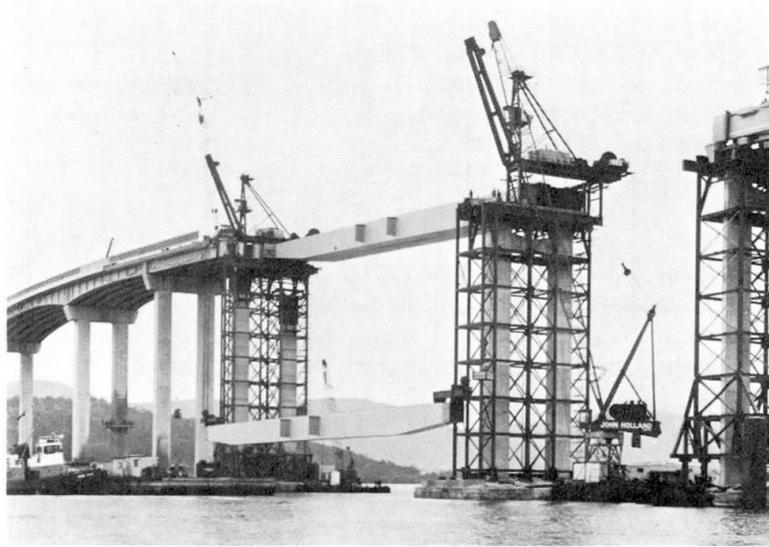
The adopted scheme used luffing 'A' frame lifting derricks specifically designed by the Contractor for the purpose (Fig. 11). By using temporary cantilever extensions at the ends of the boxes, they were lifted outboard of the towers as a single unit and positioned on top of the towers. The boxes were towed to site on a barge and then lifted. The operation from mooring of the barge to lifting the girders 40 m, and positioning them on temporary bearings on the falsework towers took about 20 minutes.

Fig. 11 Box girder erection

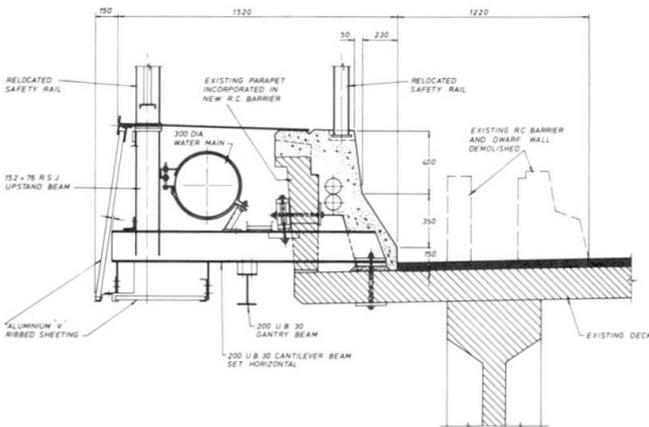
While the bridge was out of service the opportunity was taken to widen it from four to five lanes over its full length. This permitted the operation of a rather more comfortable 3:2 tidal flow system rather than 3:1 as previously. The widening was achieved by cantilevering new footways and using the existing concrete deck for the five lanes (Fig. 12).

Fig. 12 Bridge widening details

The 42.7 m span, prestressed concrete beams in the main viaducts were constructed segmentally. Due to the extra load from the widening, the outer beams were in tension at working loads and for serviceability reasons it was decided to

strengthen them by adding external tendons in a "Vee" shape one on each side of the web (Fig. 13). The tendons were 8 x 12.5 mm strands grouted into a 75 mm steel pipe and were stressed by pulling them down at mid span, and anchored by bolting to the mid span saddle to give an uplift force of 38 tonnes.

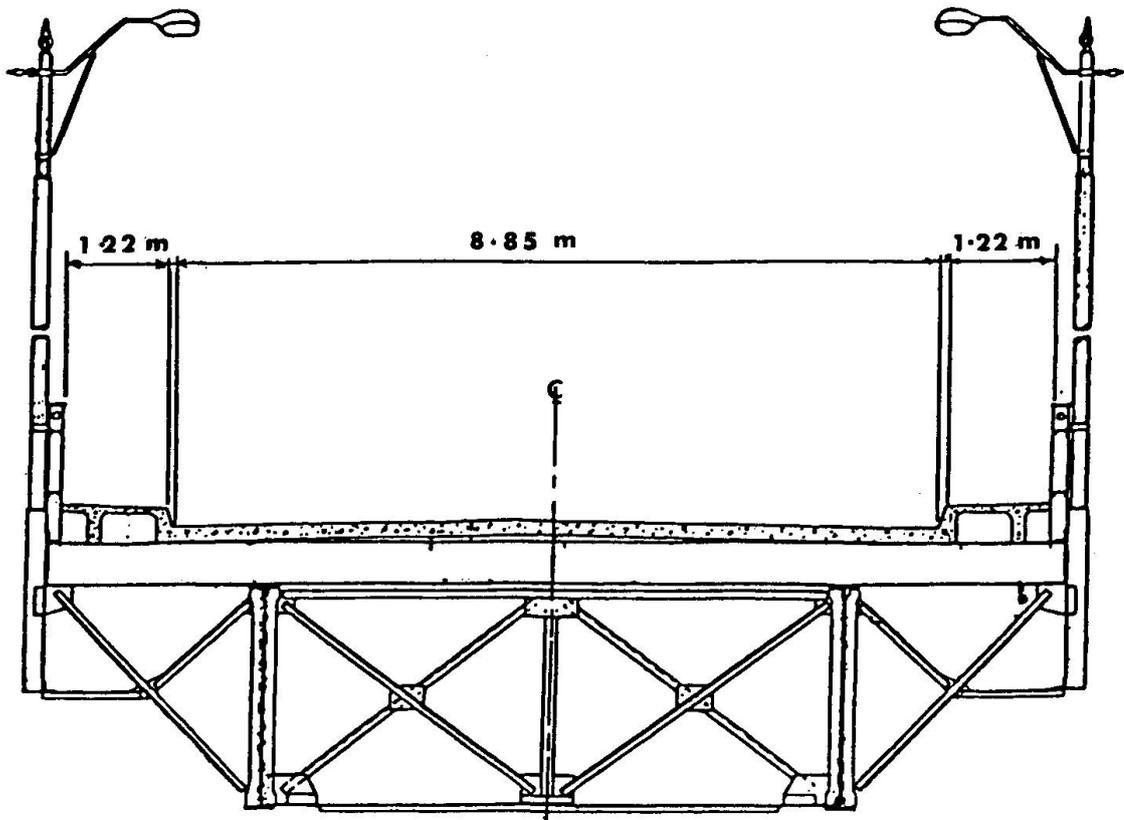
Fig. 2 Cross Section of North Viaduct

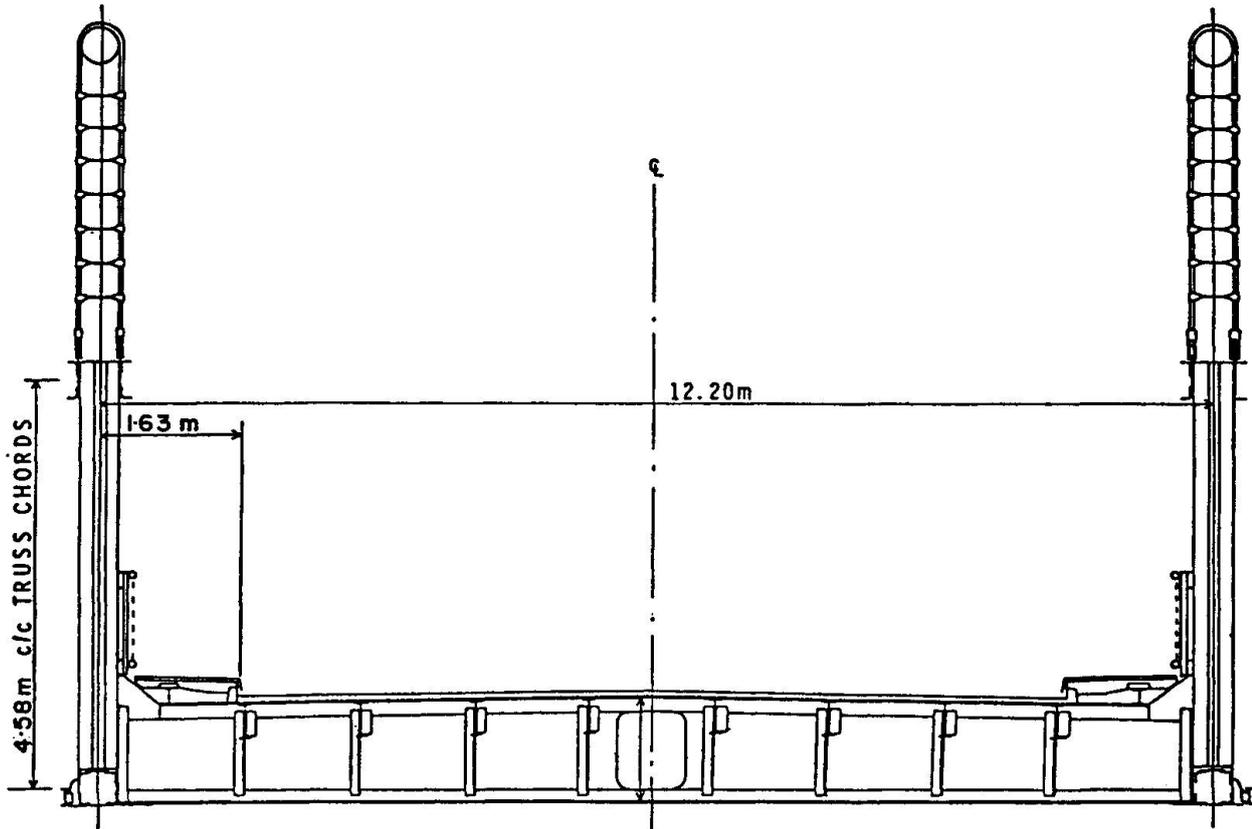
Fig. 3 Cross Section of Suspension Bridge.

The stiffening truss, being of a U shape in cross section (see Figure 3), has a low torsional rigidity. The towers are made of rivetted boxes and the girders and bents of the North Viaduct are rivetted steel plate girders. The South Main Tower is founded on rock, but all other foundations are spread footings on gravel.

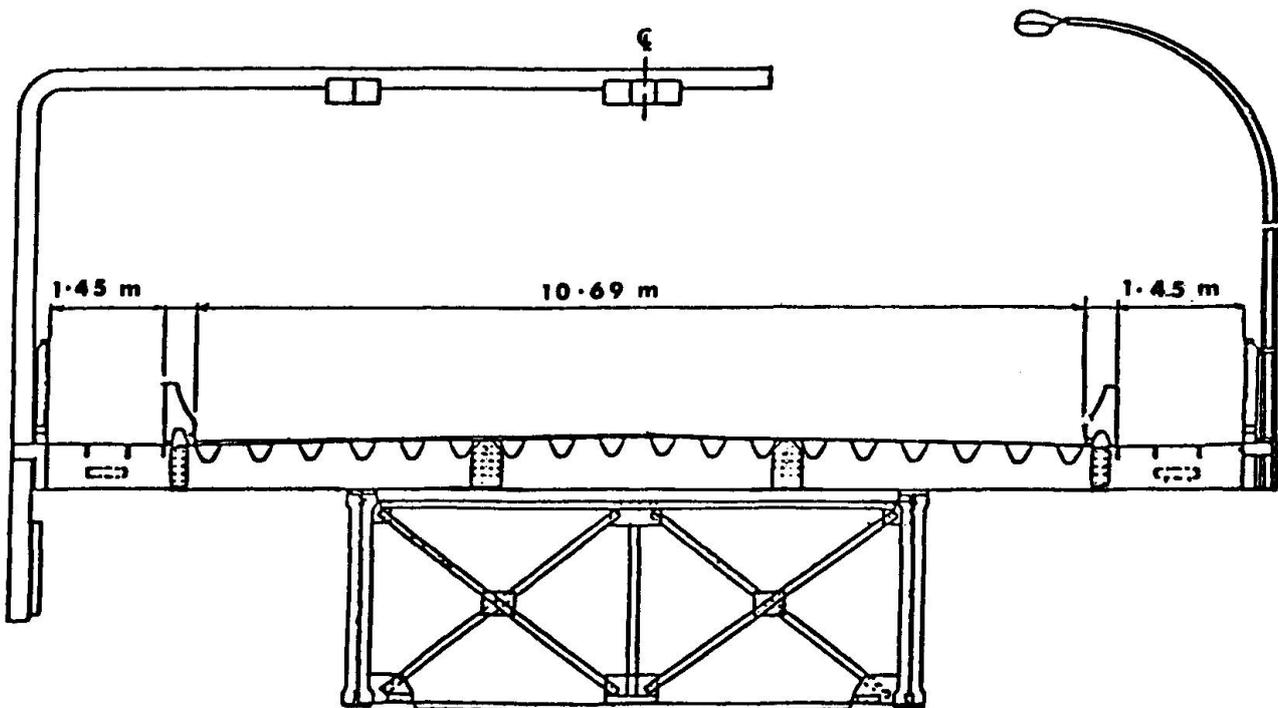
Fig. 4 Cross Section of Renovated North Viaduct

Consideration of the constraints on a structural solution for the North Viaduct led to two conclusions. Firstly, the new deck must have a much lower dead weight than the original in order to afford margins for wearing surface, increased width, traffic barriers etc. and secondly, the new deck and girder system must have increased live load bending capacity to handle a higher live load with a girder capacity reduced by corrosion.

A suitable solution was found in the form of an orthotropic steel deck connected by diaphragms to the existing longitudinal girders in order to ensure composite behaviour under live load. This effectively reduced dead load well below previous values and also reduced girder live load bending stresses.

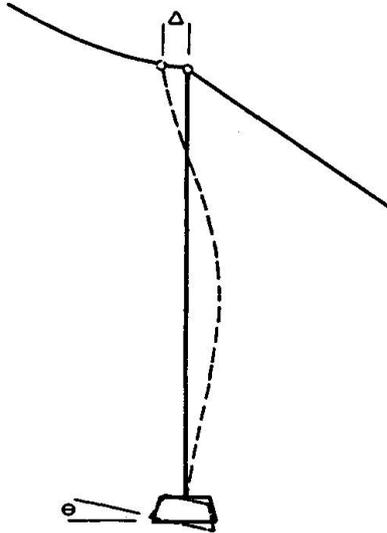
The stability of this tower is critical to the safety of the entire bridge. Other significant structural defects in the Suspension Bridge included live load bending overstress in the stiffening truss and inelastic stretch in the main cables which caused main tower out of plumb and secondary bending in the

stiffening truss. The suspended spans also suffered from the same basic problems as the North Viaduct due to crevice corrosion in the support steelwork and towers plus decay of the deck structure due to corrosion and wear. In this case the deck construction is steel tee grid infilled with concrete. This deck has no wearing surface and is unacceptably slippery when wet. Furthermore, the deck is not waterproof and corrosion between the tees and on the top of the floorbeams tends to cause the tees to pry loose from one another and the support steel.

Fig. 5 Schematic View of North Cable Bent

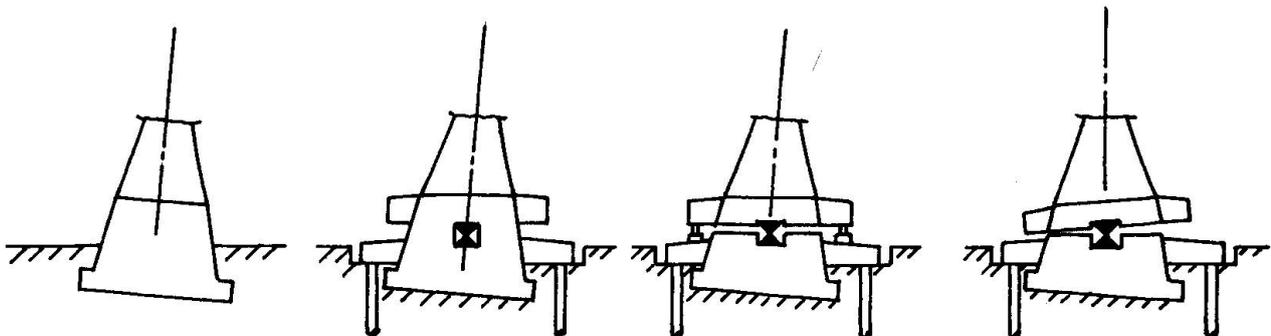
Fig. 6 Stabilization of North Cable Bent

The first objective of this phase of the renovation was to restore the North Cable Bent to a stable condition prior to commencing other work in the suspended spans. Bridge strand tiebacks were installed between the North anchorage and the top of the bent in order to prevent further slippage of the clamp among the main cables. After this was completed, the footing was underpinned to prevent further settlement and then rotated to relieve secondary bending in the column. The steps in this process are illustrated schematically below:-

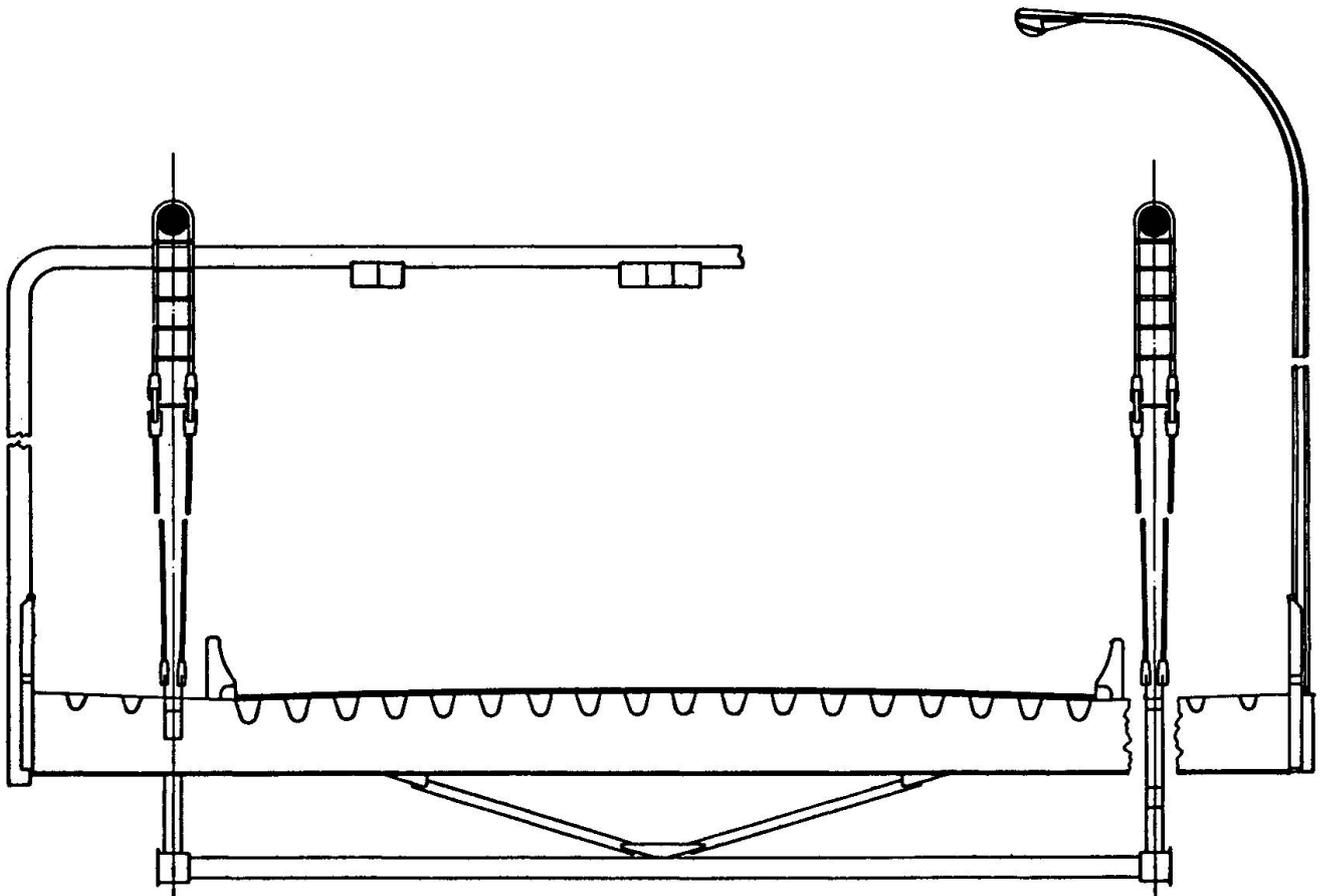
Fig. 7 Suspension Bridge New Stiffening Truss Section

Upon consideration by the Owner of all these factors, including aerodynamics, maintenance, strength, ease of renovation etc., it was decided not to install a renovated deck within the existing truss but to design a new truss integral with a wider orthotropic deck. This decision permitted the new truss to be sized and detailed specifically to suit the requirements of renovation. It was dimensioned sufficiently shallow to fit entirely below the deck, which participates in the vertical bending of the truss. The bending stiffness of the new truss system is less than the original. However, the aerodynamic stability of the new section is made superior to the existing by closing the new truss into a box configuration and thus improving the torsional stiffness by a large factor. A cross section of the new configuration is shown below.

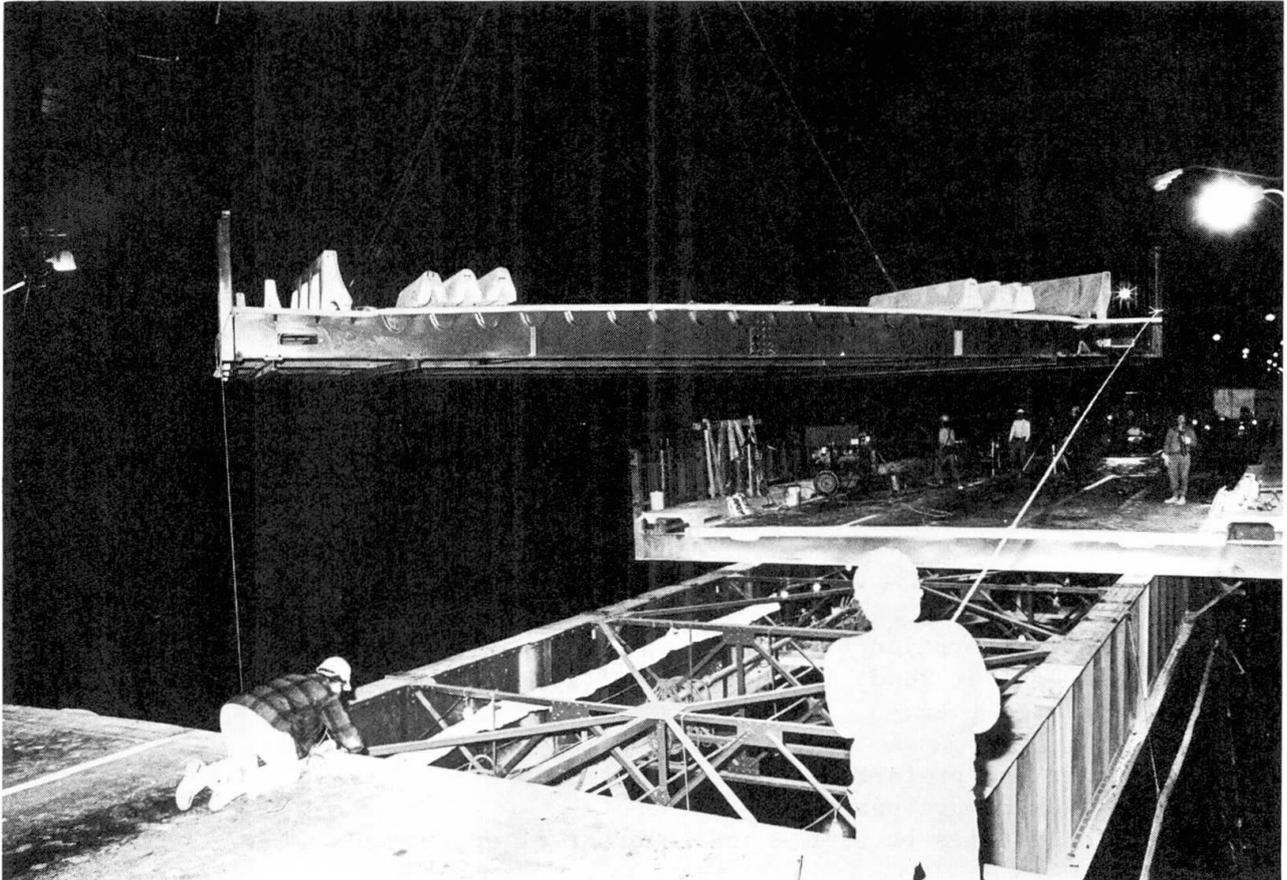
Fig. 8 Section of North Viaduct during Installation.

For the North Viaduct, connection to the top flange of the existing plate girders was made by removing four existing rivets and bolting a nominal 40mm thick shim pack to the top of the girder with countersunk bolts. The height and tilt of the top surface of the shims could be adjusted by adding or removing shims, tapered if necessary. Once at the correct level and bolted down, the countersunk bolts afforded a flat surface, permitting the new deck cross beams to be moved laterally or longitudinally to the appropriate position before welding down. This simple device thus afforded linear and rotational movement in each of the three axes and permitted complete freedom of adjustment.
