Artikel: Restoration and widening of the Tasman bridge

Autor: Lee, D.J. / Crossley, B.K.G.

Restoration and Widening of the Tasman Bridge

Three out of 22 river spans of the Tasman Bridge were destroyed by ship collision. The paper describes the method of debris survey in the deep water site conditions and the method of restoration determined therefrom. The unusual engineering tasks involved in the work included temporary repairs, demolition, major steel falsework, unusual vertical piling, the incorporation of a long steel span into the prestressed concrete bridge and erection techniques used. The whole bridge was widened concurrently with the restoration.

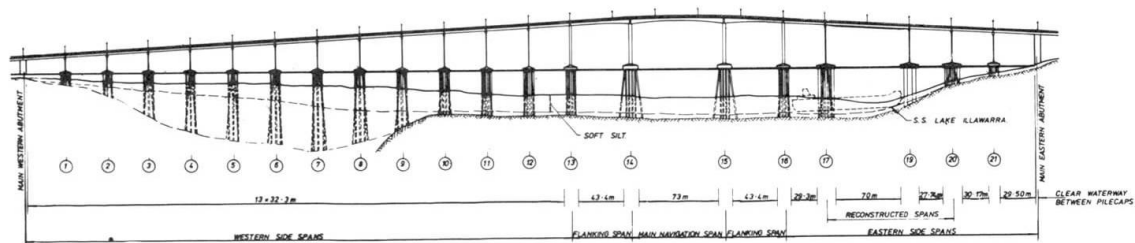
Fig. 2 Elevation of restored bridge

At the bridge site the river is wide and deep, water depths generally being in excess of 30 m. The bridge itself consists of three separate structures (Fig. 2), the navigation spans in mid river, 13 x 42.7 m spans in the western main viaduct and 6 x 42.7 m spans in the eastern main viaduct. The original design recognised the possibility of a ship collision although the
