Artikel: Application of photon tomography to weld inspection
Autor: Frank, Karl H. / Kohutek, Terry L.
DOI: <https://doi.org/10.5169/seals-28935>

Application of Photon Tomography to Weld Inspection

Weld cores from the Silver Memorial Bridge located at Point Pleasant, West Virginia, U.S.A., were scanned as part of a study to determine the significance of the cracks found in a field inspection of the bridge. The details of the study are given in Ref. 2. The results of two weld cores are detailed below.

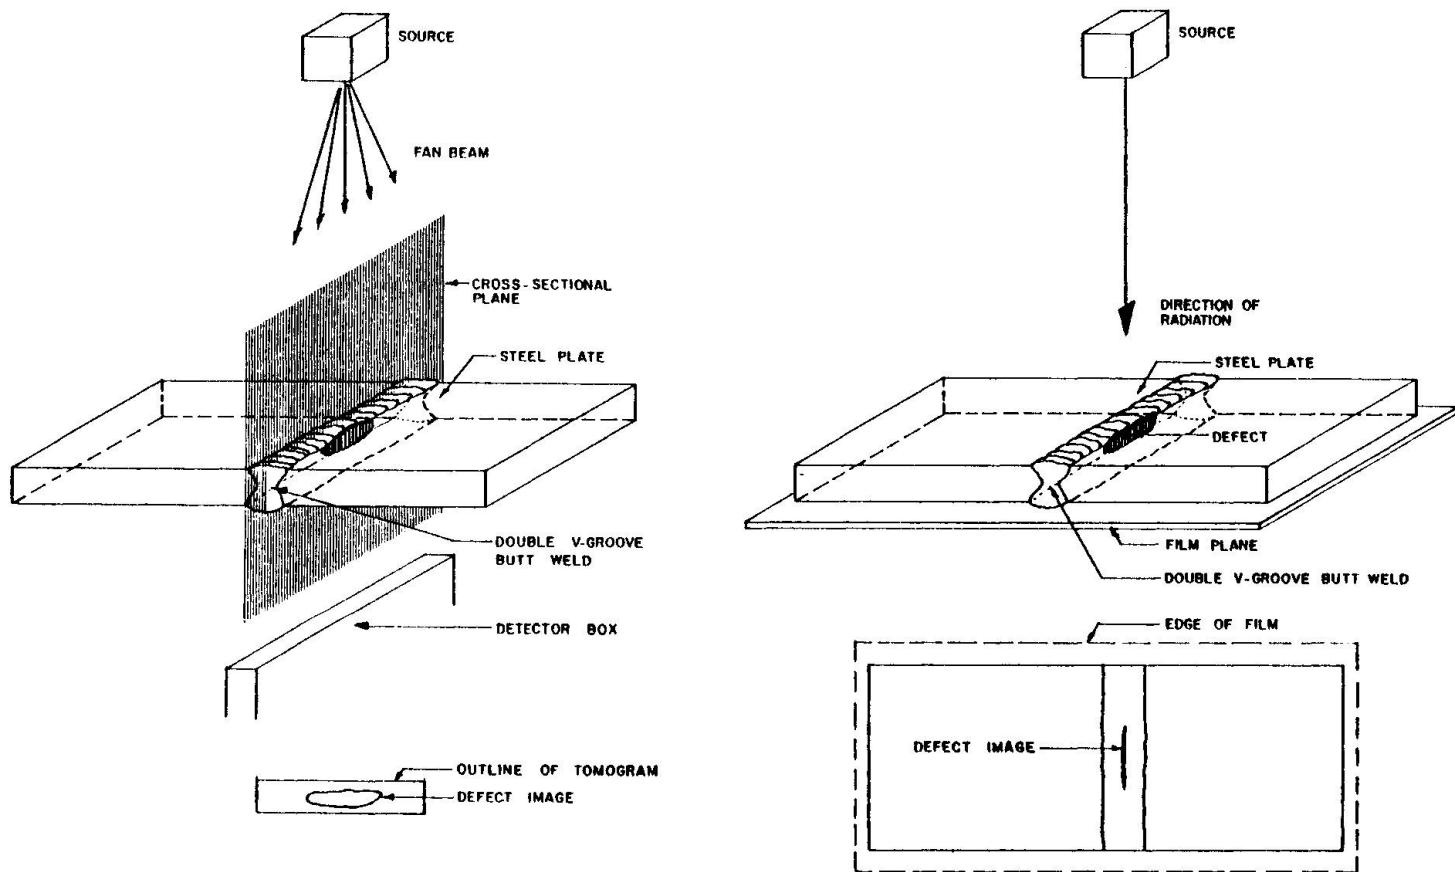
Fig. 1 Defect Imaging with CT and RT

A comparison of the information obtained from computerized tomography (CT) and RT inspection of a butt weld is shown in Fig. 1. The defect geometry in the slice plane is obtained in the tomogram while the radiograph yields only the length of the defect. The image of the defect in the tomogram allows the significance of the defect to be rationally assessed.
