**Artikel:** Application of photon tomography to weld inspection  
**Autor:** Frank, Karl H. / Kohutek, Terry L.  
**DOI:** <https://doi.org/10.5169/seals-28935>

## **Application of Photon Tomography to Weld Inspection**

### **KARL H. FRANK**

### **TERRY L. KOHUTEK**

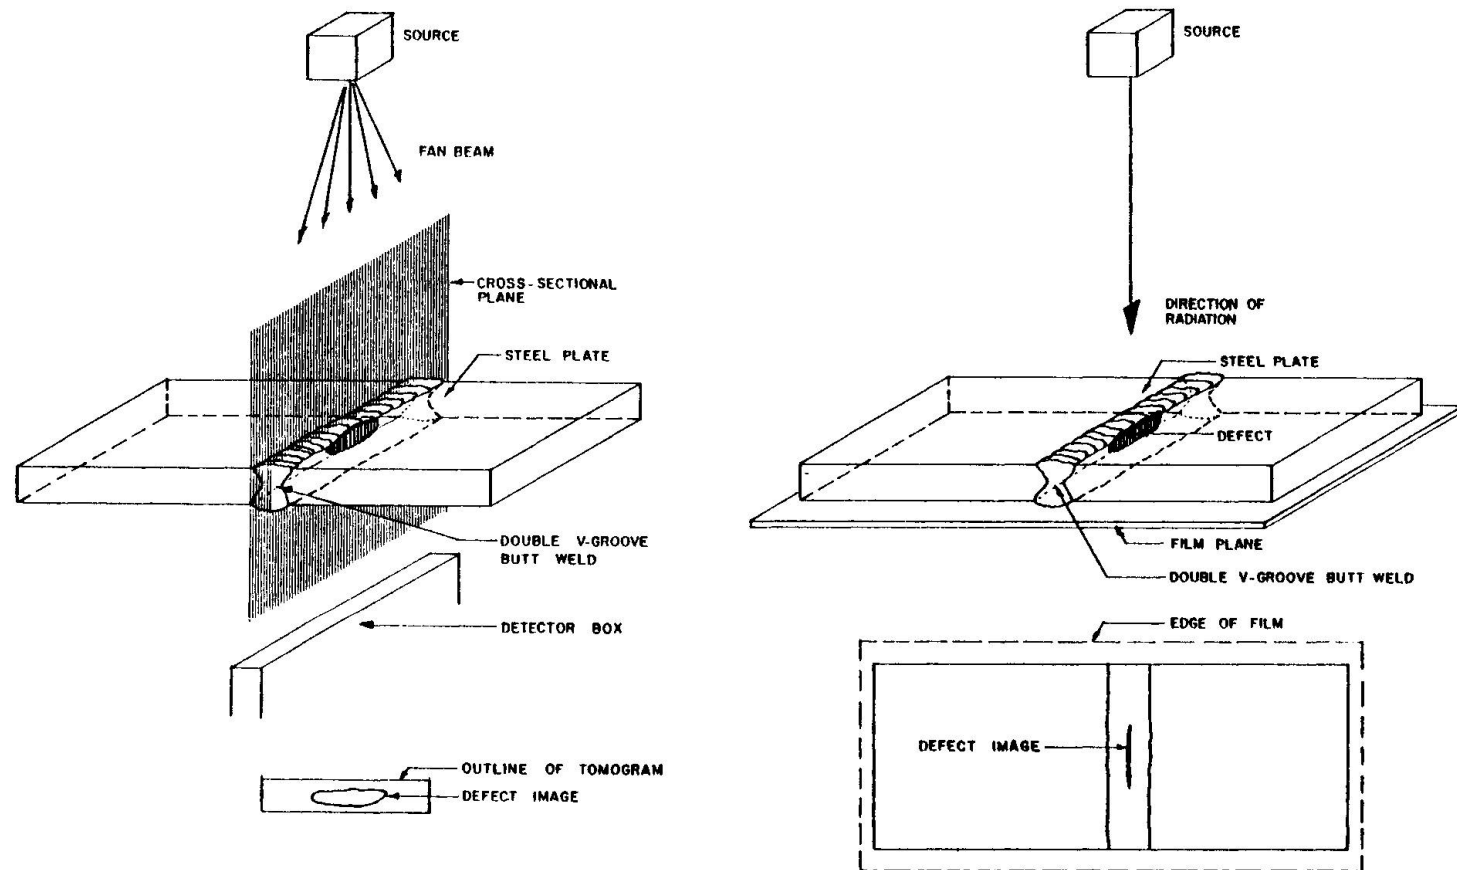
Fig. 1 Defect Imaging with CT and RT

A comparison of the information obtained from computerized tomography (CT) and RT inspection of a butt weld is shown in Fig. 1. The defect geometry in the slice plane is obtained in the tomogram while the radiograph yields only the length of the defect. The image of the defect in the tomogram allows the significance of the defect to be rationally assessed.
