**Zeitschrift:** IABSE reports = Rapports AIPC = IVBH Berichte  
**Band:** 37 (1982)

**Artikel:** Design and retrofit for fatigue damage in web gap  
**Autor:** Fisher, Thomas A. / Fisher, John W. / Kostem, Celal N.  
**DOI:** <https://doi.org/10.5169/seals-28952>

## Design and Retrofit for Fatigue Damage in Web Gap

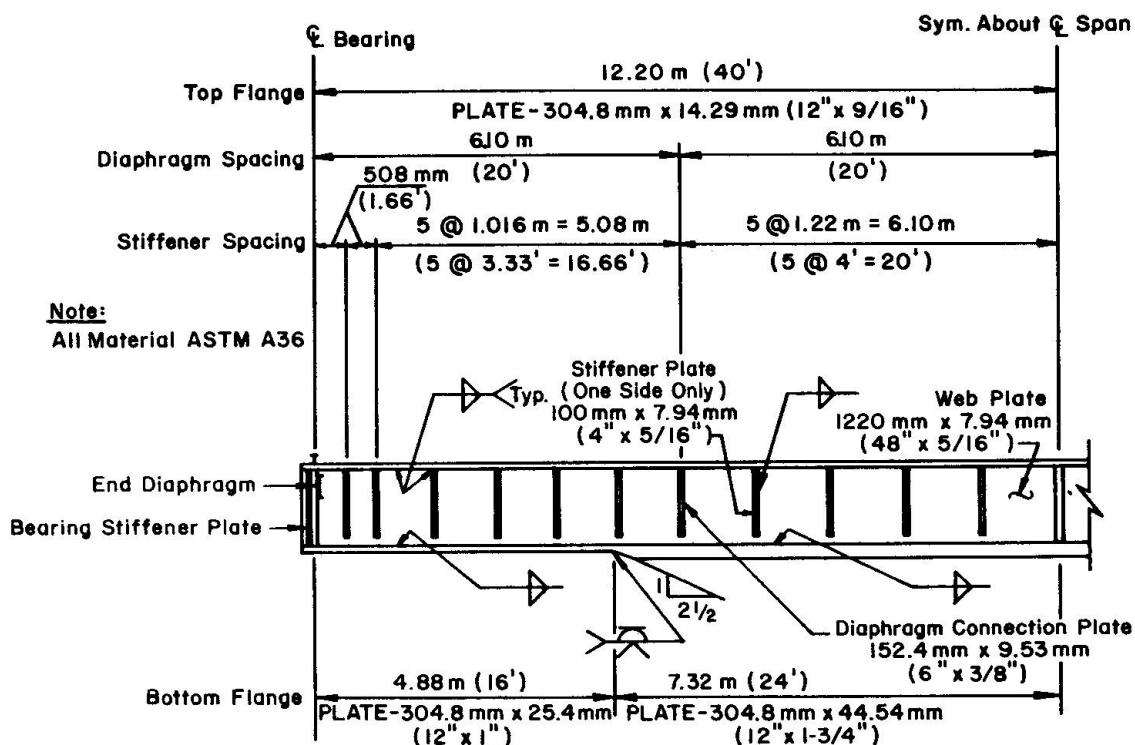
Fig. 2 Elevation of the Bridge Girder

be the prototype for the investigation (Figs. 2 and 3). All design dimensions and details of the bridge reflect the current design practice in the U.S.A. This structure was modeled using the finite element method and Program SAP IV [5]. The primary finite element model accounted for all structural details. Subsequently, the structural detail region of interest, the web gap region, was substructured using a highly refined finite element mesh. Various design parameters were changed to assess their effects on the stress concentration near the web gap region. Some of these parameters were: different vehicular configurations, placement of the vehicle, stiffness of the cross-bracings, connection details of the cross-bracings, web and flange thickness of main girders, and web gap length.

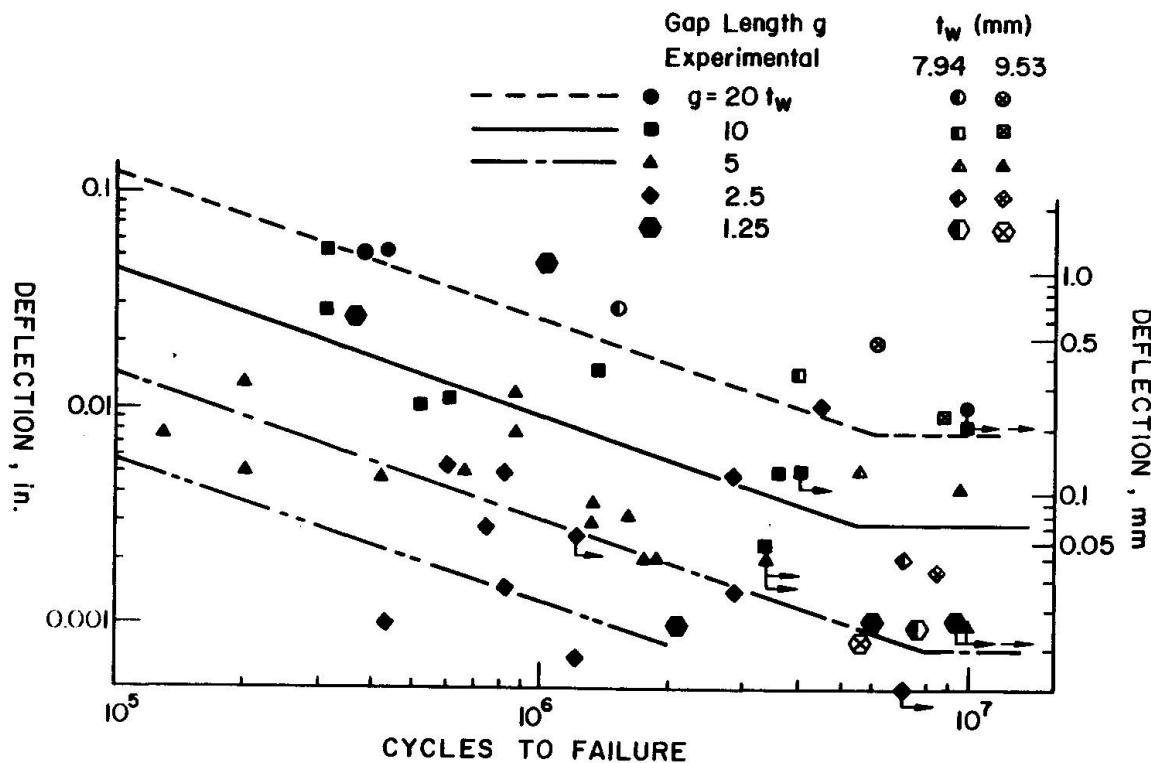
Fig. 4 Experimental and Theoretical Results of Out-of-Plane Displacement

with an initial crack size of 0.762 mm. A final through thickness crack size of 28.6 mm was also selected, but this value had very little effect on the fatigue life estimates. This final crack size was selected, because it represented the length of a typical crack for the experimental data (Fig. 4) [7]. The deflections used in plotting the theoretical values were the relative displacement between the end of the cut short stiffener and the tension flange. This comparison between experimental and theoretical data is shown in Fig. 4. Figure 4 shows that

the theoretical data followed the same trends as the experimental data. The theoretical fatigue life estimates generally overestimated the experimental fatigue lives of the details.
