**Artikel:** Design and retrofit for fatigue damage in web gap  
**Autor:** Fisher, Thomas A. / Fisher, John W. / Kostem, Celal N.  
**DOI:** <https://doi.org/10.5169/seals-28952>

## **Design and Retrofit for Fatigue Damage in Web Gap**

Unanticipated fatigue cracking has resulted because of out-of-plane distortions as a result of the three dimensional behaviour of structures. This paper provides a summary of two separate studies. In one, a recommendation is provided to minimize cracking in the web at diaphragm connection plates in right bridges. The second reviews retrofit procedures for the cracking in longitudinal girder webs at floor beam connection plates.

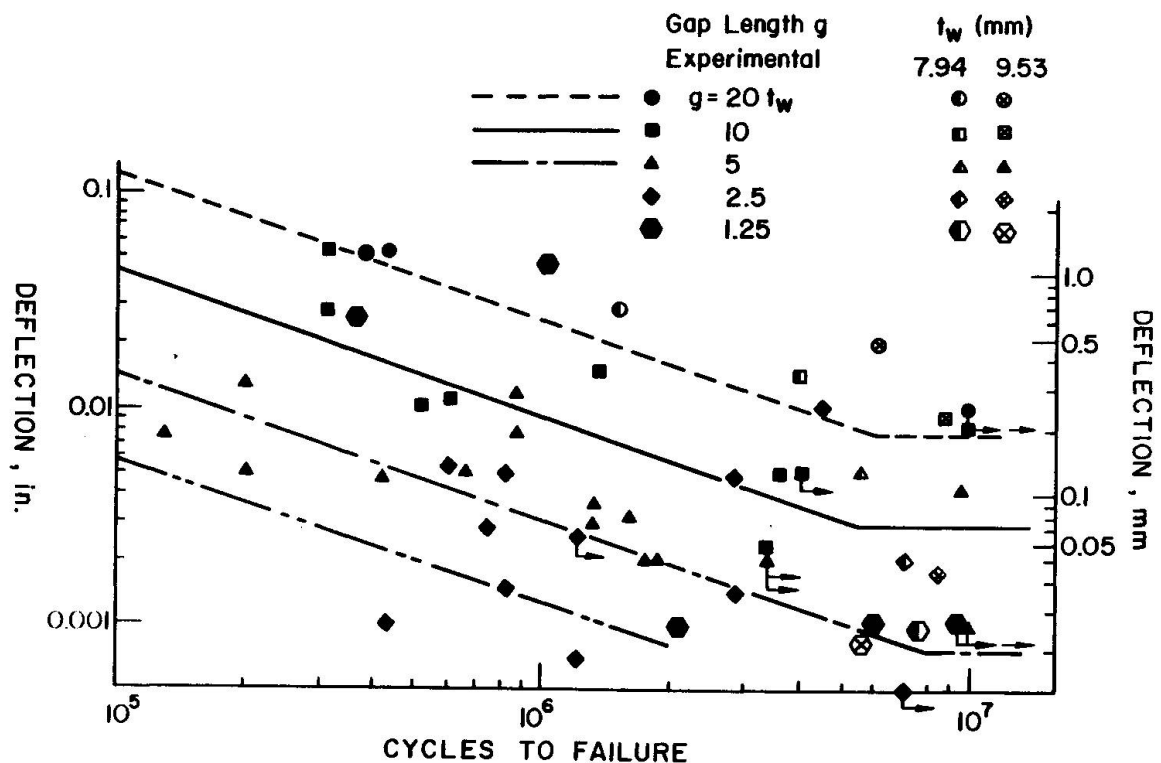
Fig. 4 Experimental and Theoretical Results of Out-of-Plane Displacement

with an initial crack size of 0.762 mm. A final through thickness crack size of 28.6 mm was also selected, but this value had very little effect on the fatigue life estimates. This final crack size was selected, because it represented the length of a typical crack for the experimental data (Fig. 4) [7]. The deflections used in plotting the theoretical values were the relative displacement between the end of the cut short stiffener and the tension flange. This comparison between experimental and theoretical data is shown in Fig. 4. Figure 4 shows that

the theoretical data followed the same trends as the experimental data. The theoretical fatigue life estimates generally overestimated the experimental fatigue lives of the details.
