Artikel: Design and retrofit for fatigue damage in web gap

Autor: Fisher, Thomas A. / Fisher, John W. / Kostem, Celal N.

Design and Retrofit for Fatigue Damage in Web Gap

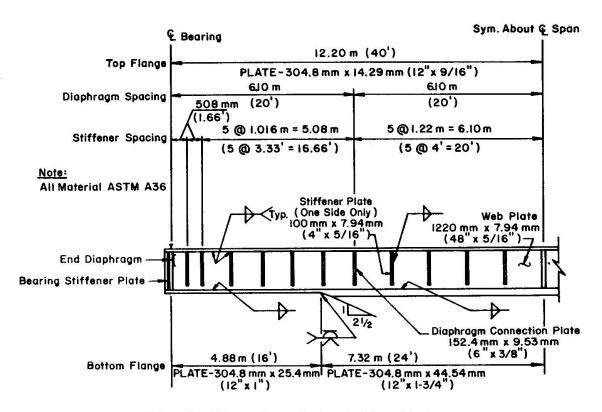
Fig. 2 Elevation of the Bridge Girder

be the prototype for the investigation (Figs. 2 and 3). All design dimensions and details of the bridge reflect the current design practice in the U.S.A. This structure was modeled using the finite element method and Program SAP IV [5]. The primary finite element model accounted for all structural details. Subsequently, the structural detail region of interest, the web gap region, was substructured using a highly refined finite element mesh. Various design parameters were changed to assess their effects on the stress concentration near the web gap region. Some of these parameters were: different vehicular configurations, placement of the vehicle, stiffness of the cross-bracings, connection details of the cross-bracings, web and flange thickness of main girders, and web gap length.

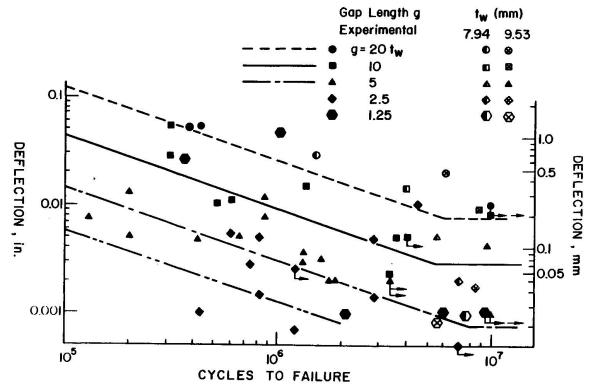
Fig. 4 Experimental and Theoretical Results of Out-of-Plane Displacement

with an initial crack size of 0.762 mm. A final through thickness crack size of 28.6 mm was also selected, but this value had very little effect on the fatigue life estimates. This final crack size was selected, because it represented the length of a typical crack for the experimental data (Fig. 4) [7]. The deflections used in plotting the theoretical values were the relative displacement between the end of the cut short stiffener and the tension flange. This comparison between experimental and theoretical data is shown in Fig. 4. Figure 4 shows that

Parametric studies were conducted to determine the variation of the maximum web gap stress with varying gap length, web thickness and type of connection of cross-bracing to the transverse connection plate. The results of several studies can be seen in Fig. 4. They correspond to 7.94 mm web with moment connection and a 9.53 mm web with moment connection. The parametric studies permit the following observations and recommendations. The out-of-plane web stresses can be minimized by providing a gap of six to ten times the thickness of the web. They can be effectively eliminated if the transverse connection plate is welded to the tension flange. Welding the transverse connection plate to the tension flange should satisfy the fatigue restrictions of [2], Category "C", with only minor adjustments to the original girder design, because the end of the cut short stiffener is very close to the tension flange and is also classified as a Category "C" detail. If a gap of six to ten times the web thickness is selected, then web buckling under tension field action should be checked.
