**Zeitschrift:** IABSE reports = Rapports AIPC = IVBH Berichte  
**Band:** 39 (1982)

**Rubrik:** Session 3: Rehabilitation and repair of bridges

## Maintenance of Reinforced and Prestressed Concrete Bridges in the Federal Republic of Germany

### Heribert THUL

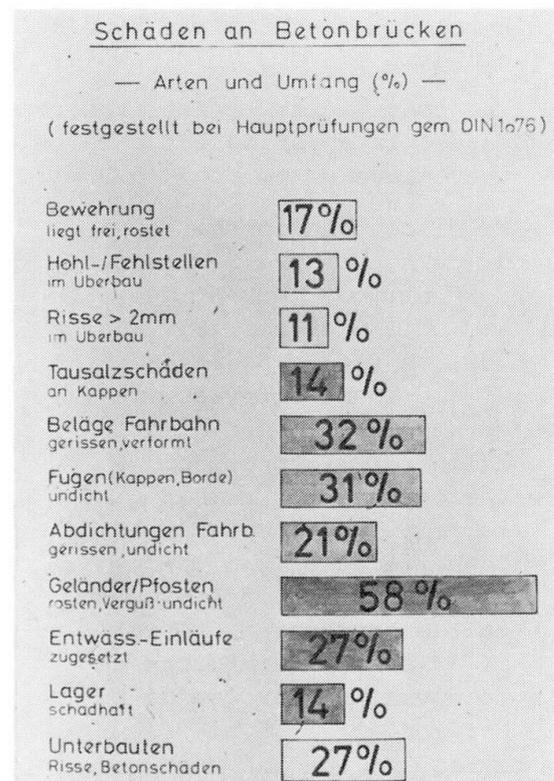
**Fig. 13** Damage to concrete bridges; type and extent

The few defects that do occur can be broken down into the following types of damage, which have been found with the following frequency in one Federal Land during main inspections (according to standard DIN 1076) (Fig. 13):

- open reinforcement, rusting	17 %
- hollows/defects in the concrete of the superstructure	13 %
- cracks of more than 0.2 mm width in the superstructure	11 %
- damage due to de-icing salt along footpaths	14 %
- surfacing cracked, deformed	32 %
- joints in kerbs leaky	31 %
- waterproofing defect	21 %
- rails and posts rusting; sealing compound defect	58 %
- drainage intakes blocked	27 %
- bearings defect	14 %
- substructures: concrete deterioration, cracks	27 %

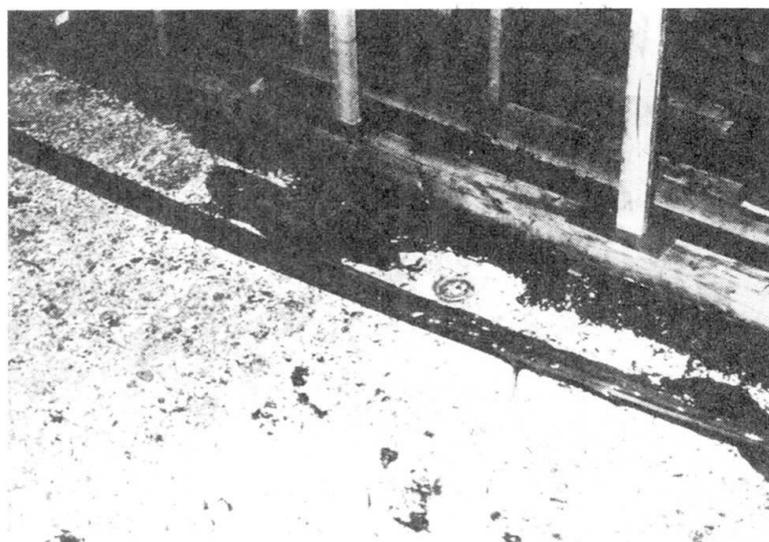
Fig. 26 Application of the steel plate (valley bridge Sterbecke)

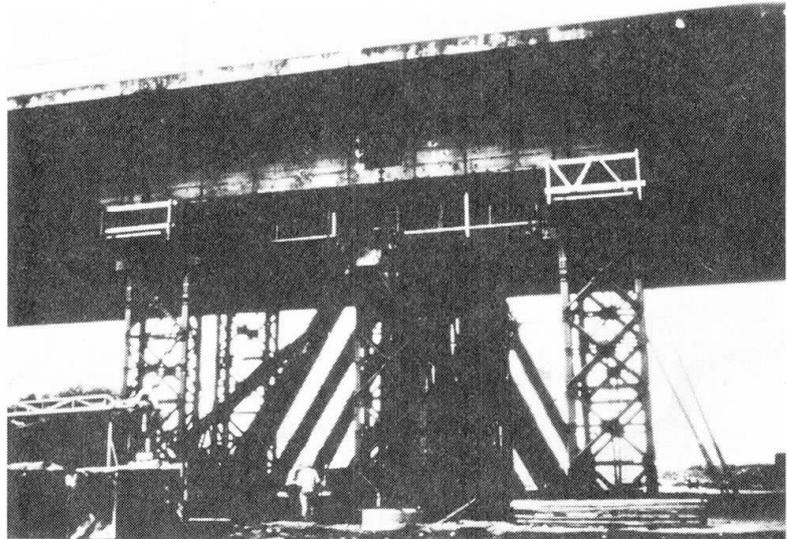
Fig. 27 Erecting tower for the replacement of the bearing (bridge over the river Main at Hochheim)

- exceeding the limits of foreseen movement (rolling off the bearing plate),
- fracture of the rolls,
- overstressing and failure of elastomeric bearings,
- failure of neoprene pot bearings due to fracture of the sealing ring or insufficient lubrication or sliding surface area.

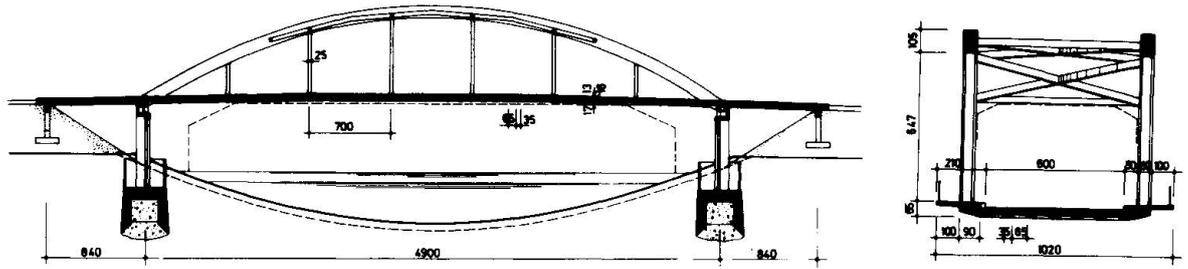
Fig. 1 Bridge "A", general arrangement

Bridge A (Fig.1) is from an older generation of prestressed bridges in Yugoslavia, classified into a group for detailed control. The low building height induced the solution of the arch system above the prestressed two-way ribbed deck structure, being a tie at the same time. Suspenders are precast and prestressed. Such solutions are abandoned today. The arch is not indicated for small spans, and the conception with a suspended deck is a forced solution and belongs to the past.

During the detailed surveying vertical cracks almost on all suspenders were observed. In view of the vital significance of these members, possible causes of deterioration, the actual state and the necessity of interventions were analysed in detail. The results of the examination of concrete showed that the required

strength was achieved. The examination of cable corrosion showed that the protection of cables (grouting) was not satisfactory. Cables were seized by severe corrosion, with a considerable reduction of cross section. A considerable contribution to this state was made by a detail to which not sufficient attention was paid during the construction (Fig.2). After the grouting, control pipes on the arch extrados were cut off without particular treatment of these places. The insufficient compaction of the grouting mass enabled with time the penetration of weathering waters into the lower parts of suspenders, and the corrosion cables.

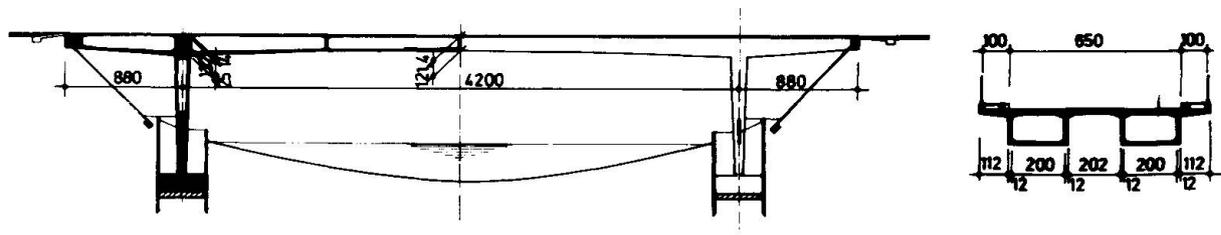
Fig. 4 Bridge "B", general arrangement

In Bridge "B" (Fig.4) all the basic forms of the above mentioned defects occurred (inadequate static system under today's conditions of traffic, defects in construction and defects connected with maintenance).

In a detailed examination of the bridge, it was established that the cracks of the main girder above the medium supports, registered and injected already during the inspection of quality of work (20 years ago), were 0.1 - 0.3 mm wide and were still effective. Also, cracks were discovered in the central part of the middle span in the lower zone of the upstream box, as well as vertical cracks on the walls of piers through which cables were embedded. By detailed examination and analysis it was found that vertical cracks of piers were the result of the low percentage of reinforcement, particularly of transverse one. Cracks of the main

girder in the central part of the span indicated a far more serious situation, also after heavy vehicles crossings the bridge, it vibrated for a long time. As during the bridge construction openings for box inspections were not left, they were now immediately made. On entering the upstream box, the surprise was not small. One of the four groups of all bridge cables running directly close to the pier, was almost completely broken due to corrosion (Fig.5). Although cable protection, practically along the whole length, was well and efficiently carried out, above the pier, where cables entered the carriageway slab (Fig.6), there was a small zone in which the cable protection could not be efficiently performed. However, the absence of waterproofing and the appearance of cracks in the carriageway slab were enough to produce serious damage which was discovered late, but still on time.

The bridge, because of seriously jeopardized stability, was excluded from traffic and rehabilitated according to a particular design. Cables of the girder were completely replaced, and supports were formed at either end of the bridge, so that the system for live load was transferred into a continuous frame with three spans. Cable replacement was made without a special falsework by temporary underpinning of the main girder by external cables.

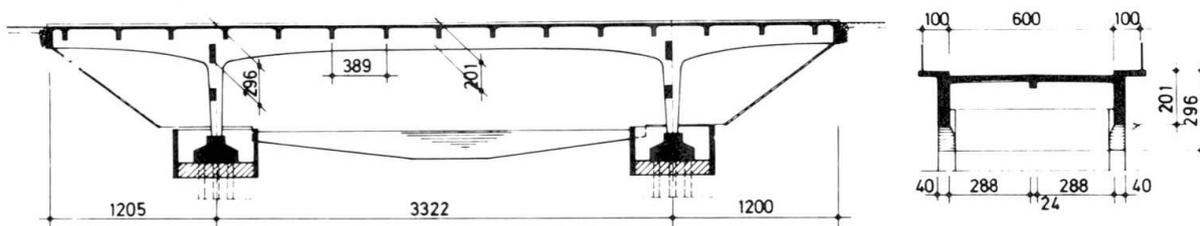
Fig.7 Bridge "C", general arrangement

Bridge C (Fig.7), across the channel, is a reinforced concrete skew frame with cantilevers. It was reconstructed during World War II on the modified foundations of a destroyed, similar bridge from 1939. The bridge conception, with comparatively large cantilevers and considerable deflections at the ends, with a small width of the carriageway, with steep bridge approaches in sharp horizontal curvatures and without transition slabs, does not correspond to the contemporary principles of bridge construction and to the conditions of today's traffic.

This fact required an urgent intervention. Opposite to the author's opinion that the best solution was to construct a new bridge, nevertheless, for certain reasons (of administrative nature) it was concluded to rehabilitate the existing bridge. The old carriageway slab was removed and a new one made (Fig.9).

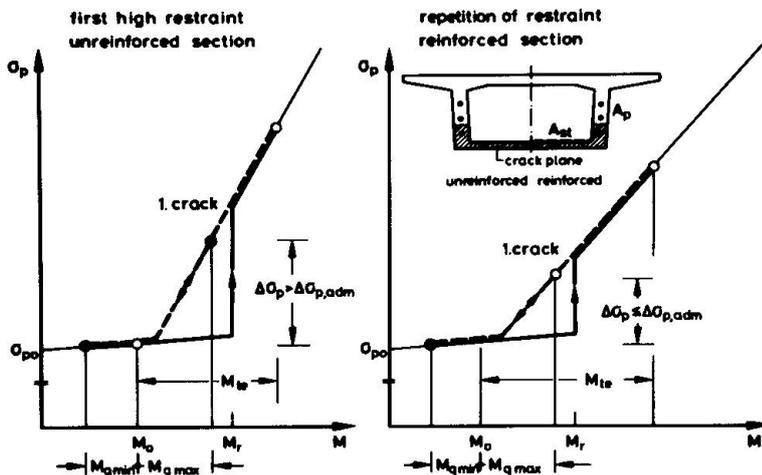
The efficiency of the bonded steel plate reinforcement with respect to fatigue stresses in the prestressing steel is shown by Fig. 1. The base moment  $M_0$  is superimposed by the moment  $M_{te}$  of the first high thermal restraint. Thereby, the cracking moment  $M_r$  is transgressed. The moments due to traffic loads cause a fatigue stress range  $\Delta\sigma_p$  which exceeds the stress range in the uncracked section. After strengthening of the section the slope of the steel stress-moment-curve will be diminished. Thus, by choice of a suitable cross-section of steel plate the stress range may be reduced to the admissible value as predetermined by acceptance tests.

Fig. 1 Efficiency of bonded steel plate strengthening with respect to fatigue stresses in prestressing steel of joint

The repair of cracks in joints by epoxy resin injection alone is not a sufficient countermeasure because the highly probable repetition of thermal restraint may cause either new cracks or the opening of injected cracks. Therefore, besides crack injection also additional reinforcement - provided for by the bonded steel plates - is necessary to reduce the amplitude of fatigue stresses and the crack widths as well.

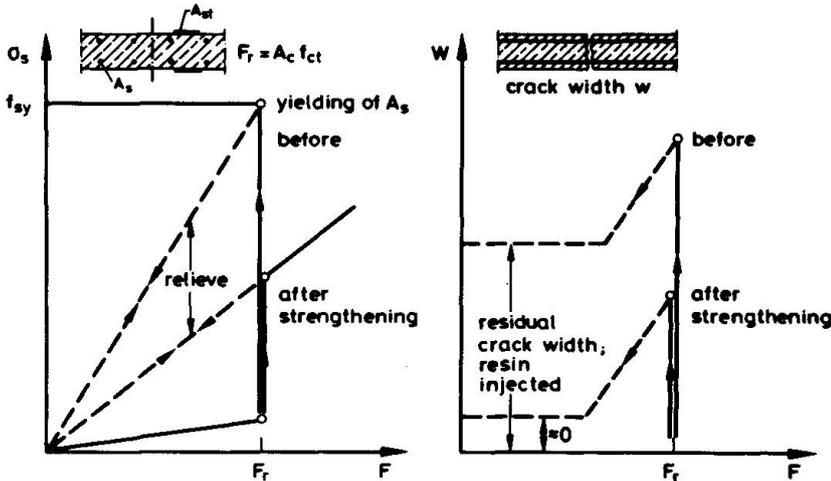
The efficiency of the additional reinforcement with respect to the steel stress of the regular reinforcement and to the crack width is depicted in Fig. 2. Due to the steel plate the steel stresses are relieved once a new crack is formed by repetition of restraint. After strengthening, both reinforcement and steel plate operate in the elastic range, thus, contracting the widths of possible new cracks without virtual residue.

Fig. 2 Influence of strengthening on the steel stress of the reinforcement and on the crack width

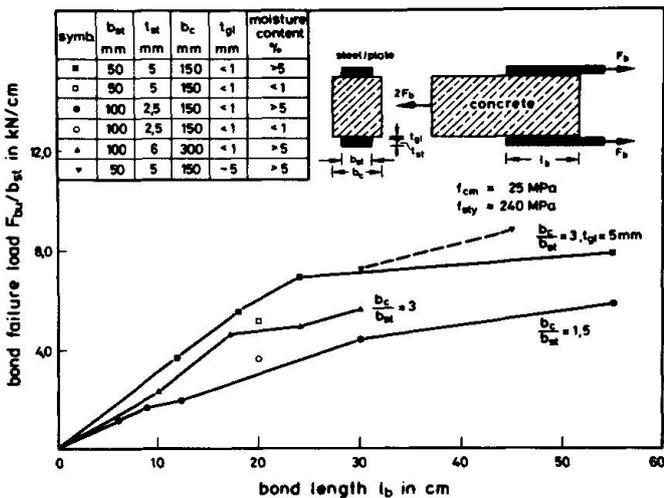
Fig. 3 Bond failure load as a function of bond length and of  $b_c/b_{st}$

From the first part of research, Fig. 3 shows the influence of the bond length on the bond failure load per unit width of the steel plate (short time tests). The most important influence is exercised by the bond length. Up to a bond length of 30 cm the bond failure load shows an approximately linear increase. Beyond this length the increase becomes small with the tendency to approach a limit value of the bond strength. A thickness of steel plate of 5 to 10 mm and a geometry ratio  $b_c/b_{st} \approx 3$  seem to be optimal. Several epoxy glues, especially formulated for this application, were tested without showing significant differences in strength. With a suitable glue and adequate preparation and fabrication of the bonding

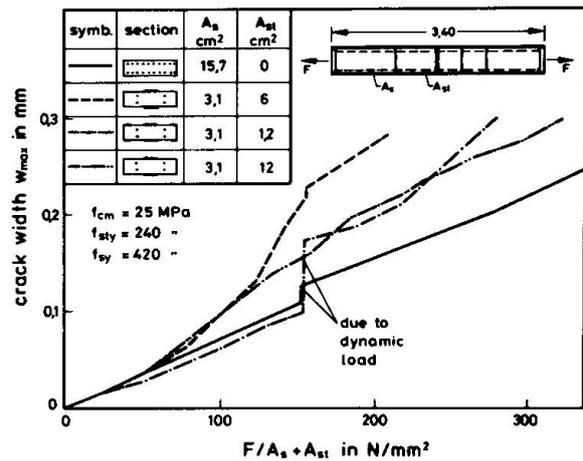
Fig. 4 Width of largest crack, depending on load and strengthening ratio

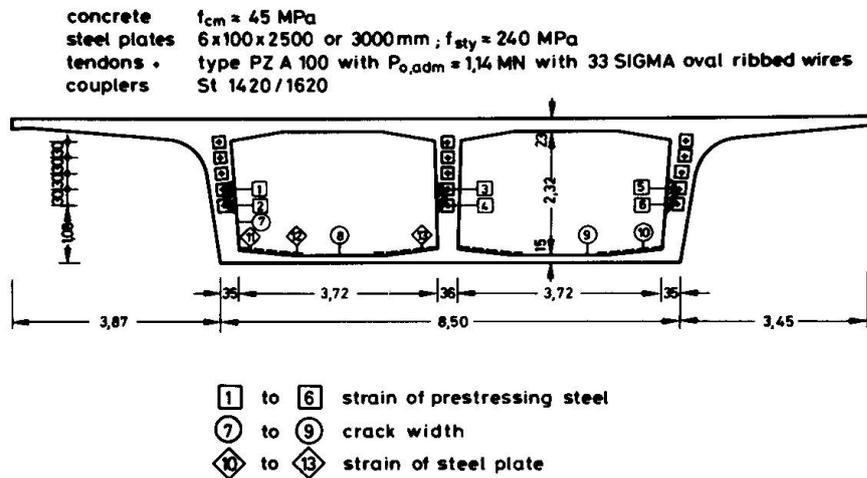
Fig. 5 Cross-section of bridge and other data

bridge consists of two separate superstructures with box sections as shown by Fig. 5. It is continuous over 7 spans of 40 m each. It was built spanwise with all of the 15 tendons being coupled at the joint near the points of contraflexure. In all working joints the bottom slab was cracked; the crack plane extended into the webs, passing the lower couplings. The necessary cross-section of the bonded steel plate reinforcement was chosen to reduce the calculated stress-range of the prestressing steel in the coupling to the admissible value of the prestressing system. The arrangement of the plates is depicted in Fig. 5. The length of the plates was chosen to cover the region of possible concrete tensile stresses at the bottom due to repeated restraint and other actions.

The work on site consisted of several steps. Firstly, the cracks were injected with an approved epoxy resin. Then, the top surface of the bottom slab had to be prepared by vacuum grit blasting and by a shaper to the desired planeness. The grit blasted steel plates were glued to the concrete piecewise and pressed down by plane and stiff wooden distributing beams for the first 24 hours. Local deviations from the desired planeness of the concrete surface can be tolerated: they can be evened-out with thicker layers of glue ( $\leq 10$  to 15 mm). It is very important that the steel plates remain straight; tests have shown that transverse

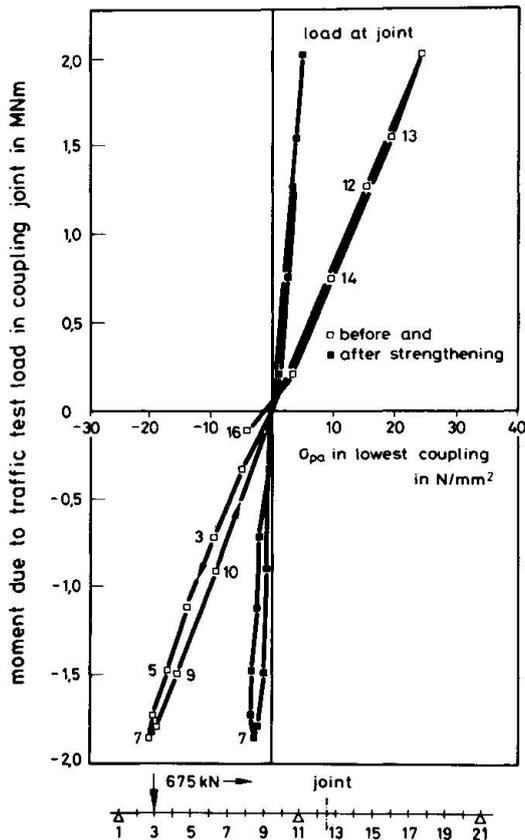
Fig. 6 Stress amplitude of prestressing steel of the lowest coupling, depending on test load moment

In order to assess the efficiency of the strengthening extensive on-site tests were performed prior and after strengthening. The test loading was executed with three 22,5 tons lorries which travelled along the bridge in different patterns. Fig. 6 shows the stress amplitude of the prestressing steel at one of the lowest couplings as a function of the moment at the joint due to the lorries travelling side by side. The stress amplitude is dramatically reduced proving the desired efficiency of the chosen strengthening method. The design loads will cause greater moment amplitudes, however, the admissible stress range of  $\Delta\sigma_p = 55 \text{ N/mm}^2$  will not be transgressed. The complete results will be published soon.

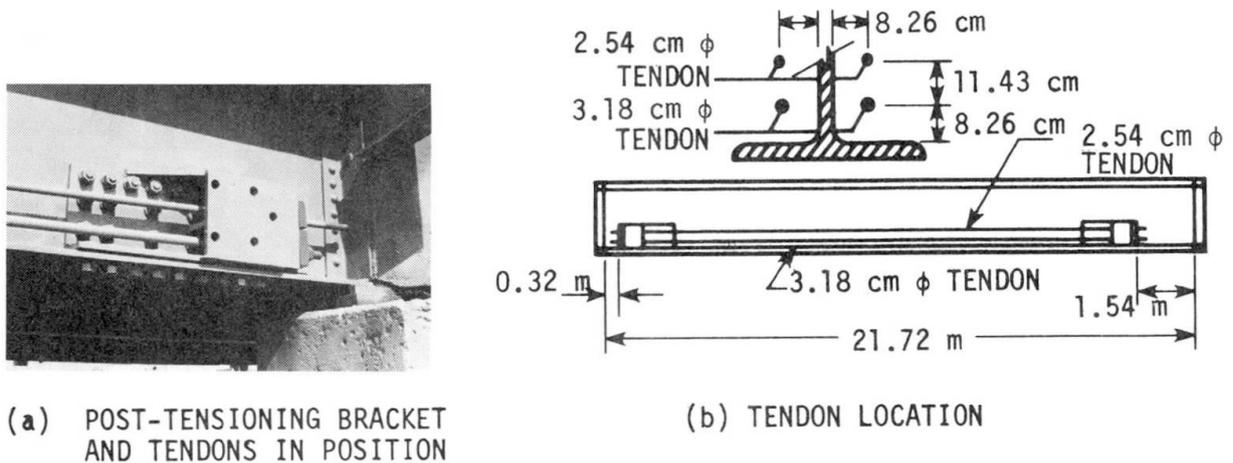
Fig. 2. Post-tensioning details - Bridge 2.

Details of the post-tensioning system employed are shown in Figure 2. Figure 2a illustrates one of the brackets bolted into place with high strength bolts; each bracket was fabricated from 1.91 cm thick plate. The position of the 3.18 cm  $\phi$  and 2.54 cm  $\phi$  post-tensioning tendons is shown in Figure 2b; note that the bracket is located at a great distance from the center line of bearing on the jacking end of the stringer.

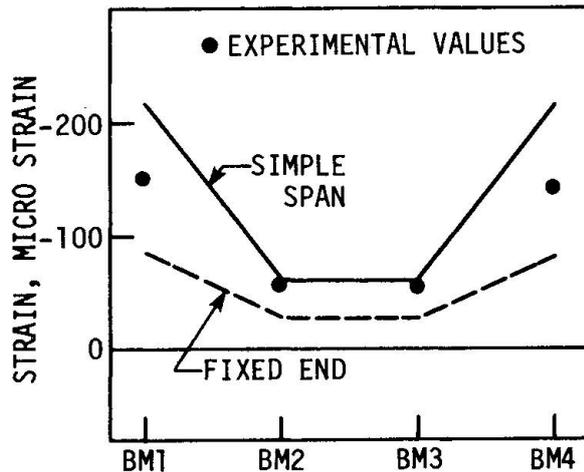
The desired post-tensioning force for each bridge was based upon the results of Phase I of the study. Thus, subjecting each exterior stringer to a force of 818.5 kN was supposed to cause a strain reduction in the lower flange of 218  $\mu\epsilon$ . This was based upon the assumption that the bridge was simply supported. However when the 818.5 kN force was applied in the field, a strain reduction of only 147  $\mu\epsilon$  was obtained due to restraint of the ends of the stringers. Figure 3 compares the midspan strains measured with theoretical strains assuming the stringer to be completely restrained against rotation and completely free to rotate. Note that the measured strains are essentially midway between the fixed and the free condition. Thus, although the desired strain reduction was not obtained, it should be noted that the end restraint also reduces the effect live load has on the bridge.

Fig. 3. Midspan, bottom flange strains resulting from post-tensioning: Bridge #1.

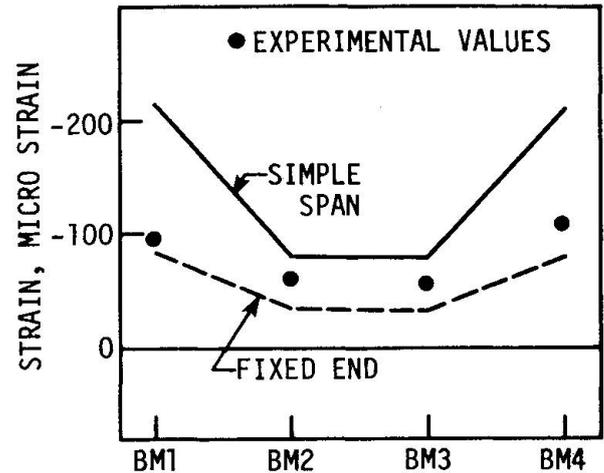
As in Bridge #1, the force applied to each exterior stringer (1361.2 kN) was determined assuming the stringers to be simply supported. The 1361.2 kN force was to cause a strain reduction in the lower flange of 212  $\mu\epsilon$ . When the desired force was applied in the field, a reduction of only 102  $\mu\epsilon$  was obtained because of end restraint. Figure 4 compares the midspan strains measured with the theoretical strains assuming the stringers to be first completely restrained against rotation and second completely free to rotate. As may be seen, the strains in the exterior stringers approach the fixed end condition.

Fig. 4. Midspan, bottom flange strains resulting from post-tensioning: Bridge #2.

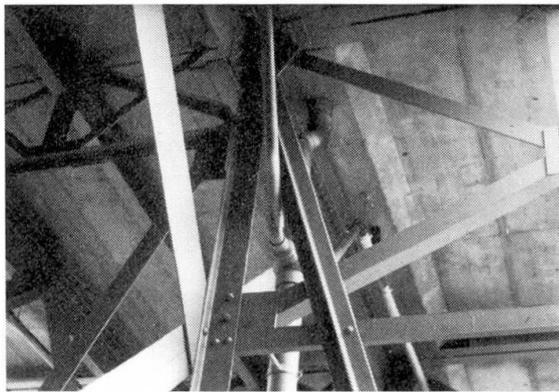
Diese Kontrollen zeigen, dass die Sicherheit auch bei vermindertem Fahrbahngewicht nicht ganz ausreicht. Zudem waren unterhalb der Fahrbahn nur waagrechte Verbindungen zwischen den Pfosten vorhanden. Der obere Bereich der Querscheiben wurde deshalb K-artig ausgefacht (Fig. 2): man erreicht eine einwandfreie Stützung der T-Pfosten sowie eine Verminderung deren Einspannlänge, daher mit bescheidenen Kosten eine fühlbare Erhöhung der Tragkraft der Obergurte.

Fig. 2 Verstärkung der Querscheiben mit K-artiger Unterteilung

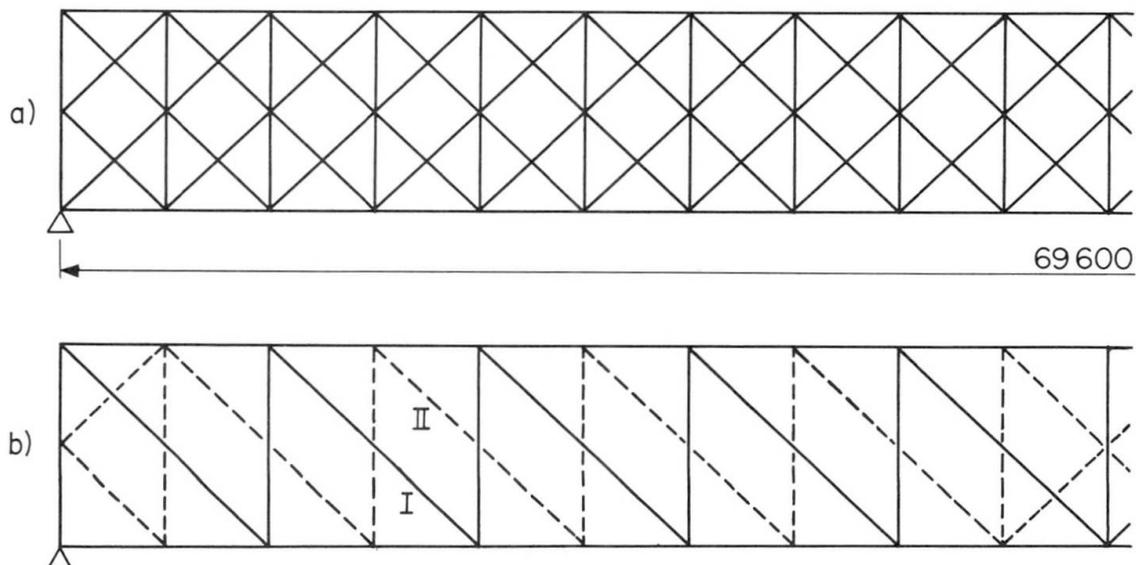
Fig. 3a zeigt die Ausfachtung der Aussenträger, mit vier Streben in jedem Vertikalschnitt. Die Stabkräfte wurden elektronisch bestimmt, wobei einerseits die Biegesteifigkeit der durchgehenden Gurte und der Endpfosten, andererseits die Exzentrizitäten infolge der veränderlichen Anzahl Lamellen berücksichtigt wurden. Dagegen betrachtet man die Strebenanschlüsse als gelenkig und führt deren Kreuzungspunkte nicht als gemeinsame Knoten ein.

Fig. 3 Ausfachtung im unterkritischen a) und im überkritischen b) Knickbereich

Bei der Bestimmung der Knicklänge der Druckstreben wurde berücksichtigt, dass diese Stäbe in ihrer Mitte durch die in Fig. 2 abgebildeten K-Verbände seitlich gehalten sind und zudem in den Viertelpunkten durch die Zugdiagonalen elastisch gestützt sind. Die Ausbildung als aussenliegender Doppelwinkel bedingt allerdings Exzentrizitätsmomente, welche den Knickwiderstand abmindern. Die Sicherheit beträgt somit nur ca. 1,4.

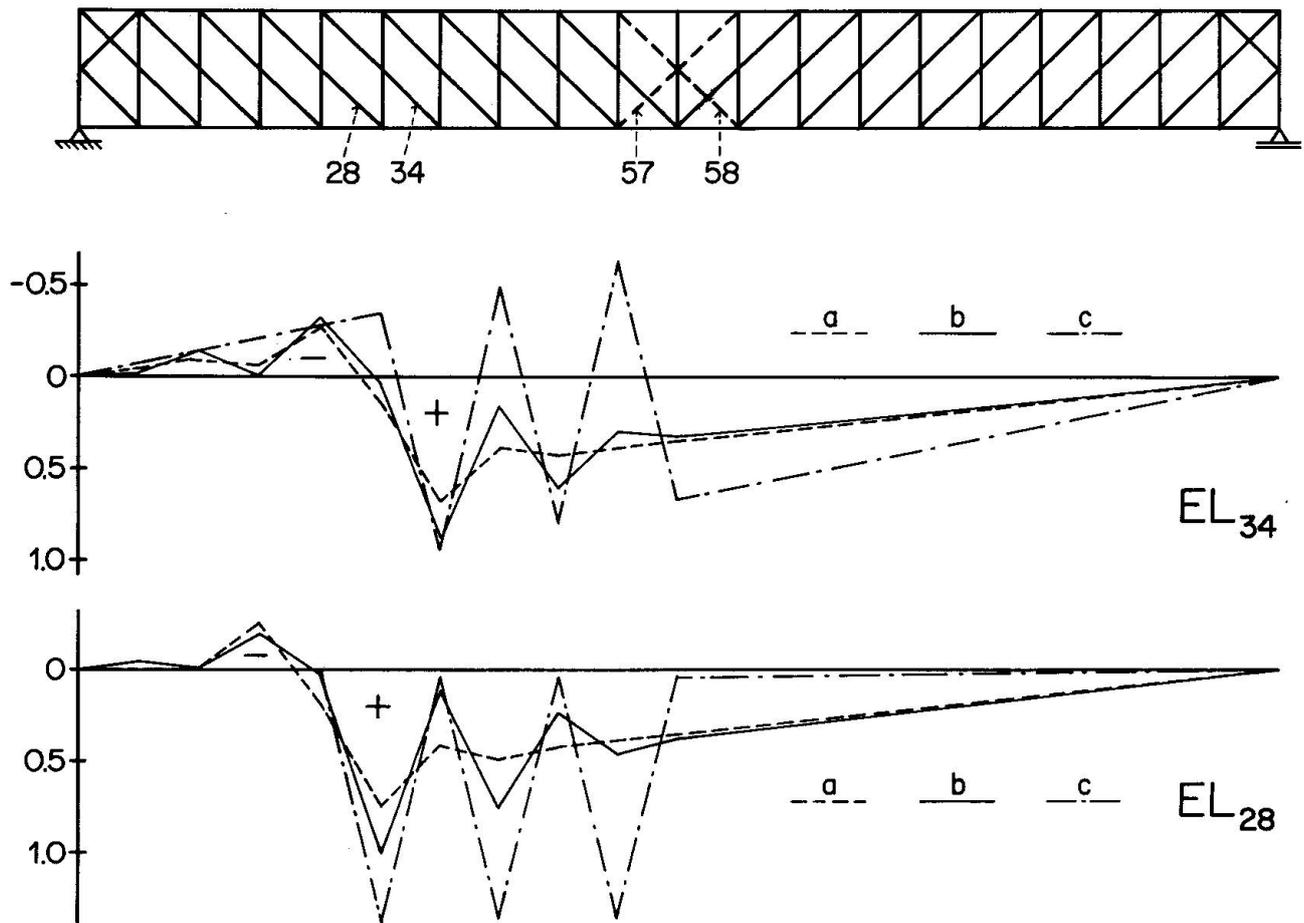
Beim doppelten Ständerfachwerk nach Fig. 3b bzw. Fig. 4 hängt der Verlauf der Einflusslinien der Füllungsglieder stark von den Berechnungsannahmen ab. In Fig. 4 bezieht sich der Linienzug a) auf ein Fachwerk mit über den Knoten durchgehenden Gurtungen (vgl. 5.3), wie dies der konstruktiven Gestaltung entspricht. Linie b) gilt für ein System mit gelenkigen Gurtanschlüssen (CULMANN), während bei c) das zentrale Andreaskreuz als inaktiv gedacht ist. Das mehrfache Fachwerk ist dann statisch bestimmt [5]. Der durchgehende Strebenzug mit der Diagonale 34 übernimmt direkt die in den geraden Knoten angreifenden Lasten und überträgt sie in üblicher Art zu den Lagern. Die in Trägermitte unterbrochene Ausfachung mit der Strebe 28 leitet die Belastung der ungeraden Knoten nur zum linken Lager, so dass der durchgehende Strebenzug den Ausgleich zu sichern hat.

Fig. 4 Einflusslinien für zwei Streben eines doppelten Ständerfachwerkes.  
a) Gurte durchlaufend; b) CULMANNsches Fachwerk; c) Statisch bestimmtes Ständerfachwerk ohne zentrales Andreaskreuz (57 + 58)
