Zeitschrift: IABSE reports = Rapports AIPC = IVBH Berichte
Band: 39 (1982)

Rubrik: Session 3: Rehabilitation and repair of bridges

Maintenance of Reinforced and Prestressed Concrete Bridges in the Federal Republic of Germany

Heribert THUL

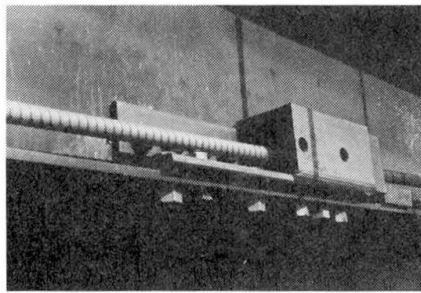
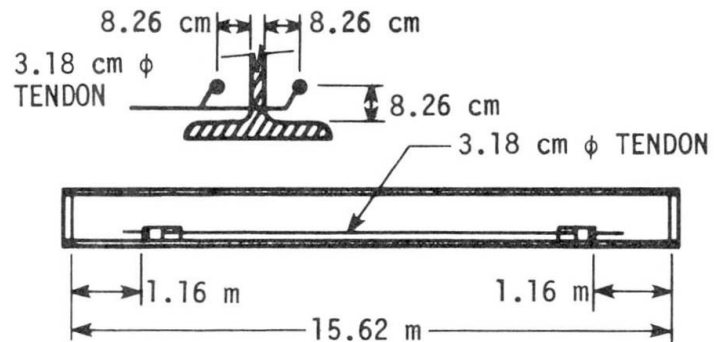
Fig. 1. Post-tensioning details - Bridge 1.

Details of the post-tensioning system employed are shown in Figure 1. Due to uncertainty about the type of steel in some of the bridges to be strengthened, the connections were bolted. Figure 1a illustrates one of the 8 brackets, fabricated from 1.91 cm thick structural angle, bolted in position. The position of the 3.18 cm ϕ post-tensioning tendons is shown in Figure 1b.

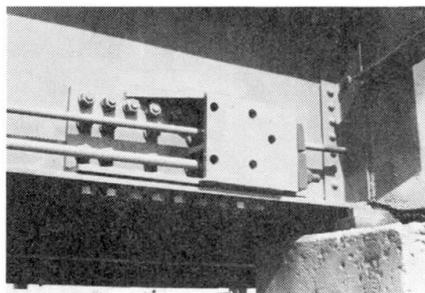
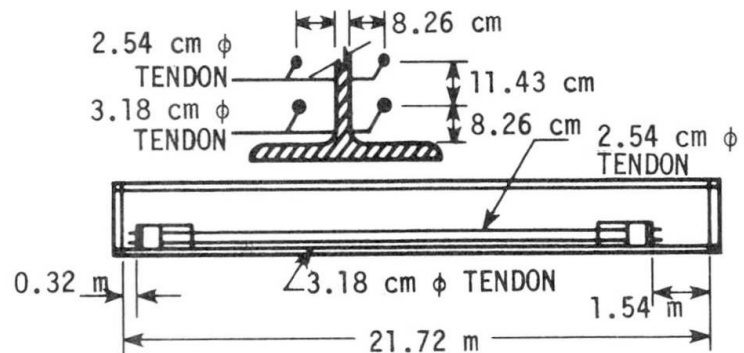
Fig. 2. Post-tensioning details - Bridge 2.

Details of the post-tensioning system employed are shown in Figure 2. Figure 2a illustrates one of the brackets bolted into place with high strength bolts; each bracket was fabricated from 1.91 cm thick plate. The position of the 3.18 cm ϕ and 2.54 cm ϕ post-tensioning tendons is shown in Figure 2b; note that the bracket is located at a great distance from the center line of bearing on the jacking end of the stringer.

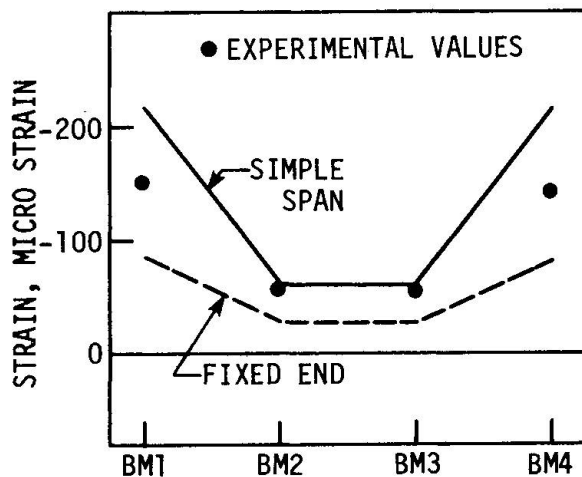
The desired post-tensioning force for each bridge was based upon the results of Phase I of the study. Thus, subjecting each exterior stringer to a force of 818.5 kN was supposed to cause a strain reduction in the lower flange of 218 $\mu\epsilon$. This was based upon the assumption that the bridge was simply supported. However when the 818.5 kN force was applied in the field, a strain reduction of only 147 $\mu\epsilon$ was obtained due to restraint of the ends of the stringers. Figure 3 compares the midspan strains measured with theoretical strains assuming the stringer to be completely restrained against rotation and completely free to rotate. Note that the measured strains are essentially midway between the fixed and the free condition. Thus, although the desired strain reduction was not obtained, it should be noted that the end restraint also reduces the effect live load has on the bridge.

Fig. 3. Midspan, bottom flange strains resulting from post-tensioning: Bridge #1.

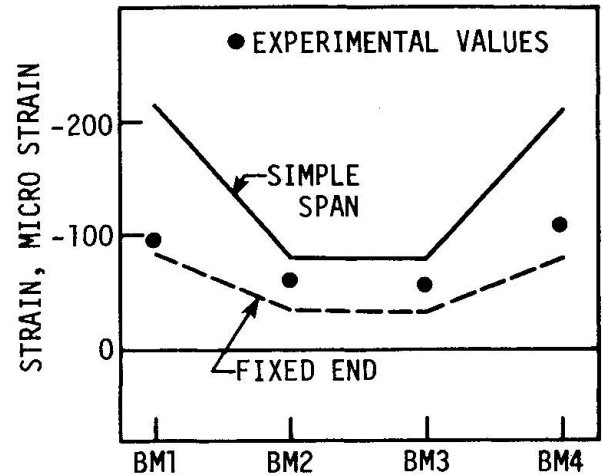
As in Bridge #1, the force applied to each exterior stringer (1361.2 kN) was determined assuming the stringers to be simply supported. The 1361.2 kN force was to cause a strain reduction in the lower flange of 212 $\mu\epsilon$. When the desired force was applied in the field, a reduction of only 102 $\mu\epsilon$ was obtained because of end restraint. Figure 4 compares the midspan strains measured with the theoretical strains assuming the stringers to be first completely restrained against rotation and second completely free to rotate. As may be seen, the strains in the exterior stringers approach the fixed end condition.

Fig. 4. Midspan, bottom flange strains resulting from post-tensioning: Bridge #2.

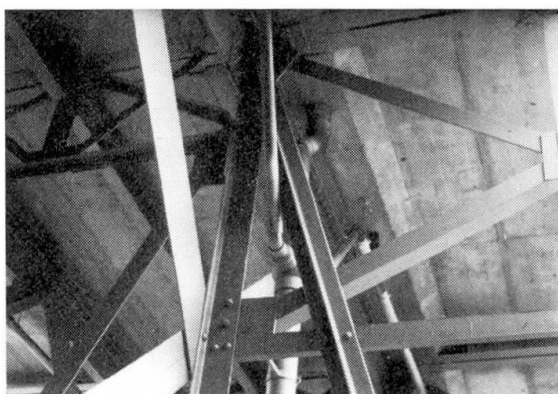
Diese Kontrollen zeigen, dass die Sicherheit auch bei vermindertem Fahrbahngewicht nicht ganz ausreicht. Zudem waren unterhalb der Fahrbahn nur waagrechte Verbindungen zwischen den Pfosten vorhanden. Der obere Bereich der Querscheiben wurde deshalb K-artig ausgefacht (Fig. 2): man erreicht eine einwandfreie Stützung der T-Pfosten sowie eine Verminderung deren Einspannlänge, daher mit bescheidenen Kosten eine fühlbare Erhöhung der Tragkraft der Obergurte.

Fig. 2 Verstärkung der Querscheiben mit K-artiger Unterteilung

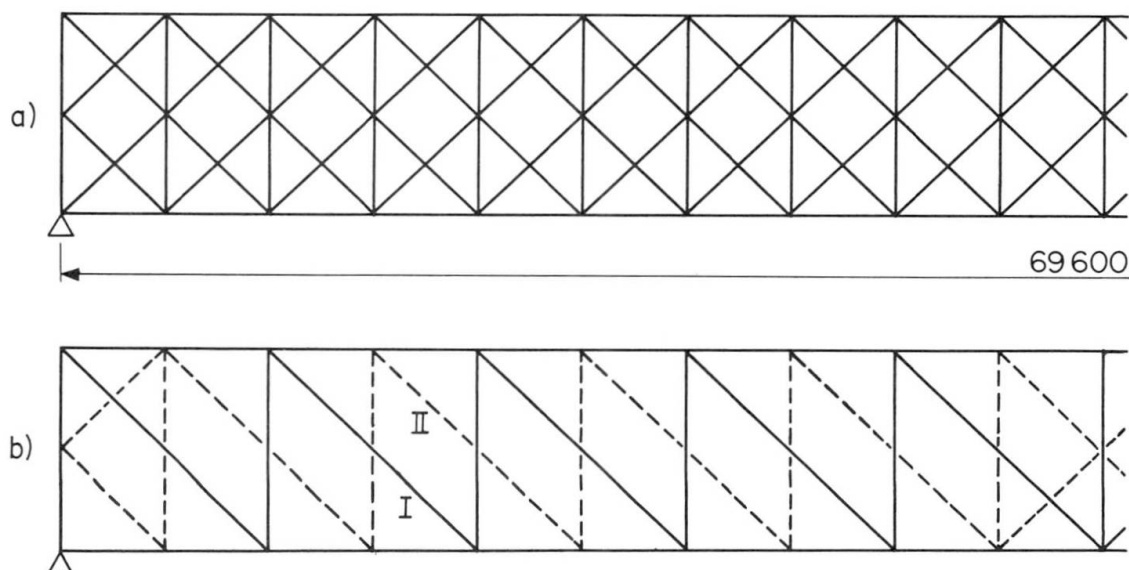
Fig. 3a zeigt die Ausfachtung der Aussenträger, mit vier Streben in jedem Vertikalschnitt. Die Stabkräfte wurden elektronisch bestimmt, wobei einerseits die Biegesteifigkeit der durchgehenden Gurte und der Endpfosten, andererseits die Exzentrizitäten infolge der veränderlichen Anzahl Lamellen berücksichtigt wurden. Dagegen betrachtet man die Strebenanschlüsse als gelenkig und führt deren Kreuzungspunkte nicht als gemeinsame Knoten ein.

Fig. 3 Ausfachtung im unterkritischen a) und im überkritischen b) Knickbereich

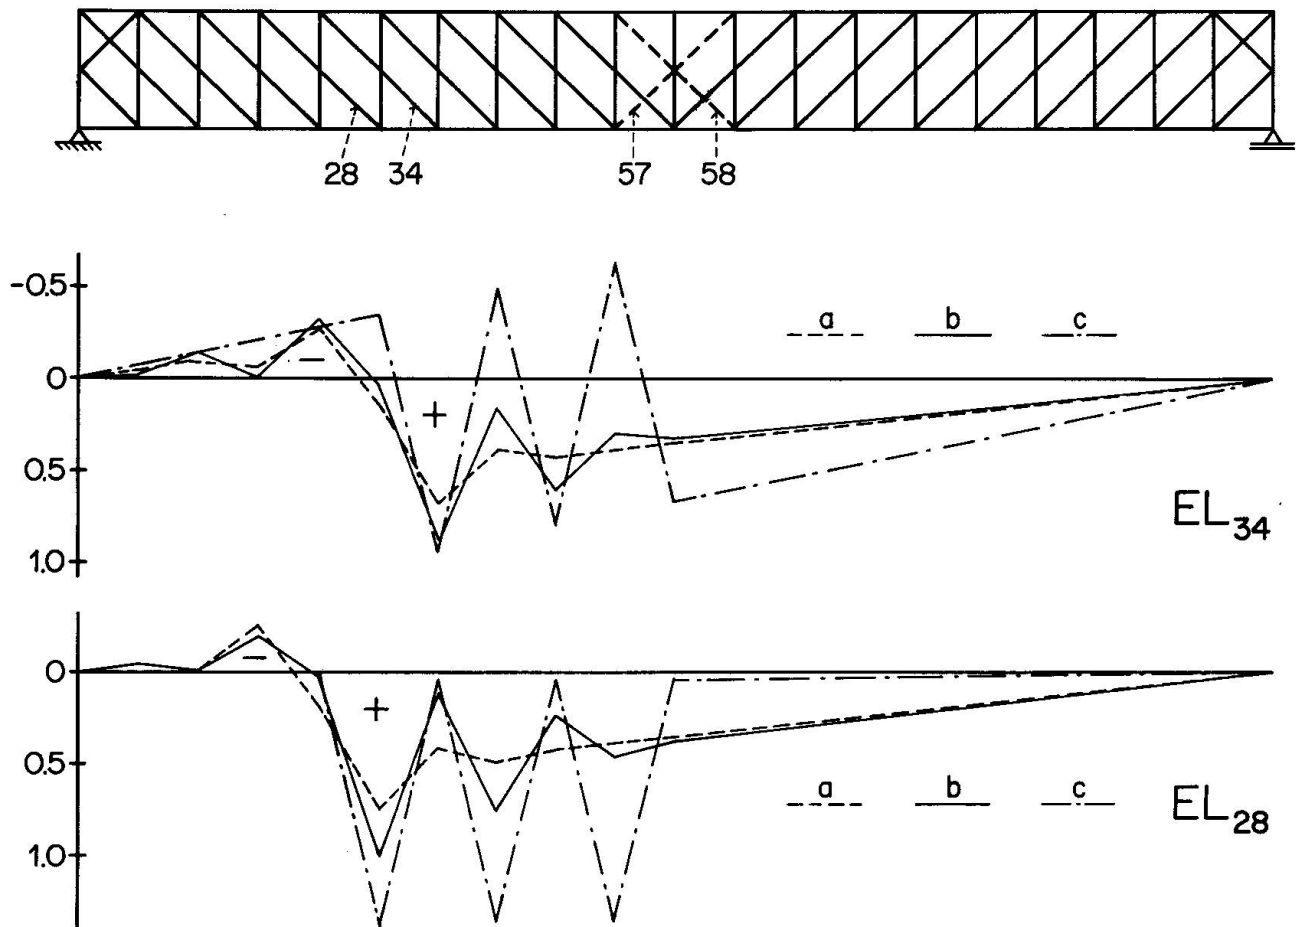
Beim doppelten Ständerfachwerk nach Fig. 3b bzw. Fig. 4 hängt der Verlauf der Einflusslinien der Füllungsglieder stark von den Berechnungsannahmen ab. In Fig. 4 bezieht sich der Linienzug a) auf ein Fachwerk mit über den Knoten durchgehenden Gurtungen (vgl. 5.3), wie dies der konstruktiven Gestaltung entspricht. Linie b) gilt für ein System mit gelenkigen Gurtanschlüssen (CULMANN), während bei c) das zentrale Andreaskreuz als inaktiv gedacht ist. Das mehrfache Fachwerk ist dann statisch bestimmt [5]. Der durchgehende Strebenzug mit der Diagonale 34 übernimmt direkt die in den geraden Knoten angreifenden Lasten und überträgt sie in üblicher Art zu den Lagern. Die in Trägermitte unterbrochene Ausfachung mit der Strebe 28 leitet die Belastung der ungeraden Knoten nur zum linken Lager, so dass der durchgehende Strebenzug den Ausgleich zu sichern hat.

Fig. 4 Einflusslinien für zwei Streben eines doppelten Ständerfachwerkes.
a) Gurte durchlaufend; b) CULMANNsches Fachwerk; c) Statisch bestimmtes Ständerfachwerk ohne zentrales Andreaskreuz (57 + 58)
