Rehabilitation and Repair of Bridges

Maintenance of Reinforced and Prestressed Concrete Bridges in the Federal Republic of Germany

Heribert THUL

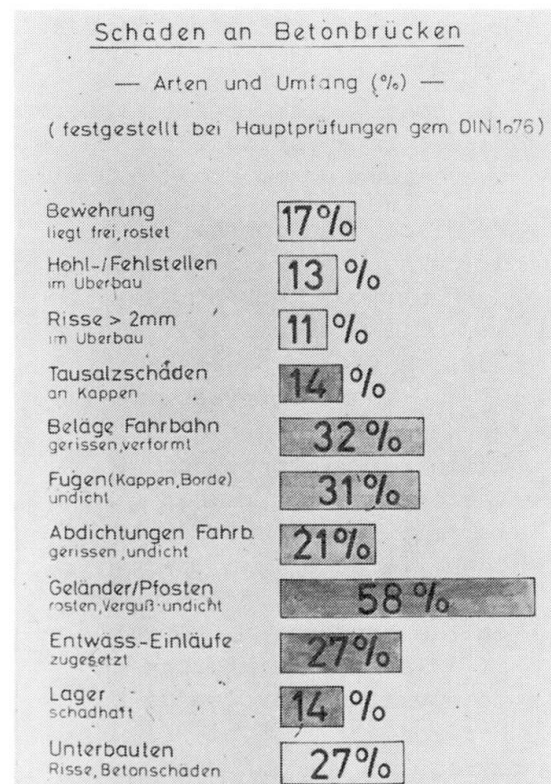
Fig. 13 Damage to concrete bridges; type and extent

The few defects that do occur can be broken down into the following types of damage, which have been found with the following frequency in one Federal Land during main inspections (according to standard DIN 1076) (Fig. 13):

- open reinforcement, rusting	17 %
- hollows/defects in the concrete of the superstructure	13 %
- cracks of more than 0.2 mm width in the superstructure	11 %
- damage due to de-icing salt along footpaths	14 %
- surfacing cracked, deformed	32 %
- joints in kerbs leaky	31 %
- waterproofing defect	21 %
- rails and posts rusting; sealing compound defect	58 %
- drainage intakes blocked	27 %
- bearings defect	14 %
- substructures: concrete deterioration, cracks	27 %

These figures refer in each case to 100 inspected bridges, but they do not say anything about the extent and the degree of the damage, and are therefore limited in their statistical value.

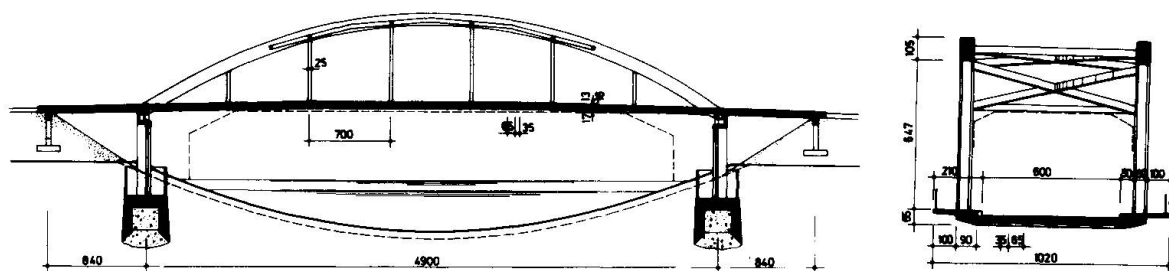
Fig.1 Bridge "A", general arrangement

Bridge A (Fig.1) is from an older generation of prestressed bridges in Yugoslavia, classified into a group for detailed control. The low building height induced the solution of the arch system above the prestressed two-way ribbed deck structure, being a tie at the same time. Suspenders are precast and prestressed. Such solutions are abandoned today. The arch is not indicated for small spans, and the conception with a suspended deck is a forced solution and belongs to the past.

During the detailed surveying vertical cracks almost on all suspenders were observed. In view of the vital significance of these members, possible causes of deterioration, the actual state and the necessity of interventions were analysed in detail. The results of the examination of concrete showed that the required

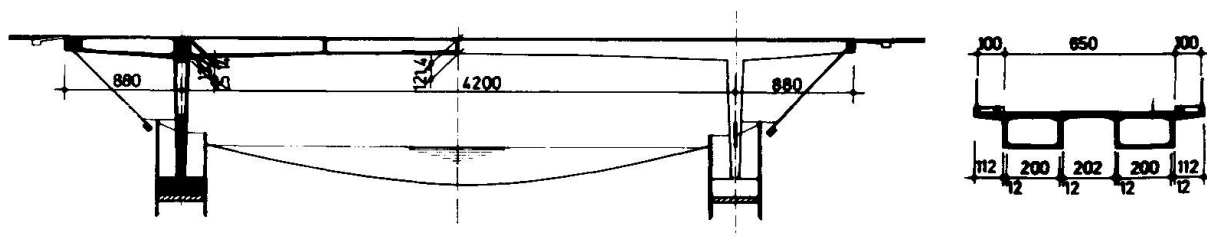
Fig.4 Bridge "B", general arrangement

In a detailed examination of the bridge, it was established that the cracks of the main girder above the medium supports, registered and injected already during the inspection of quality of work (20 years ago), were 0.1 - 0.3 mm wide and were still effective. Also, cracks were discovered in the central part of the middle span in the lower zone of the upstream box, as well as vertical cracks on the walls of piers through which cables were embedded. By detailed examination and analysis it was found that vertical cracks of piers were the result of the low percentage of reinforcement, particularly of transverse one. Cracks of the main

girder in the central part of the span indicated a far more serious situation, also after heavy vehicles crossings the bridge, it vibrated for a long time. As during the bridge construction openings for box inspections were not left, they were now immediately made. On entering the upstream box, the surprise was not small. One of the four groups of all bridge cables running directly close to the pier, was almost completely broken due to corrosion (Fig.5). Although cable protection, practically along the whole length, was well and efficiently carried out, above the pier, where cables entered the carriageway slab (Fig.6), there was a small zone in which the cable protection could not be efficiently performed. However, the absence of waterproofing and the appearance of cracks in the carriageway slab were enough to produce serious damage which was discovered late, but still on time.

The bridge, because of seriously jeopardized stability, was excluded from traffic and rehabilitated according to a particular design. Cables of the girder were completely replaced, and supports were formed at either end of the bridge, so that the system for live load was transferred into a continuous frame with three spans. Cable replacement was made without a special falsework by temporary underpinning of the main girder by external cables.

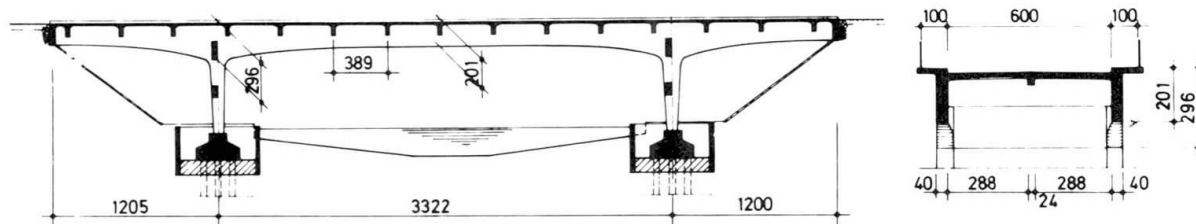
Fig.7 Bridge "C", general arrangement

Bridge C (Fig.7), across the channel, is a reinforced concrete skew frame with cantilevers. It was reconstructed during World War II on the modified foundations of a destroyed, similar bridge from 1939. The bridge conception, with comparatively large cantilevers and considerable deflections at the ends, with a small width of the carriageway, with steep bridge approaches in sharp horizontal curvatures and without transition slabs, does not correspond to the contemporary principles of bridge construction and to the conditions of today's traffic.

This fact required an urgent intervention. Opposite to the author's opinion that the best solution was to construct a new bridge, nevertheless, for certain reasons (of administrative nature) it was concluded to rehabilitate the existing bridge. The old carriageway slab was removed and a new one made (Fig.9). The connection

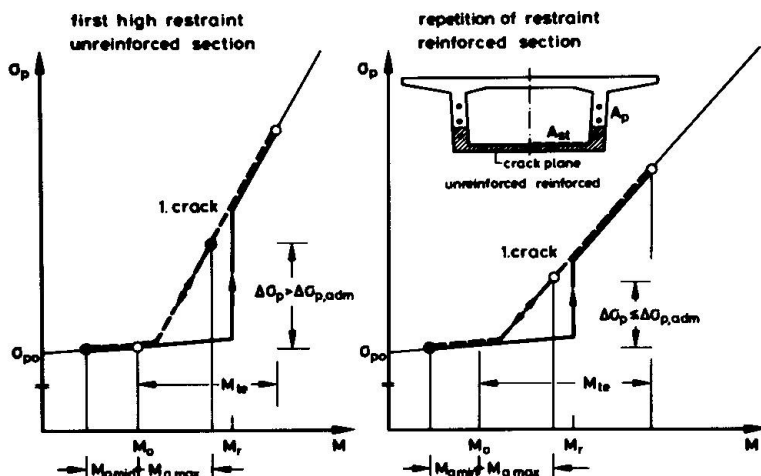
Fig. 1 Efficiency of bonded steel plate strengthening with respect to fatigue stresses in prestressing steel of joint

The efficiency of the bonded steel plate reinforcement with respect to fatigue stresses in the prestressing steel is shown by Fig. 1. The base moment M_0 is superimposed by the moment M_{te} of the first high thermal restraint. Thereby, the cracking moment M_r is transgressed. The moments due to traffic loads cause a fatigue stress range $\Delta\sigma_p$ which exceeds the stress range in the uncracked section. After strengthening of the section the slope of the steel stress-moment-curve will be diminished. Thus, by choice of a suitable cross-section of steel plate the stress range may be reduced to the admissible value as predetermined by acceptance tests.

The repair of cracks in joints by epoxy resin injection alone is not a sufficient countermeasure because the highly probable repetition of thermal restraint may cause either new cracks or the opening of injected cracks. Therefore, besides crack injection also additional reinforcement - provided for by the bonded steel plates - is necessary to reduce the amplitude of fatigue stresses and the crack widths as well.

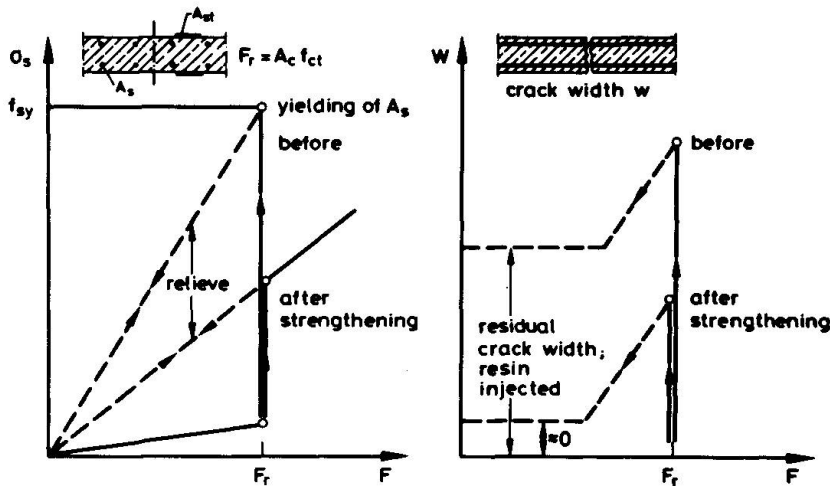
Fig. 2 Influence of strengthening on the steel stress of the reinforcement and on the crack width

The efficiency of the additional reinforcement with respect to the steel stress of the regular reinforcement and to the crack width is depicted in Fig. 2. Due to the steel plate the steel stresses are relieved once a new crack is formed by repetition of restraint. After strengthening, both reinforcement and steel plate operate in the elastic range, thus, contracting the widths of possible new cracks without virtual residue.

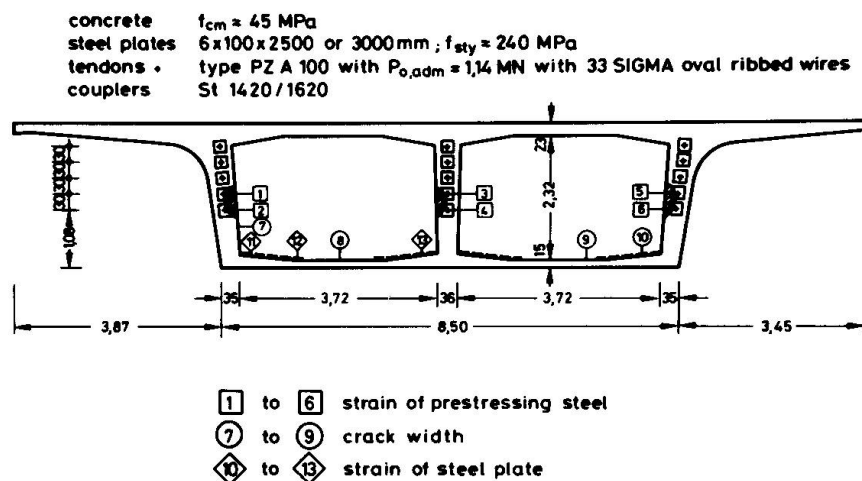
Fig. 5 Cross-section of bridge and other data

bridge consists of two separate superstructures with box sections as shown by Fig. 5. It is continuous over 7 spans of 40 m each. It was built spanwise with all of the 15 tendons being coupled at the joint near the points of contraflexure. In all working joints the bottom slab was cracked; the crack plane extended into the webs, passing the lower couplings. The necessary cross-section of the bonded steel plate reinforcement was chosen to reduce the calculated stress-range of the prestressing steel in the coupling to the admissible value of the prestressing system. The arrangement of the plates is depicted in Fig. 5. The length of the plates was chosen to cover the region of possible concrete tensile stresses at the bottom due to repeated restraint and other actions.

The work on site consisted of several steps. Firstly, the cracks were injected with an approved epoxy resin. Then, the top surface of the bottom slab had to be prepared by vacuum grit blasting and by a shaper to the desired planeness. The grit blasted steel plates were glued to the concrete piecewise and pressed down by plane and stiff wooden distributing beams for the first 24 hours. Local deviations from the desired planeness of the concrete surface can be tolerated: they can be evened-out with thicker layers of glue (≤ 10 to 15 mm). It is very important that the steel plates remain straight; tests have shown that transverse

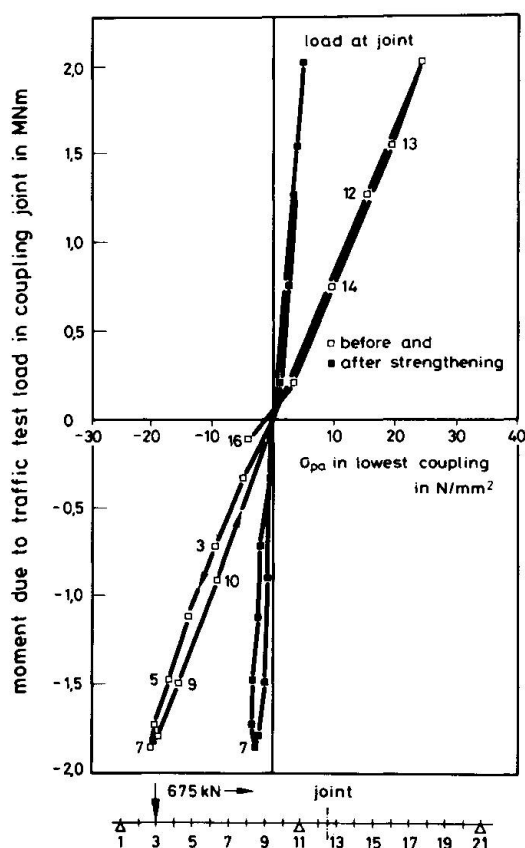
Fig. 6 Stress amplitude of prestressing steel of the lowest coupling, depending on test load moment

In order to assess the efficiency of the strengthening extensive on-site tests were performed prior and after strengthening. The test loading was executed with three 22,5 tons lorries which travelled along the bridge in different patterns. Fig. 6 shows the stress amplitude of the prestressing steel at one of the lowest couplings as a function of the moment at the joint due to the lorries travelling side by side. The stress amplitude is dramatically reduced proving the desired efficiency of the chosen strengthening method. The design loads will cause greater moment amplitudes, however, the admissible stress range of $\Delta\sigma_p = 55 \text{ N/mm}^2$ will not be transgressed. The complete results will be published soon.

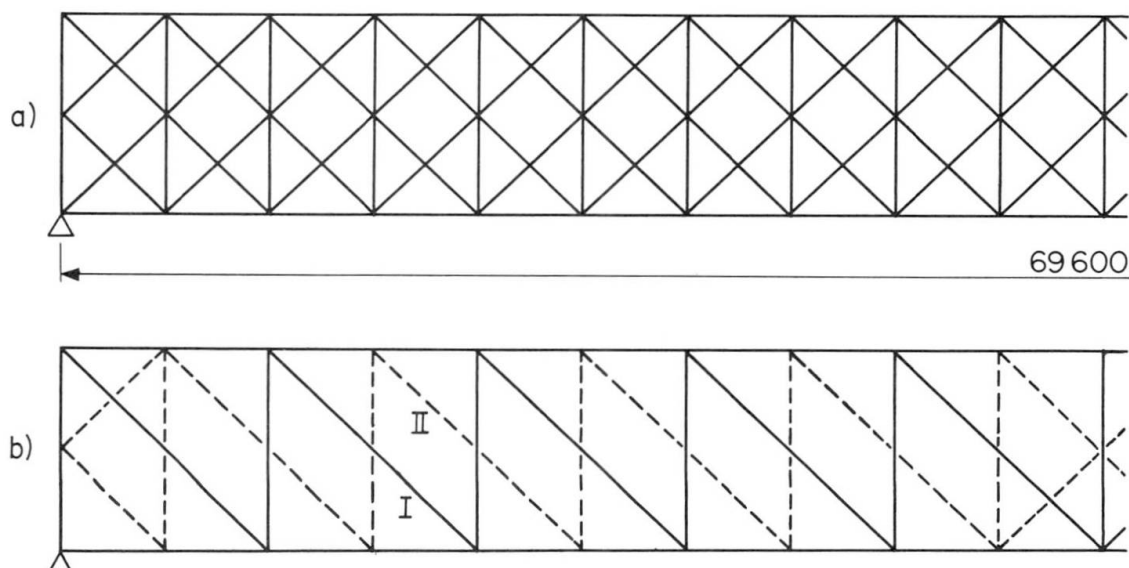
Fig. 3 Ausfachtung im unterkritischen a) und im überkritischen b) Knickbereich

Fig. 3a zeigt die Ausfachtung der Aussenträger, mit vier Streben in jedem Vertikalschnitt. Die Stabkräfte wurden elektronisch bestimmt, wobei einerseits die Biegesteifigkeit der durchgehenden Gurte und der Endpfosten, andererseits die Exzentrizitäten infolge der veränderlichen Anzahl Lamellen berücksichtigt wurden. Dagegen betrachtet man die Strebenanschlüsse als gelenkig und führt deren Kreuzungspunkte nicht als gemeinsame Knoten ein.

Bei der Bestimmung der Knicklänge der Druckstreben wurde berücksichtigt, dass diese Stäbe in ihrer Mitte durch die in Fig. 2 abgebildeten K-Verbände seitlich gehalten sind und zudem in den Viertelpunkten durch die Zugdiagonalen elastisch gestützt sind. Die Ausbildung als aussenliegender Doppelwinkel bedingt allerdings Exzentrizitätsmomente, welche den Knickwiderstand abmindern. Die Sicherheit beträgt somit nur ca. 1,4.

Zu Beginn des Knickvorganges nehmen aber die Druckstreben ihre Traglasten weiterhin auf, so dass nur die darüber hinausgehenden Querkräfte (entsprechend 1,8 - 1,4 als Sicherheitsmass) einem überkritischen Tragsystem zuzuweisen sind: es handelt sich um ein doppeltes Ständerfachwerk (Fig. 3b) mit den gleichen Zugdiagonalen wie in der unterkritischen Ausfachung (Fig. 3a) und mit den Druckpfosten, die im primären System nur wenig beansprucht sind und daher genügende Tragreserven besitzen. Auch hier wirken sich die neuen K-Verbände bezüglich des Knickens der Ständer aus der Ebene günstig aus. Was die Zugstreben anbelangt, so genügen sowohl die Querschnittsflächen als auch die Nietanschlüsse. Da die Ausfachung II nach Fig. 3b als K-Feld endet, musste die entsprechende Druckstrebe leicht verstärkt werden.
