Artikel: Case stories of dolphin accidents and remedies
Autor: Naoi, Yoshiaki / Ishikawa, Toshiyuki
DOI: <https://doi.org/10.5169/seals-32401>

Case Stories of Dolphin Accidents and Remedies

Yoshiaki NAOI

The report outlines recent ship collision accidents with dolphins in Iwakuni, Japan and their remedies.

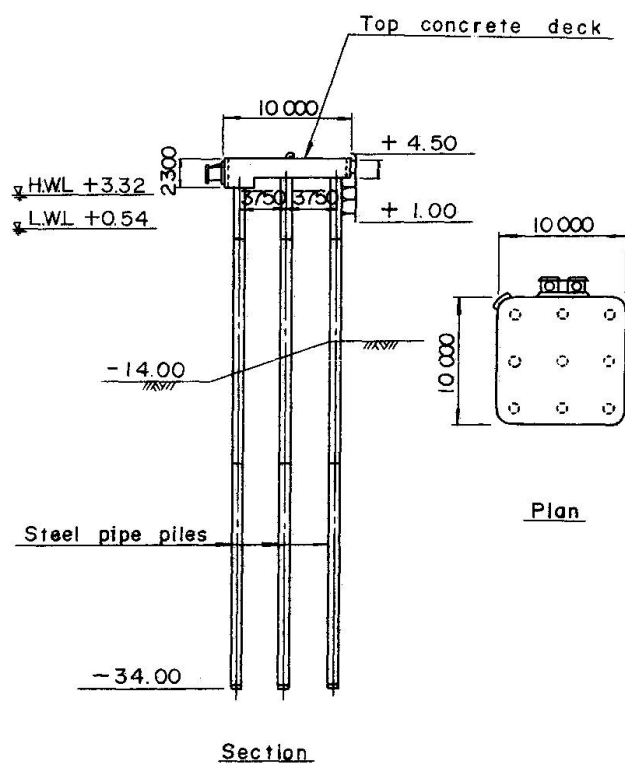
Fig.2 Structure of Dolphin B-3

As shown in Fig.2 the Dolphin B-3 consists of 9 steel pipe piles (914.4 mm in diameter, 16.0 mm in thickness, and 41.5 m in length) and the top concrete deck. The structure has the flexibility to absorb the kinetic energy of ship berthing for an approaching velocity of 15 cm/sec. That is, the resisting capacity against impact is maintained by the mutual effect between the rigidity of the steel pipe piles and the viscoelasticity of the foundation strata.

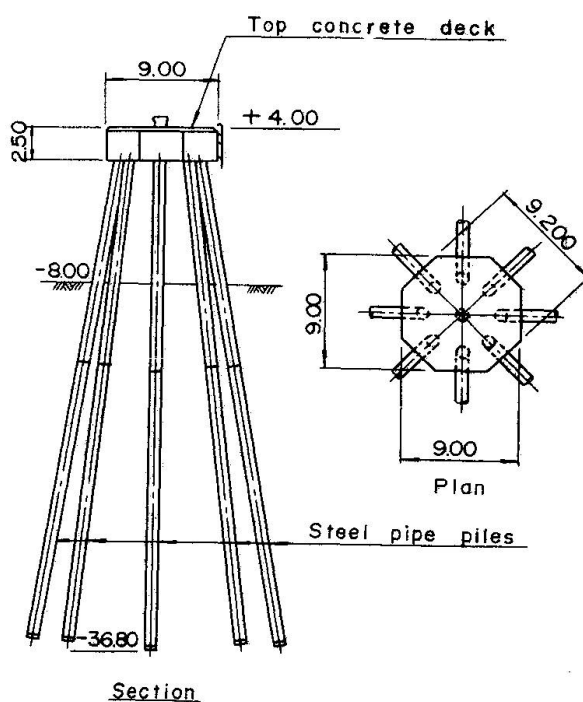
Fig.3 Structure of Dolphin M-1

In the structure of the Dolphin M-1, 9 steel pipe piles (609.6 mm in diameter, 12.7 mm in thickness, and 40.5 m in length) composed of 8 radial battered piles and 1 vertical pile are rigidly connected with the top concrete deck. This mooring dolphin has a rigid structure in contrast with the breasting dolphin, that is, the static load worked through mooring ropes is borne by the structure so that a ship can keep a certain distance with the berth.
