Artikel: Case stories of dolphin accidents and remedies
Autor: Naoi, Yoshiaki / Ishikawa, Toshiyuki
DOI: <https://doi.org/10.5169/seals-32401>

Case Stories of Dolphin Accidents and Remedies

The report outlines recent ship collision accidents with dolphins in Iwakuni, Japan and their remedies.

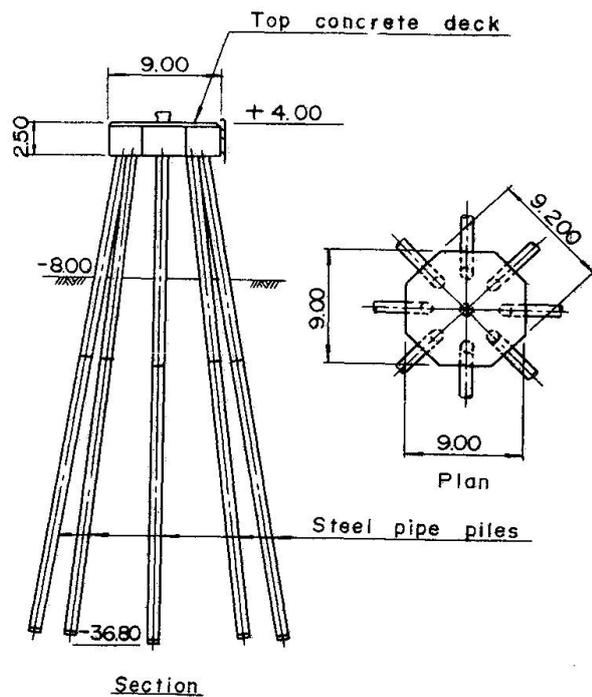
Fig.3 Structure of Dolphin M-1

In the structure of the Dolphin M-1, 9 steel pipe piles (609.6 mm in diameter, 12.7 mm in thickness, and 40.5 m in length) composed of 8 radial battered piles and 1 vertical pile are rigidly connected with the top concrete deck. This mooring dolphin has a rigid structure in contrast with the breasting dolphin, that is, the static load worked through mooring ropes is borne by the structure so that a ship can keep a certain distance with the berth.

An opening made by the collision was found at the junction of the top concrete deck with the steel pipe piles. This opening was 20 cm at its maximum in a direction of north-west. At the same time a wedge from the shearing force (1.6 m in width, 0.2 m in height, and 0.4 m in depth) appeared in the concrete deck.

Upon measuring the deformation of the central vertical pile in three directions, the maximum displacement of 25 cm was observed in the direction of south-east. (See Fig.6)
