Artikel: Vulnerability of Norwegian bridges across channels

Autor: Tambs-Lyche, Per

Vulnérabilité des ponts enjambant des canaux de navigation, en Norvège Verwundbarkeit von Wasserstraßen überquerender Brücken in Norwegen

Per TAMBS-LYCHE Director Bridge Division Public Roads Administration Oslo, Norway

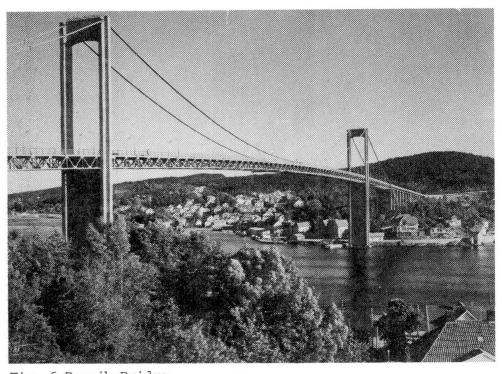
Fig. 6 Brevik Bridge

The southern tower of the main span has been regarded as vulnerable to the shiptraffic taking place through the channel. The navigational conditions are not the best ones through the shallow, narrow and tidal waters of the inlet, though certain equipment with regard to surveillance of the ships concerned has been in operation for some time.

The bottom girder of the stiffening truss was locally bent without causing serious damage to the structure. Hence the bridge was open to one lane traffic througout the replacement operation of the girder and bracings.
