Zeitschrift: IABSE reports = Rapports AIPC = IVBH Berichte

Band: 42 (1983)

Rubrik: Theme A: Case stories of recent ship collision accidents

Case Stories of Recent Ship Collision Accidents
Rapports d'accidents de collisions de bateaux
Fälle von neueren Schiffskollisionen

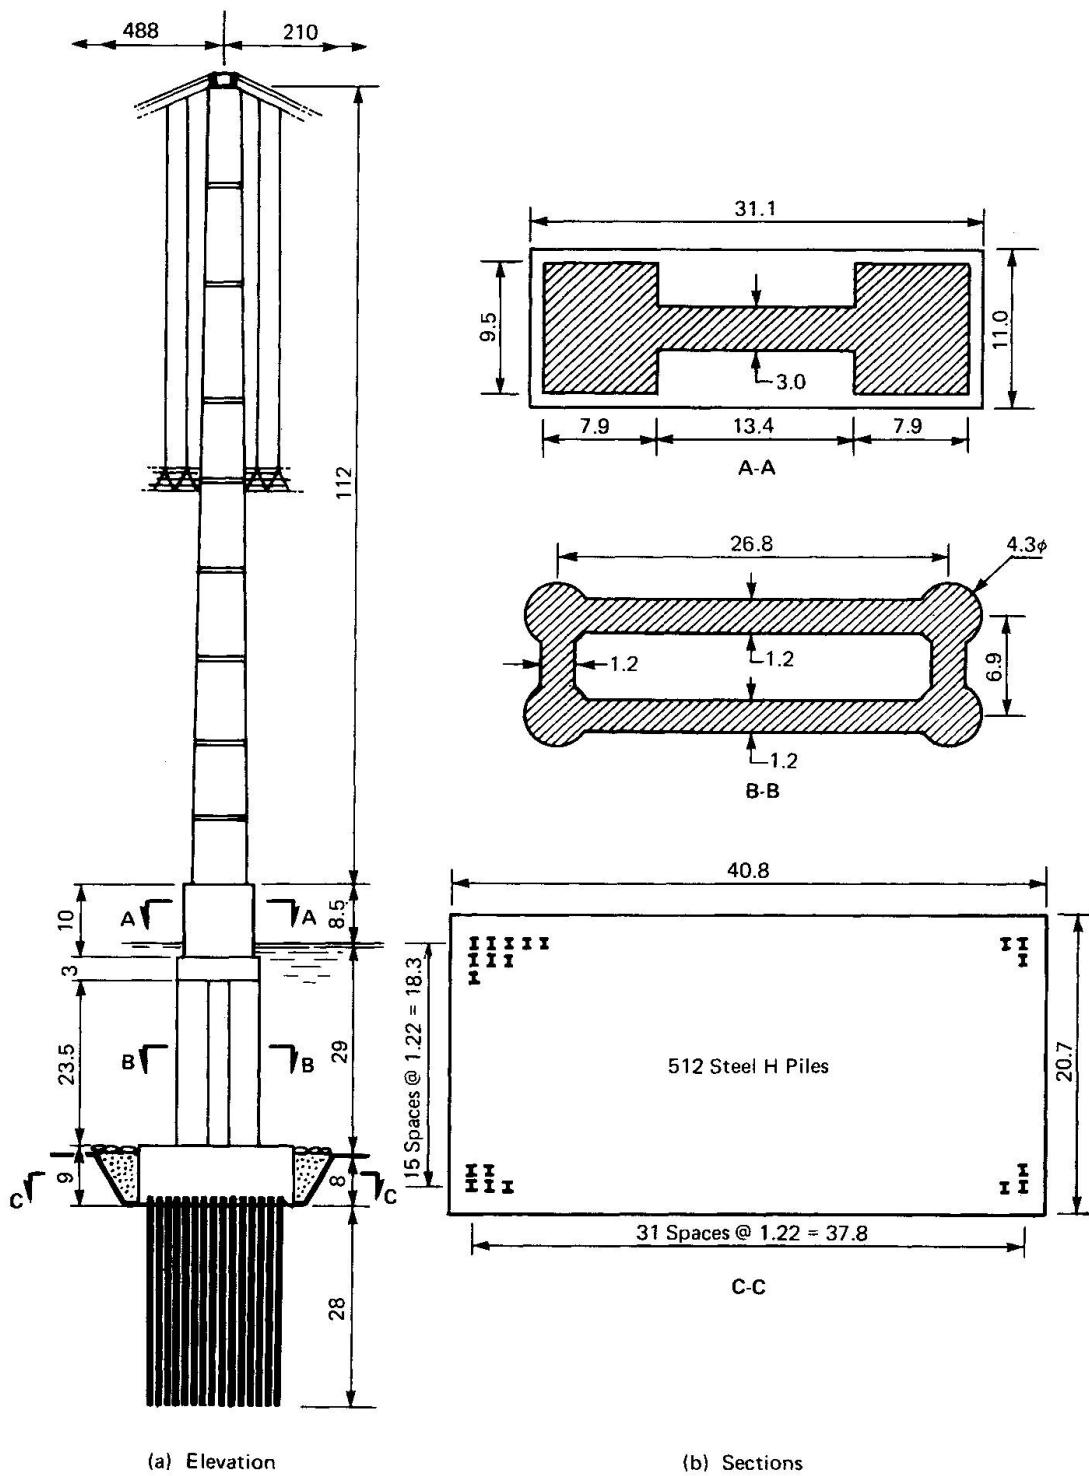
Fig. 5. Details and dimensions of pier.

Details and dimensions of the pier are shown in Figs. 5a and 5b. The dead weight of the pier (neglecting 12,000 tons buoyancy) is 32,000 tons, and the superstructure reaction to the pietop is an additional 11,000 tons.

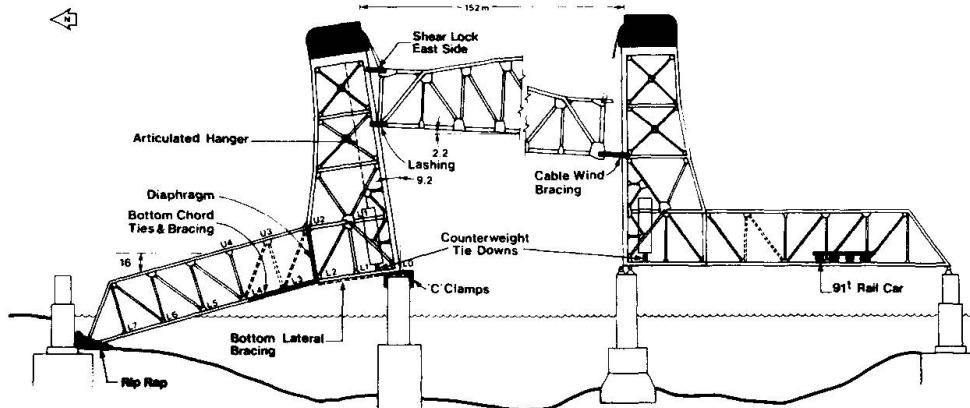
Figure 2

The initial appraisal of damage indicated a dramatic series of instantaneous failure mechanisms. The severe damage was limited to the bottom chord and web system between panel points (p.p.) L2 and L4 (see Fig. 2 for p.p. numbering). This damage permitted the remaining portion of the span to rotate against a plastic hinge which formed in the top chord at U2. An examination of the point of impact of the vessel at L3 failed to show any vertical striations in the paintwork indicating the explosive suddenness of the lateral displacement. Except for one member in the immediate area of impact, the top lateral system was undamaged, as was the portal bracing system.

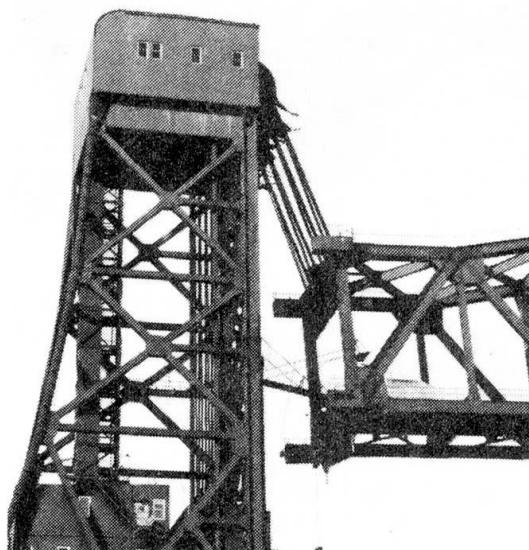
Figure 3

The tower lost substantial support as the bearings were displaced to the extent that they were partially projecting over the N.E. and S.W. edges of the main pier. In this precarious state of equilibrium the lift span, which had been torn from the vertical tower guides (Fig. 3) was left hanging, hammock-like, from the lift ropes.

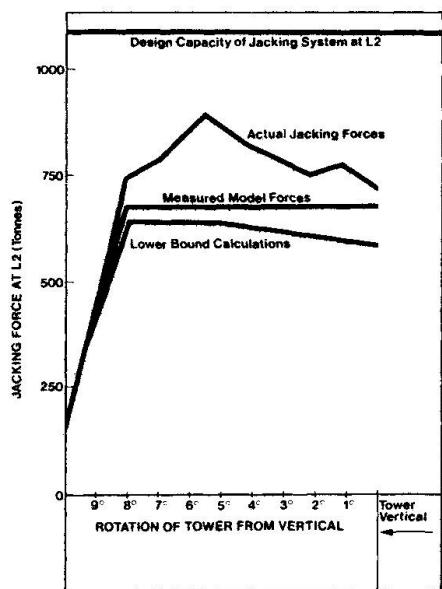
Figure 4 shows the accuracy that the various analyses achieved by plotting the jacking forces at L2 as the tower rotated to the vertical. The lower bound calculations were derived from measured forces and theoretical analysis and, as can be seen, are very close to the forces predicted by model analysis.

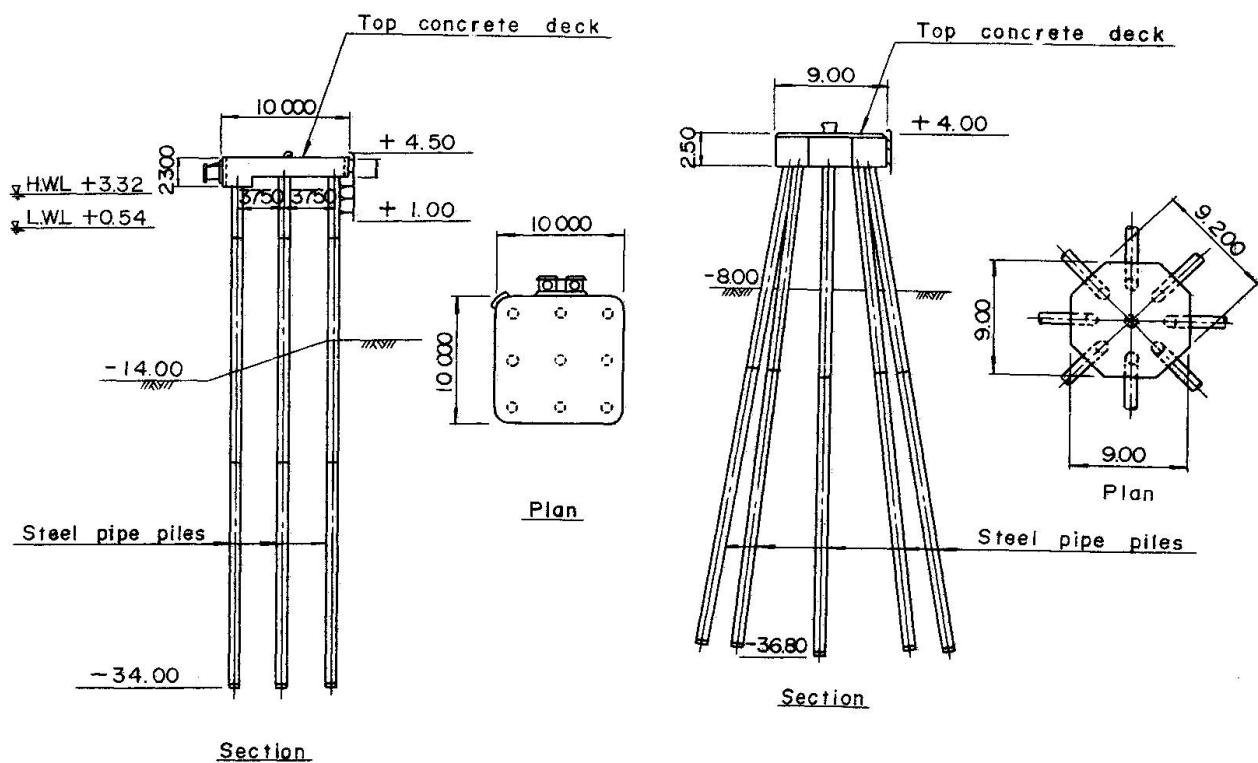
Fig.2 Structure of Dolphin B-3

The north sub-breasting dolphin (B-3 in Fig.1) was damaged in the first collision in 1978, and the south mooring dolphin (M-1 in Fig.1) was again damaged in 1979.

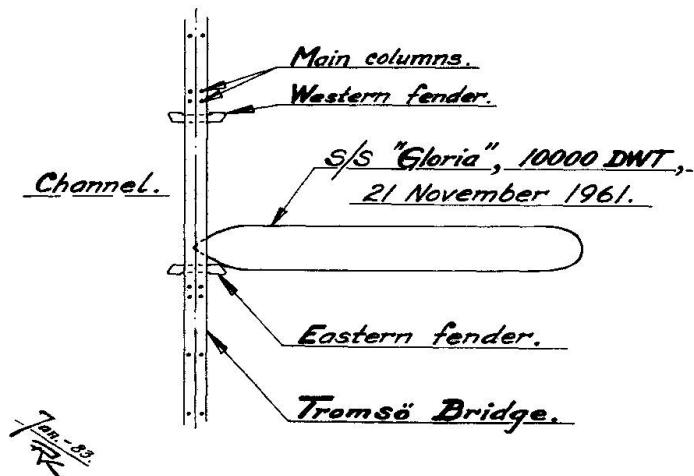
Fig. 3 Tromsø Bridge:
Collision, November 1961.
Dimensions of ship,
channel and fenders.

On the 21 November 1961, the 10 000 dwt. S/S "Gloria" ran into the eastern fender. The fender slab above the water as well as most of the concrete piles carrying the slab were completely destroyed and ended on the bottom of the sea. Fig. 3 shows the dimensions of the ship, the channel and the fenders.
