Zeitschrift:	IABSE reports = Rapports AIPC = IVBH Berichte				
Band:	42 (1983)				
Dubrile	Theme A. Coop staries of recent chip collicies assidents				
RUDIK:	I neme A: Case stories of recent ship collision accidents

Case Stories of Recent Ship Collision Accidents Rapports d'accidents de collisions de bateaux Fälle von neueren Schiffskollisionen

Ship Collisions with Danish Lighthouses Collisions de navires avec des phares danois Schiffskollisionen mit dänischen Leuchttürmen

Newport Bridge Collision Collision au pont de Newport Newport Brückenzusammenstoß

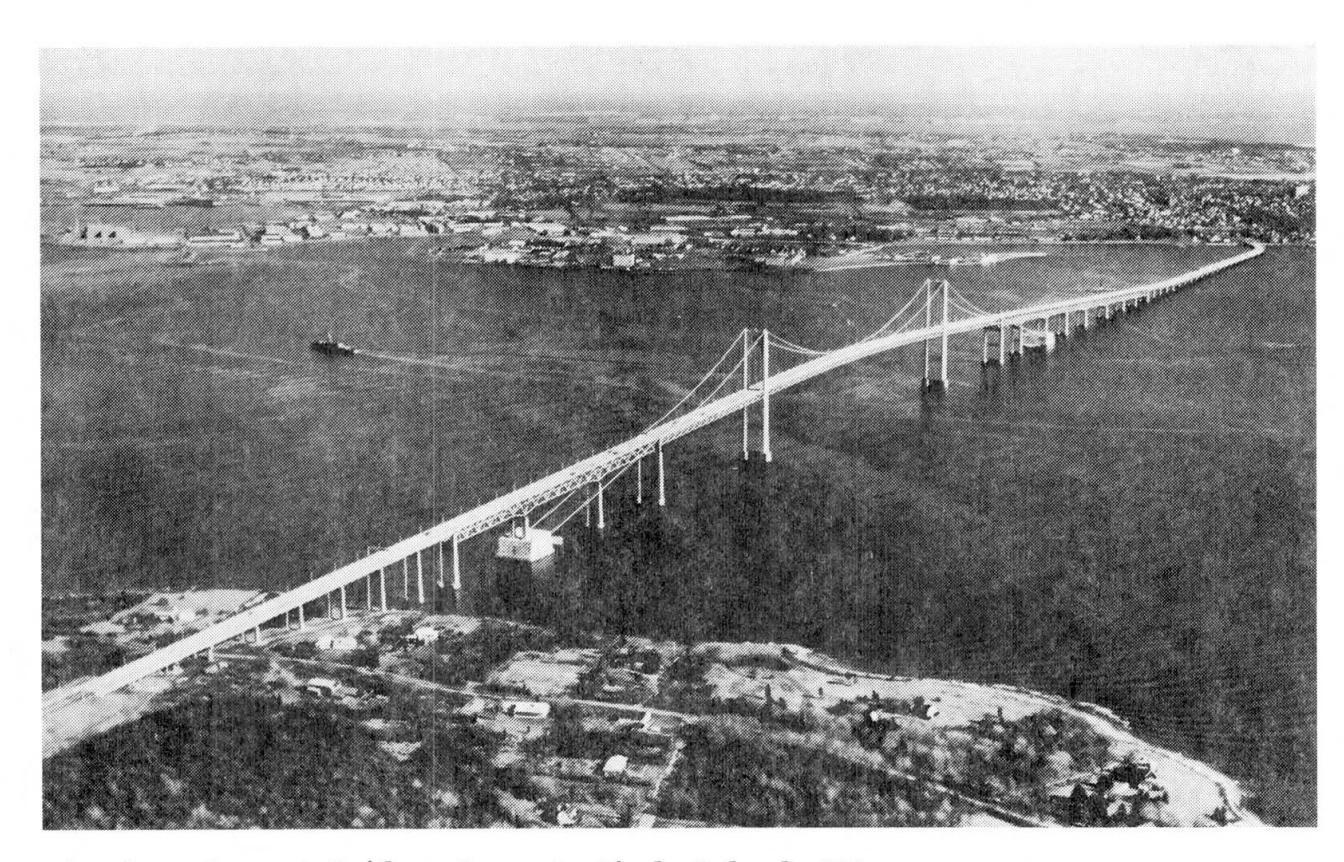
Fig. 1. Newport Bridge, Newport, Rhode Island, USA.

Shortly after noon on February 19, 1981, the bridge was struck by the tanker Gerd Maersk, which was proceeding up the bay toward Providence. The ship was fully laden with a cargo of fuel oil, and displaced 45,000 (metric) tons at the time of the accident. Navigating in a dense fog, the pilot had no warning

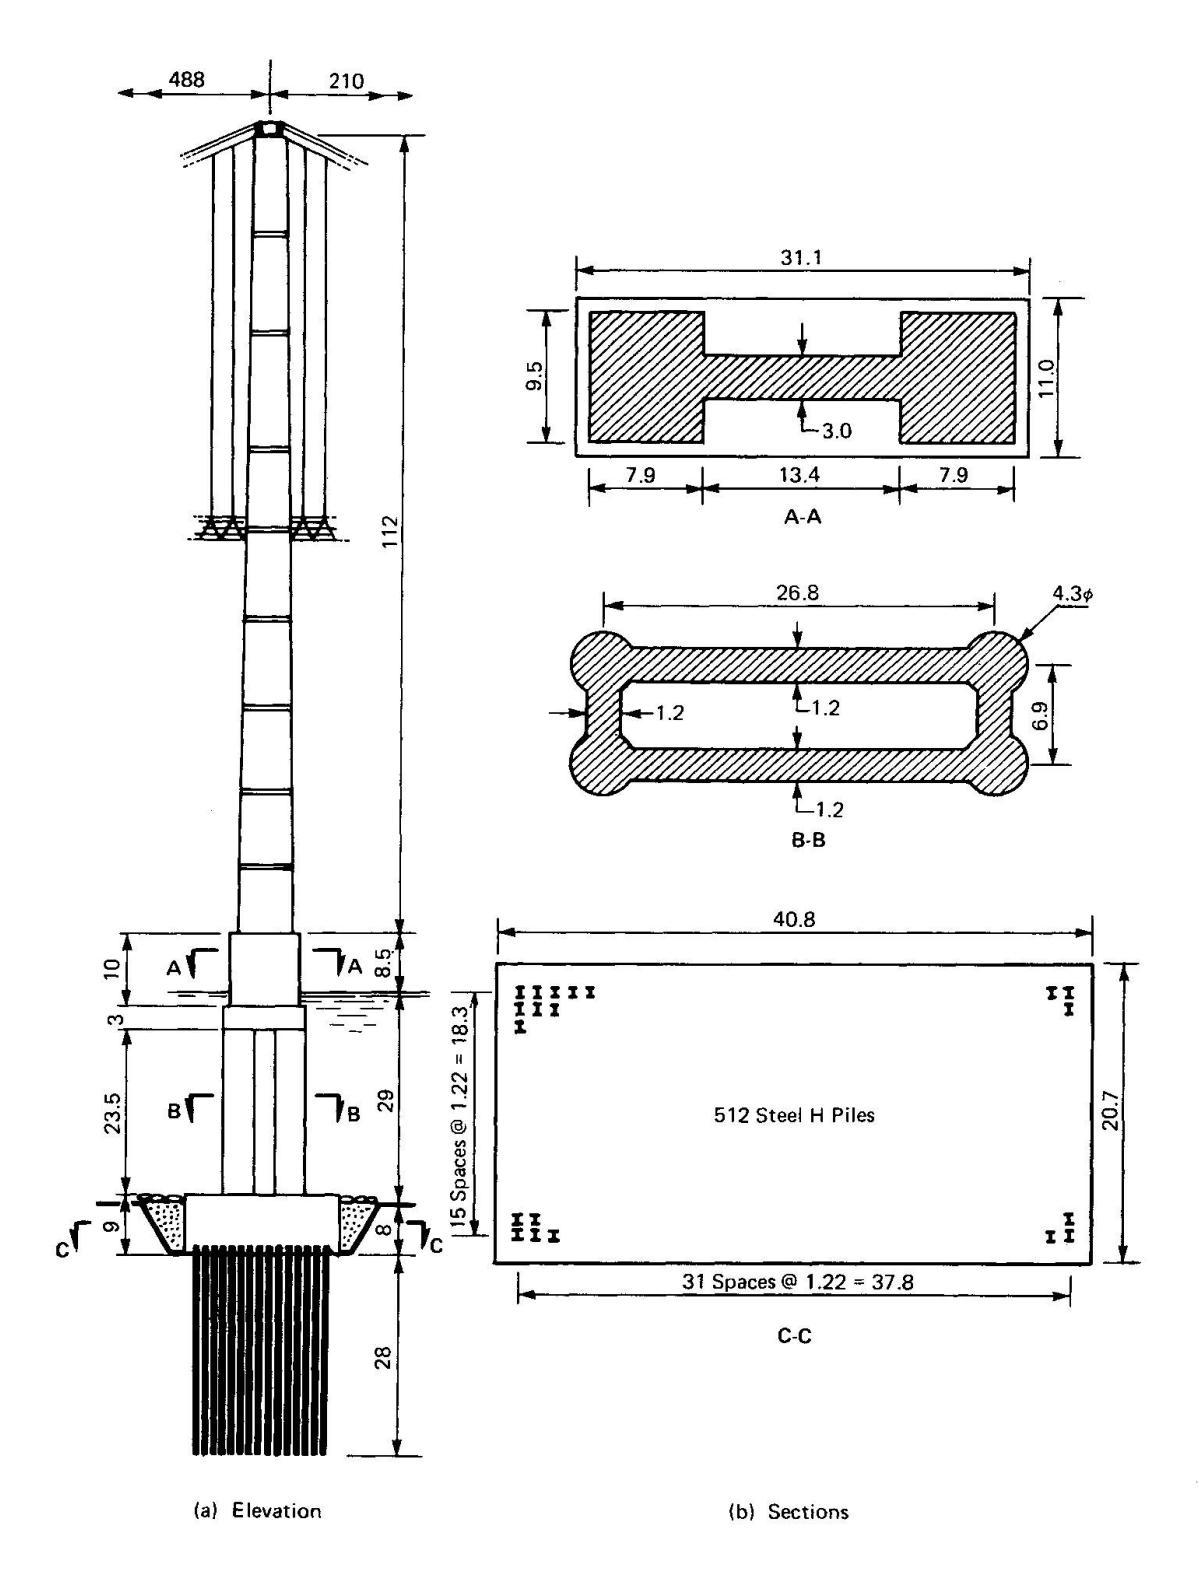
Fig. 5. Details and dimensions of pier.

Damage to the bridge was negligible. The pier suffered no displacement or rotation, and there was no misalignment of the roadway deck joints or any other superstructure elements. The side of the pier suffered extensive surface scrapes, gouges, and spalls of the concrete (Fig. 3) to a depth of 2 to 5 cm over an area roughly 7 m wide by 20 m high, approximately equally above and below the water line (Fig. 4).

There were a number of superficial tears in steel plating of the underwater caisson structure, but no damage to the concrete behind the plating. A spectacular blotch of gray paint decorated the side of the pier for several days before falling off.

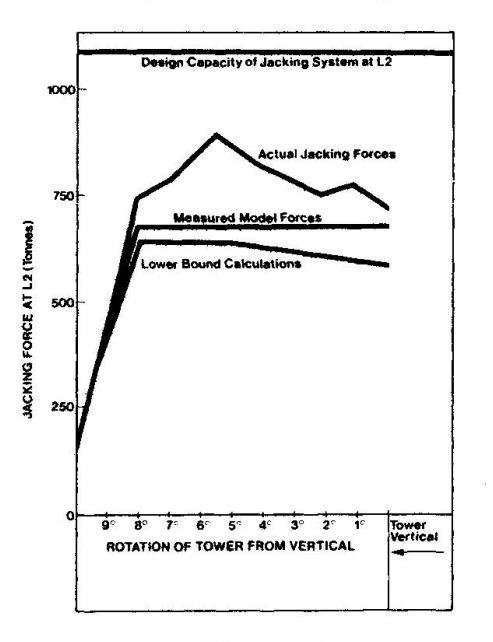
Figure 4 shows the accuracy that the various analyses achieved by plotting the jacking forces at L2 as the tower rotated to the vertical. The lower bound calculations were derived from measured forces and theoretical analysis and, as can be seen, are very close to the forces predicted by model analysis.

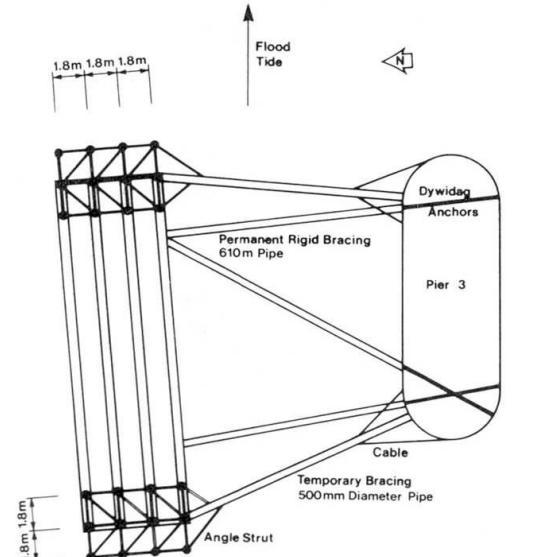
Figure 6

7 Figures 6 show the final and configuration of the L2 bent. The table beside Figure 7 lists the variety of

oscillations observed in the bent during construction. The amplitudes in most cases are visual estimates and therefore, are not too accurate. The measurement that is guaranteed, however, is the Stage 1 plus or minus 900 mm value. In this case the piles were driven at 1800 mm centres and during oscillations actually made contact with each other. Tidal flow and frequency were Vibrations only occurred for about 1 to 2 hours during accurately measured. every other tide during a two week period. It was unfortunate that the construction schedule did not fully coincide with the tidal cycle. Attempts to damp out the oscillations with ropes attached to the piers were unsuccessful. It was fortuitous that the oscillations almost always occurred after the dayshift was complete (7 p.m. to 9 p.m.) or before it started (3 a.m. to 5 a.m.) and work could always continue on bent completion during daylight hours with no oscillations. The Stage II oscillations came as a considerable surprise since group oscillation was considered to be unlikely. The east pile group survived the first set of oscillations, but top bracing of the west group was partially destroyed and was subsequently re-installed.

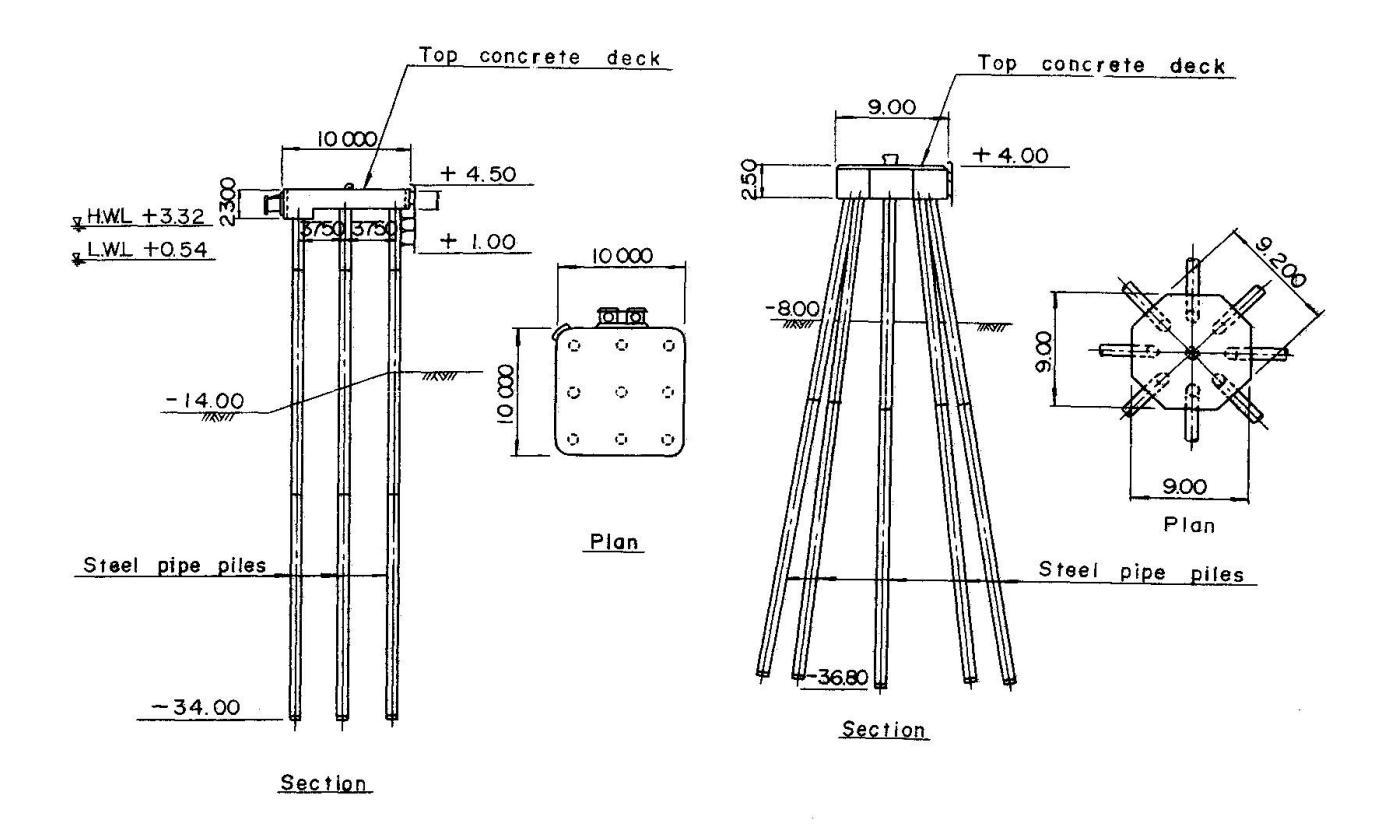
Fig.2 Structure of Dolphin B-3

In the structure of the Dolphin M-1, 9 steel pipe piles (609.6 mm in diameter, 12.7 mm in thickness, and 40.5 m in length) composed of 8 radial battered piles and 1 vertical pile are rigidly connected with the top concrete deck. This mooring dolphin has a rigid structure in contrast with the breasting dolphin, that is, the static load worked through mooring ropes is borne by the structure so that a ship can keep a certain distance with the berth.

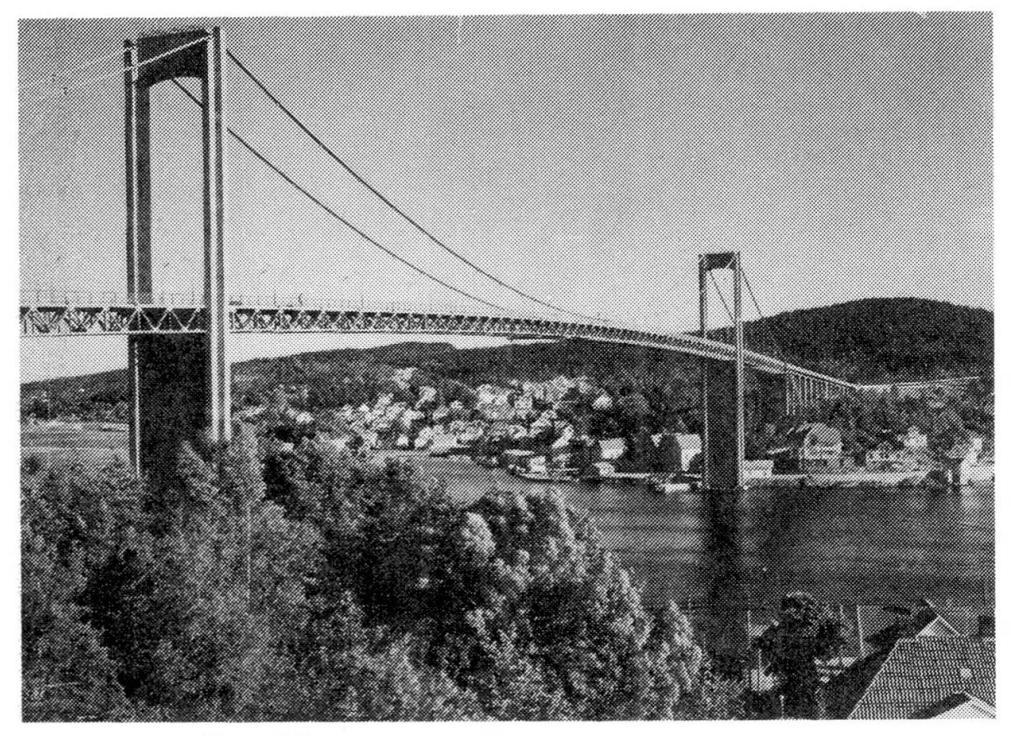
Fig. 6 Brevik Bridge

The 677m long structure consists of suspended main- and sidespans of 272m and 85m respectively in addition to 16 viaducts. Fig. 6.
