**Zeitschrift:** IABSE reports = Rapports AIPC = IVBH Berichte  
**Band:** 42 (1983)

**Rubrik:** Theme A: Case stories of recent ship collision accidents

### **Case Stories of Recent Ship Collision Accidents**

## Ship Collisions with Danish Lighthouses

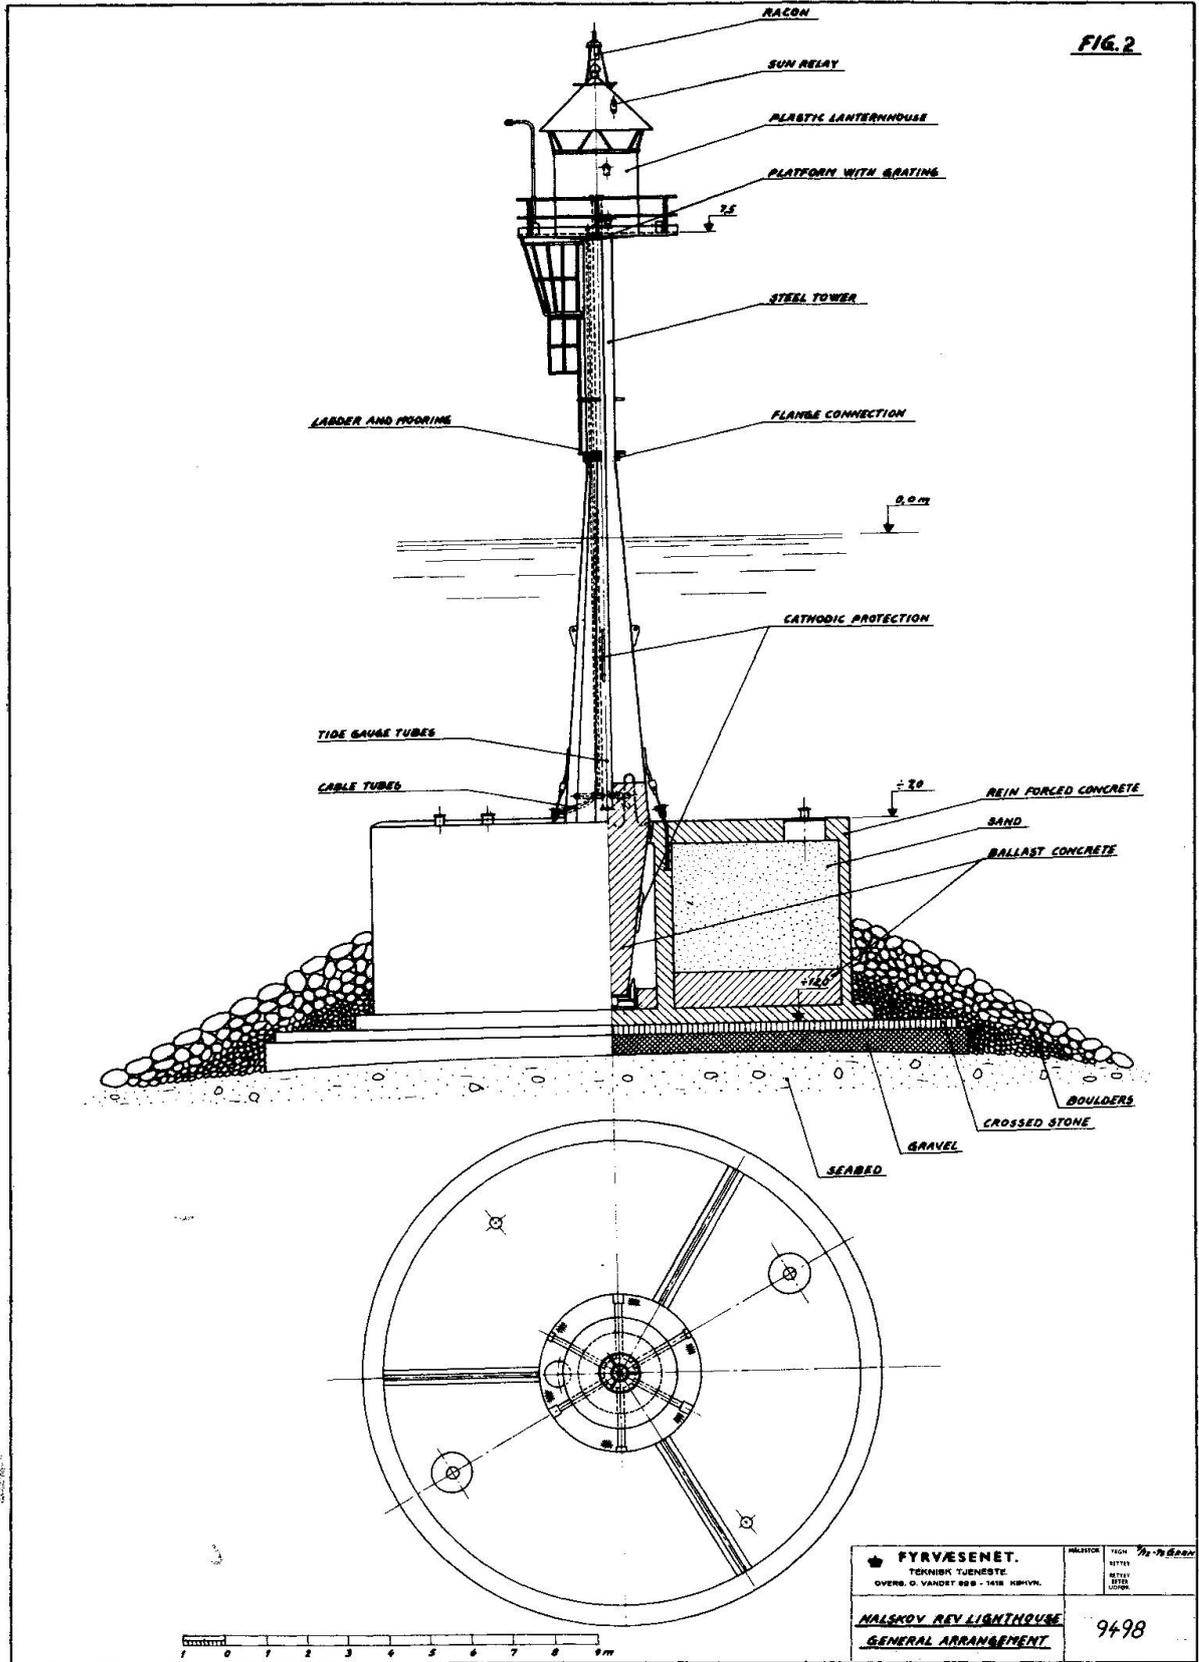
**Fig. 2** Lighthouse. General arrangement

The lighthouses have been designed in such a way that if they are run into, damages to the ship should be as insignificant as possible, as this would be less costly, less dangerous to the crew, and reduce the risk of oil pollution.

In return, it has been necessary to carry a stock of various spare parts for the lighthouses, in order that following a collision they can be promptly re-established.

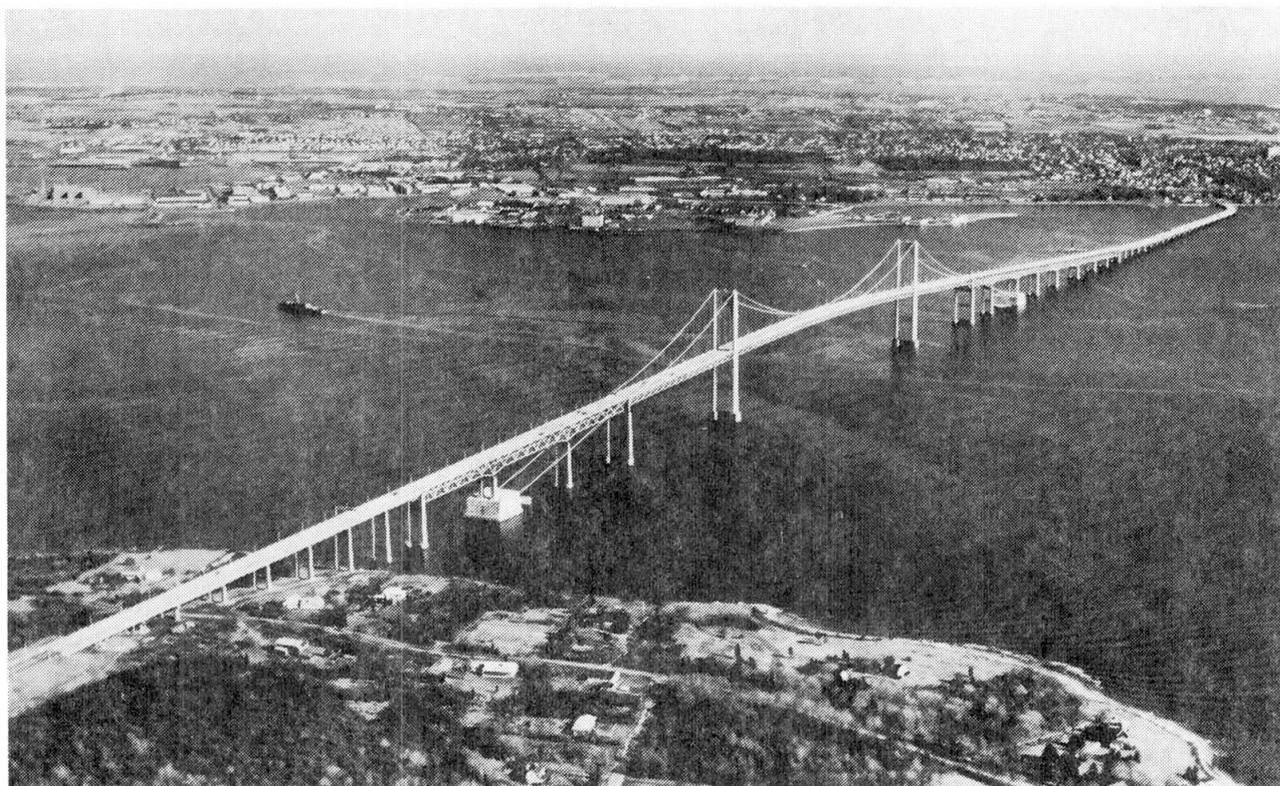
Fig. 1. Newport Bridge, Newport, Rhode Island, USA.

The Newport Bridge is approximately 3 km long, crossing the Eastern Passage of Narragansett Bay at Newport, Rhode Island (Fig. 1). The main shipping channel is bridged by a suspension span 488 m long, with a clear height of 66 m at the center of the channel. The water depth beneath the suspension spans ranges from 30 to 45 m. The tower piers are of "Potomac type" caisson construction, founded on steel H-piles driven into sands that fill the glacial gorge underlying the bay.

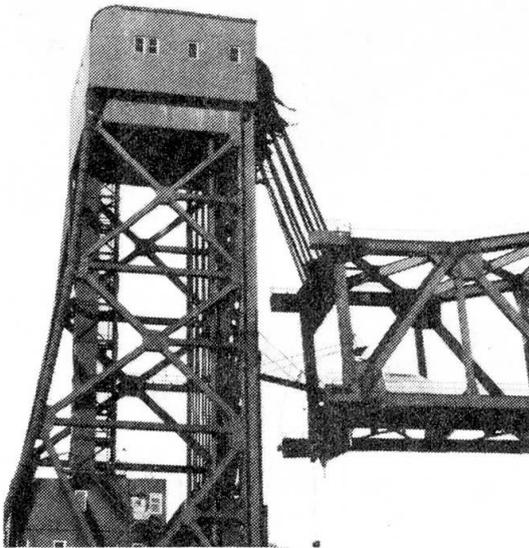
Figure 3

The tower lost substantial support as the bearings were displaced to the extent that they were partially projecting over the N.E. and S.W. edges of the main pier. In this precarious state of equilibrium the lift span, which had been torn from the vertical tower guides (Fig. 3) was left hanging, hammock-like, from the lift ropes.

Upon receipt of the instruction to undertake the work the Cannon engineering group directed their efforts toward the predominant need to stabilize the structure and to prepare recovery procedures. Stabilization included the immediate installation of wire rope diagonal bracing between the lift span and the south tower and shear devices between the lift span and the north tower. Concurrently with this work the north lift girder was stayed against further movement and the 1000t counterweight in the north tower was prevented from further downward movement by the installation of articulated platework hangers capable of carrying the total weight. Upward movement of north and south counterweights was prevented by the rigging of heavy down-haul tackle.

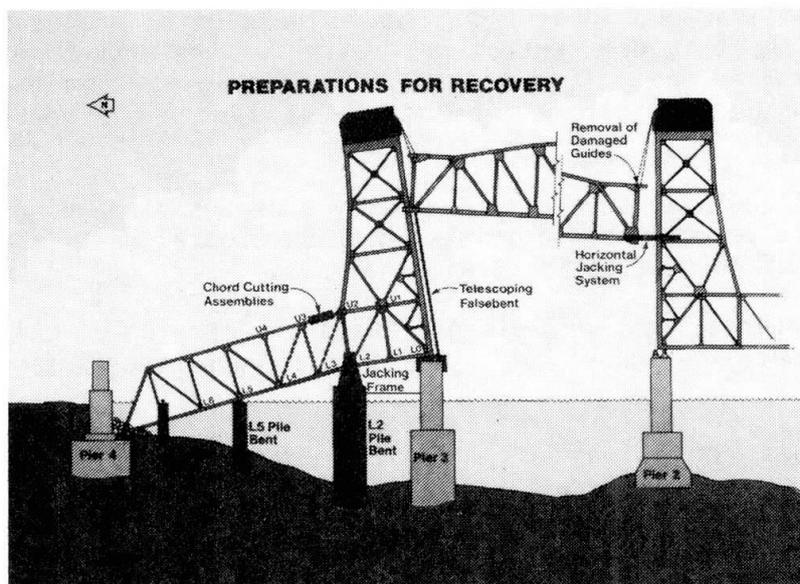
Figure 5  
severed truss span would rotate as it was raised to the horizontal for subsequent dismantling in large sections.

The philosophy of the recovery procedure envisaged isolating the lift span and tower from the partially submerged portion of the span.

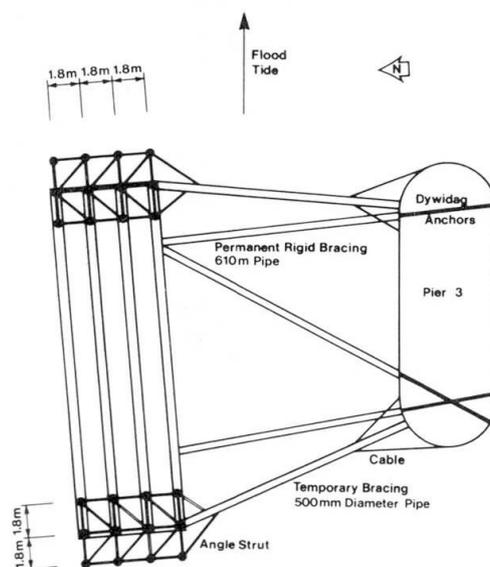
Figure 6

Figures 6 and 7 show the final configuration of the L2 bent. The table beside Figure 7 lists the variety of oscillations observed in the bent during construction. The amplitudes in most cases are visual estimates and therefore, are not too accurate. The measurement that is guaranteed, however, is the Stage 1 plus or minus 900 mm value. In this case the piles were driven at 1800 mm centres and during oscillations actually made contact with each other. Tidal flow and frequency were accurately measured. Vibrations only occurred for about 1 to 2 hours during every other tide during a two week period. It was unfortunate that the construction schedule did not fully coincide with the tidal cycle. Attempts to damp out the oscillations with ropes attached to the piers were unsuccessful. It was fortuitous that the oscillations almost always occurred after the dayshift was complete (7 p.m. to 9 p.m.) or before it started (3 a.m. to 5 a.m.) and work could always continue on bent completion during daylight hours with no oscillations. The Stage II oscillations came as a considerable surprise since group oscillation was considered to be unlikely. The east pile group survived the first set of oscillations, but top bracing of the west group was partially destroyed and was subsequently re-installed.

Temporary 500 mm dia. tube struts were installed from the bents to the piers which eliminated the violent crossflow vibrations but replaced them with plus or minus 76 mm in-line vibrations.

The jacking bent was completed as designed with 600 mm dia. pipe bracing and no serious vibrations were detected thereafter.

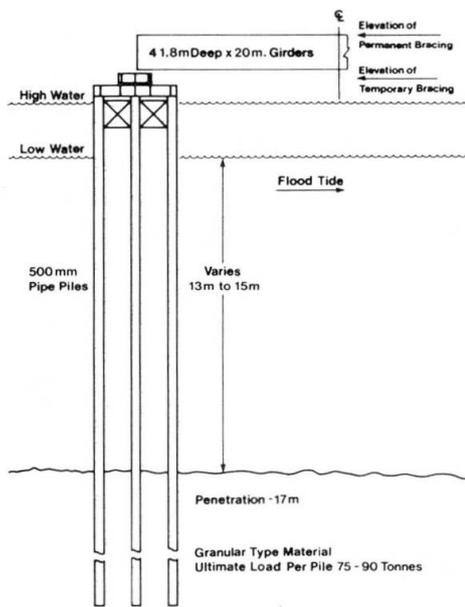
Figure 7

STAGE	HALF AMPLITUDE	DIRECTION	CYCLES/MINUTE	CURRENT (KNOTS)
I	900 mm	N/S crossflow	35	4 to 6
II East	220 mm	N/S crossflow	50	4 to 5
II West	450 mm	Do	35	4 to 5
III	75 mm	E/W in line	50	2 to 5
IV	75 mm	Do	50	2 to 5
V	7.5 mm	E/W	180	5.4
	2.5 mm	Bowstring	180	4.0
	.75 mm	E/W Random	Random	4.0

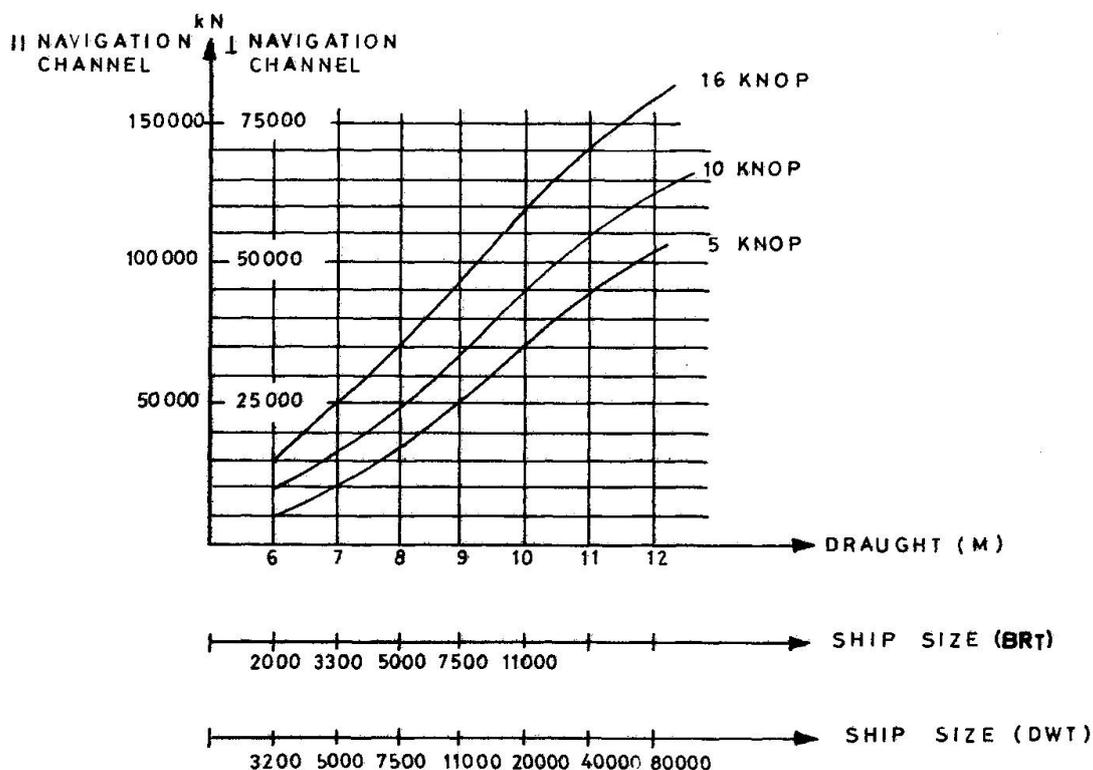
As part of the work done by the association of nordic road administrations, specifications for the static forces to be used in the design has been worked out. These are related to the size of the ship, the ship depth and velocity. See fig. 1. (1).

Fig. 1 Magnitude of ship collision force as a function of ship size and speed

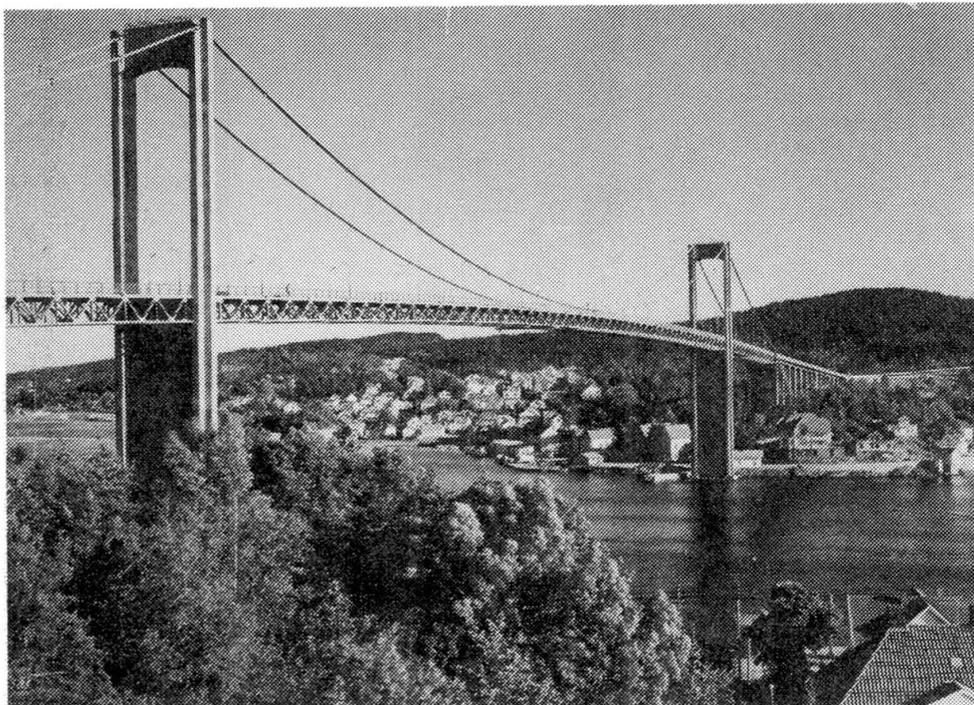
Fig. 6 Brevik Bridge

The 677m long structure consists of suspended main- and sidespans of 272m and 85m respectively in addition to 16 viaducts. Fig. 6.
