Zeitschrift: IABSE reports = Rapports AIPC = IVBH Berichte

Band: 42 (1983)

Theme A

Case Stories of Recent Ship Collision Accidents
Rapports d'accidents de collisions de bateaux
Fälle von neueren Schiffskollisionen

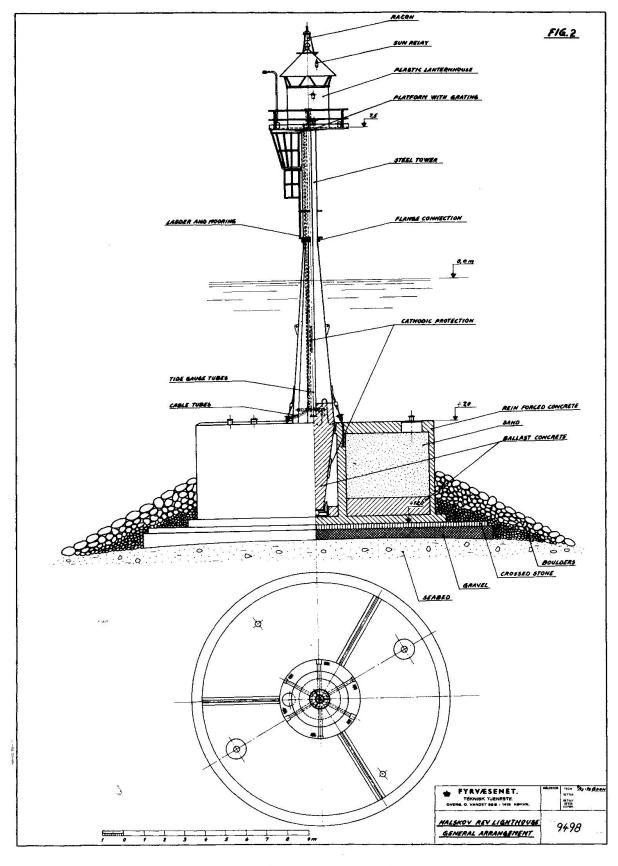
Fig. 2 Lighthouse. General arrangement

The lighthouses have been designed in such a way that if they are run into, damages to the ship should be as insignificant as possible, as this would be less costly, less dangerous to the crew, and reduce the risk of oil pollution.

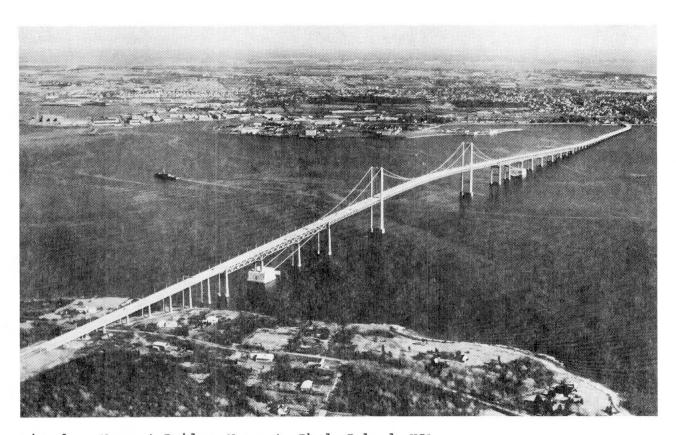
Fig. 1. Newport Bridge, Newport, Rhode Island, USA.

The Newport Bridge is approximately 3 km long, crossing the Eastern Passage of Narragansett Bay at Newport, Rhode Island (Fig. 1). The main shipping channel is bridged by a suspension span 488 m long, with a clear height of 66 m at the center of the channel. The water depth beneath the suspension spans ranges from 30 to 45 m. The tower piers are of "Potomac type" caisson construction, founded on steel H-piles driven into sands that fill the glacial gorge underlying the bay.

Shortly after noon on February 19, 1981, the bridge was struck by the tanker Gerd Maersk, which was proceeding up the bay toward Providence. The ship was fully laden with a cargo of fuel oil, and displaced 45,000 (metric) tons at the time of the accident. Navigating in a dense fog, the pilot had no warning

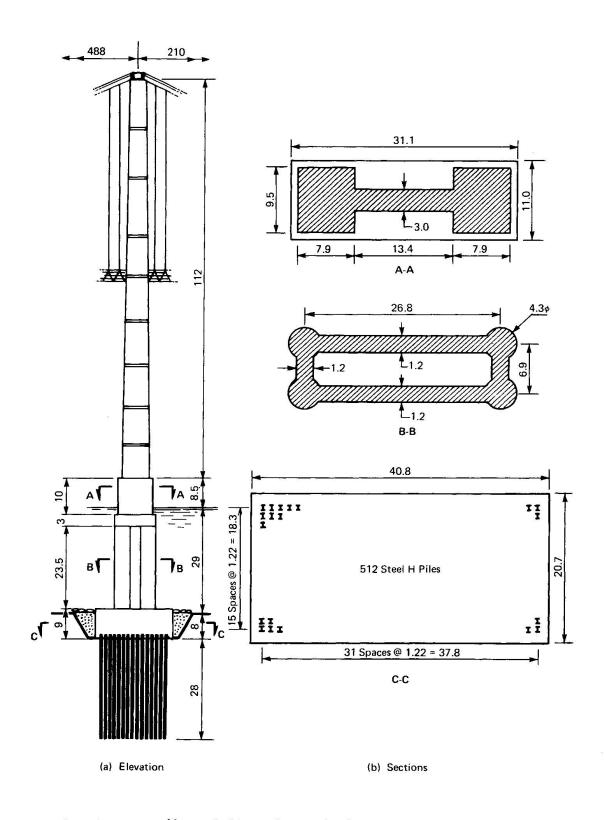
Fig. 5. Details and dimensions of pier.

Details and dimensions of the pier are shown in Figs. 5a and 5b. The dead weight of the pier (neglecting 12,000 tons buoyancy) is 32,000 tons, and the superstructure reaction to the piertop is an additional 11,000 tons.

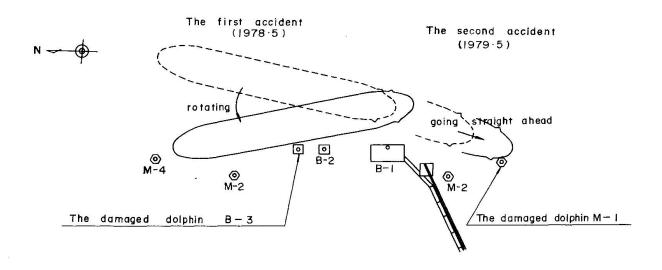
Fig. 4 Geometry of the Collisions

The circumstances of the first collision accident in 1978 is described as follows: (See Fig.4)

As in the first accident the same cargo vessel, in 1979, lost proper speed while she was approaching the berth from the north, then collided with the south mooring dolphin M-1.

Both collisions were caused by the mistakes of the operators. But, as described in the beginning of the article, Japanese coastal/offshore structures are located in very confused sea areas and it is one of the reasons of the frequent occurence of ship collision casualties.

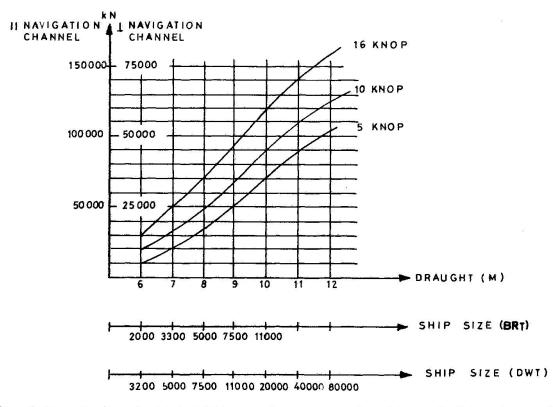
Fig. 1 Magnitude of ship collision force as a function of ship size and speed

As part of the work done by the association of nordic road administrations, spesifications for the static forces to be used in the design has been worked out. These are related to the size of the ship, the ship depth and velocity. See fig. 1. (1).
