Artikel: Recovery and repair of the Second Narrows Railway Bridge
Autor: Jamieson, Donald H. / Calder, David G.
DOI: <https://doi.org/10.5169/seals-32400>

Recovery and Repair of the Second Narrows Railway Bridge
R habilitation et r paration du pont ferroviaire de Second Narrows
Wiederherstellung und Reparatur der zweiten Eisenbahnbr cke
von Second Narrows

The paper describes the damage caused by a ship collision with the Canadian National Railway Lift Span in Vancouver, British Columbia. The theoretical and practical consideration of the stabilisation and recovery schemes are discussed and the equipment and procedures used in the twenty weeks it took to restore the train service are described in detail.

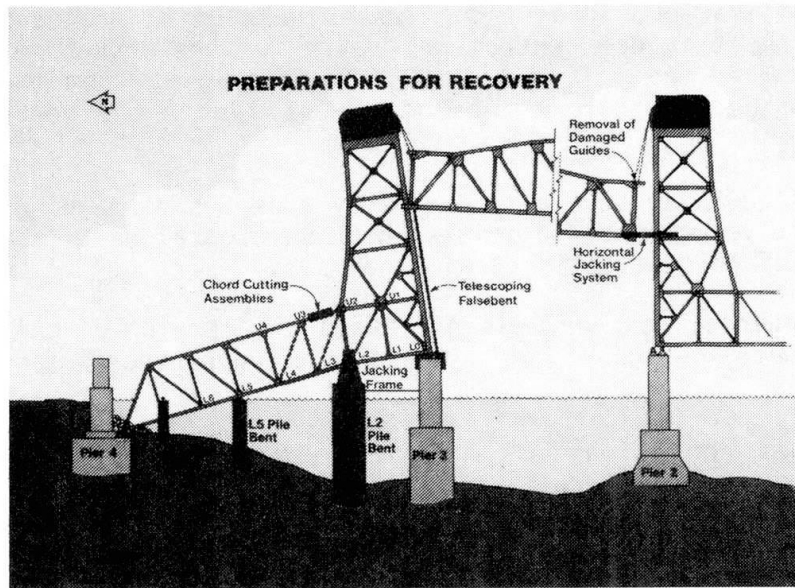
Figure 5
severed truss span would rotate as it was raised to the horizontal for subsequent dismantling in large sections.

The philosophy of the recovery procedure envisaged isolating the lift span and tower from the partially submerged portion of the span.
