**Recovery and Repair of the Second Narrows Railway Bridge**  
R habilitation et r paration du pont ferroviaire de Second Narrows  
Wiederherstellung und Reparatur der zweiten Eisenbahnbr cke  
von Second Narrows

**Donald H. JAMIESON**  
Professional Engineer  
Canron Inc.  
Vancouver, BC, Canada

**David G. CALDER**  
Professional Engineer  
Swan Wooster Eng. Co. Ltd.  
Vancouver, BC, Canada

The paper describes the damage caused by a ship collision with the Canadian National Railway Lift Span in Vancouver, British Columbia. The theoretical and practical consideration of the stabilisation and recovery schemes are discussed and the equipment and procedures used in the twenty weeks it took to restore the train service are described in detail.

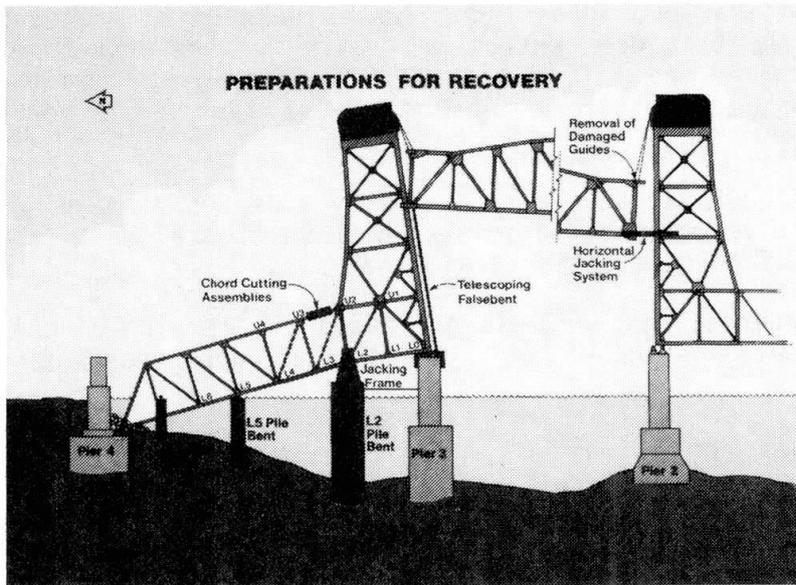
Figure 5  
severed truss span would rotate as it was raised to the horizontal for subsequent dismantling in large sections.

The philosophy of the recovery procedure envisaged isolating the lift span and tower from the partially submerged portion of the span.
