Recovery and Repair of the Second Narrows Railway Bridge

The paper describes the damage caused by a ship collision with the Canadian National Railway Lift Span in Vancouver, British Columbia. The theoretical and practical consideration of the stabilisation and recovery schemes are discussed and the equipment and procedures used in the twenty weeks it took to restore the train service are described in detail.

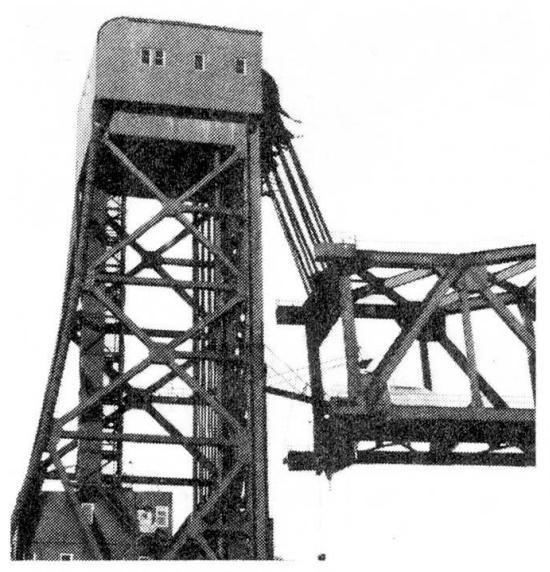
Figure 3

The tower lost substantial support as the bearings were displaced to the extent that they were partially projecting over the N.E. and S.W. edges of the main pier. In this precarious state of equilibrium the lift span, which had been torn from the vertical tower guides (Fig. 3) was left hanging, hammock-like, from the lift ropes.

Upon receipt of the instruction to undertake Canron engineering the work the aroup directed their efforts toward the predominant stabilize the structure and to need to Stabilization prepare recovery procedures. included the immediate installation of wire rope diagonal bracing between the lift span and the south tower and shear devices between the lift span and the north tower. Concurrently with this work the north lift girder was stayed against further movement and the 1000t counterweight in the north tower was prevented from further downward movement by the installation of articulated platework hangers capable of carrying the total weight. Upward movement of north and south counterweights was prevented by the rigging of heavy down-haul tackle.
