Repair and Strengthening of Reinforced Concrete Buildings

In 1978, a severe earthquake shook the Peninsula Izu located 120 km southwest of Tokyo, Japan. Several R/C school buildings were damaged. This paper presents the damage, the method of repair and strengthening, and the seismic capacity of the pre- and post-strengthened buildings.

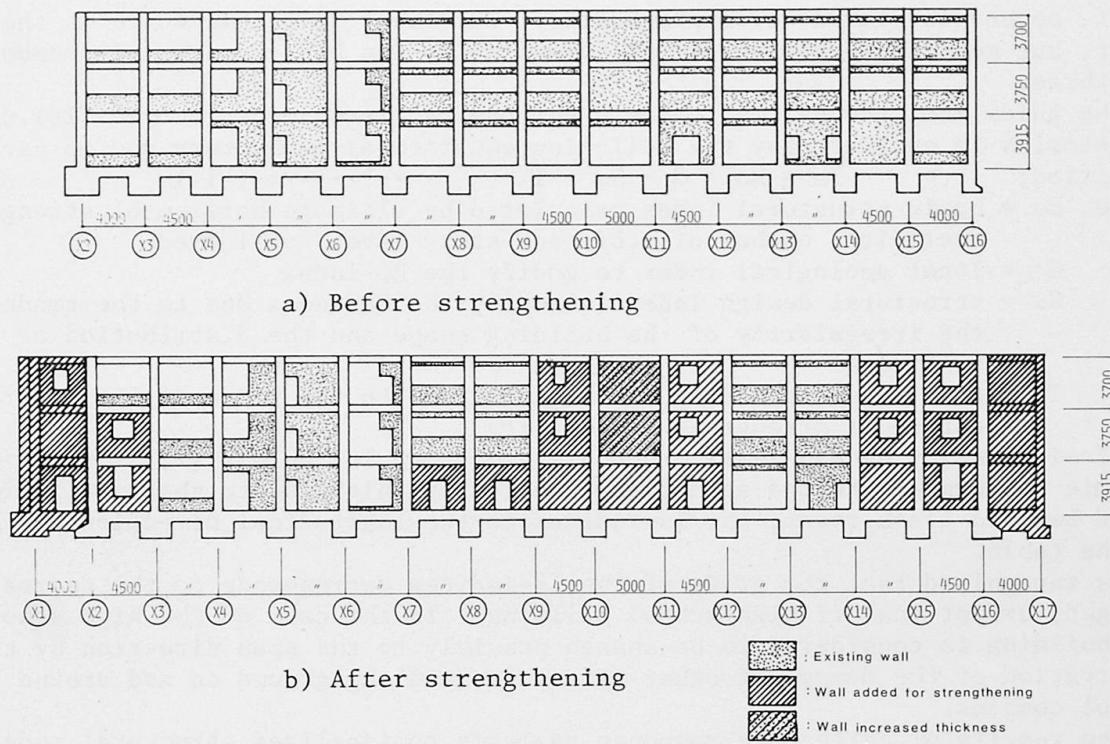
Fig. 8 Frame #Y3 of Atagawa Junior High School

Atagawa junior high school building was one of the damaged buildings. A number of cracks were seen in columns, beams and walls. Both ends of the building were sunk several centimeters. By the excavation of ground, it was found that the footing beams at the west end were failed in shear. Seismic performance of other school buildings were quite well, while hair cracks in the structures, and damage to the non-structural elements were found.

In the case of Inatori junior high school buildings, the center core was demolished immediately and reconstructed. The expansion joints were newly provided between the center core and both wings. The cracks in the west and east wing were repaired by epoxy injection. Cracks in other buildings were also repaired by epoxy injection.
