Artikel: Repair and strengthening of reinforced concrete buildings
Autor: Okada, Tsuneo / Murakami, Masaya / Seki, Matsutaro
DOI: <https://doi.org/10.5169/seals-35872>

Repair and Strengthening of Reinforced Concrete Buildings

In 1978, a severe earthquake shook the Peninsula Izu located 120 km southwest of Tokyo, Japan. Several R/C school buildings were damaged. This paper presents the damage, the method of repair and strengthening, and the seismic capacity of the pre- and post-strengthened buildings.

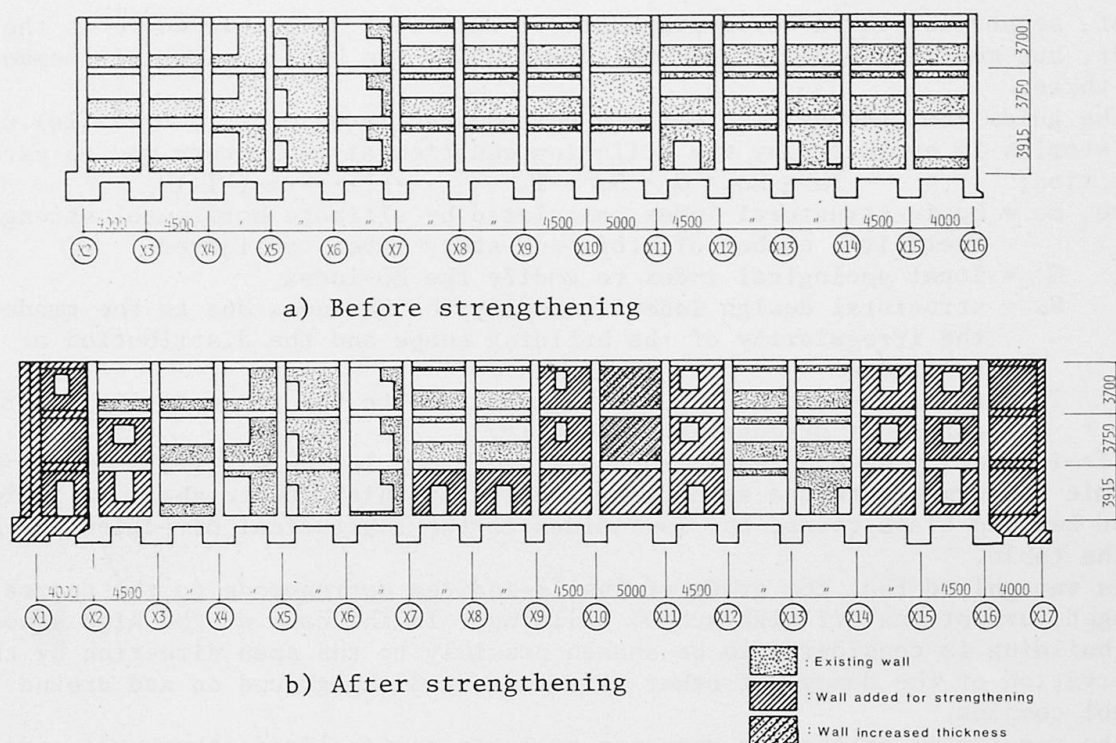
Fig. 8 Frame #Y3 of Atagawa Junior High School

Atagawa junior high school building was one of the damaged buildings. A number of cracks were seen in columns, beams and walls. Both ends of the building were sunk several centimeters. By the excavation of ground, it was found that the footing beams at the west end were failed in shear. Seismic performance of other school buildings were quite well, while hair cracks in the structures, and damage to the non-structural elements were found.
