Artikel: Repair and strengthening of reinforced concrete buildings

Repair and Strengthening of Reinforced Concrete Buildings

In 1978, a severe earthquake shook the Peninsula Izu located 120 km southwest of Tokyo, Japan. Several R/C school buildings were damaged. This paper presents the damage, the method of repair and strengthening, and the seismic capacity of the pre- and post-strengthened buildings.

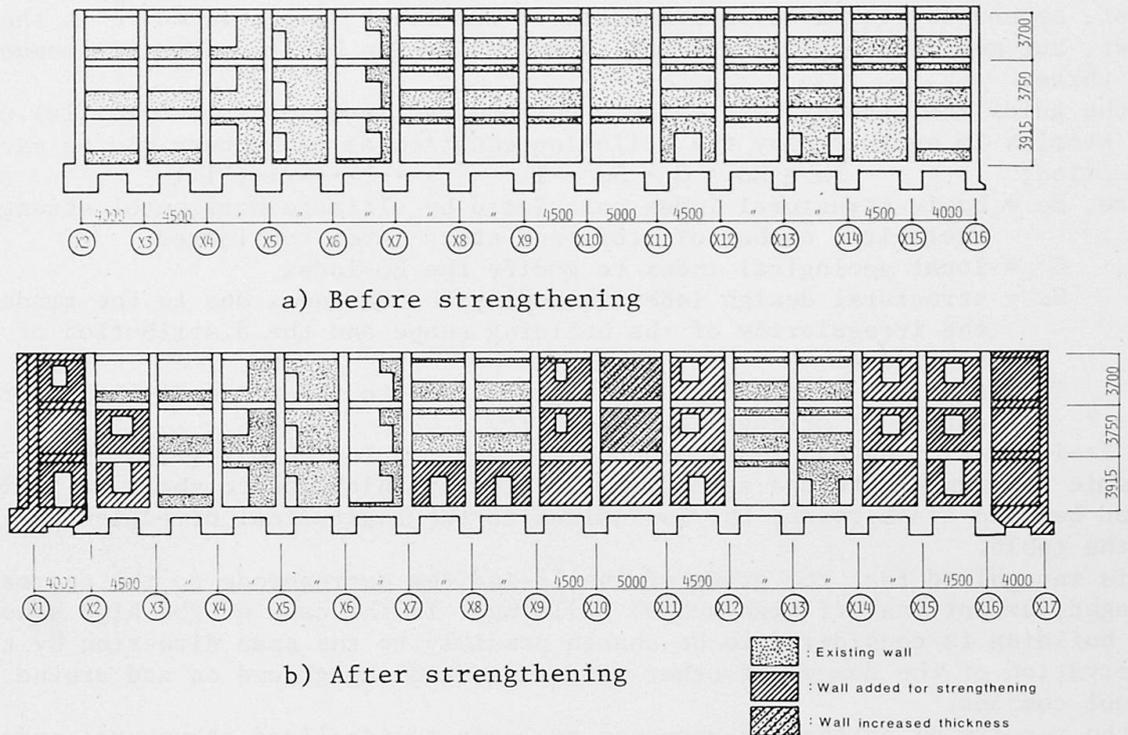
Fig. 8 Frame #Y3 of Atagawa Junior High School

Atagawa junior high school building was one of the damaged buildings. A number of cracks were seen in columns, beams and walls. Both ends of the building were sunk several centimeters. By the excavation of ground, it was found that the footing beams at the west end were failed in shear. Seismic performance of other school buildings were quite well, while hair cracks in the structures, and damage to the non-structural elements were found.
